COMMERCIAL WINDSTORM MITIGATION REPORT (OIR-B1-1802)

Windrush Bay Condominium Association, Inc.

23 Windrush Bay Dr
Tarpon Springs, FL 34689

As of 2/13/2020
FPAT File# MUD2013974

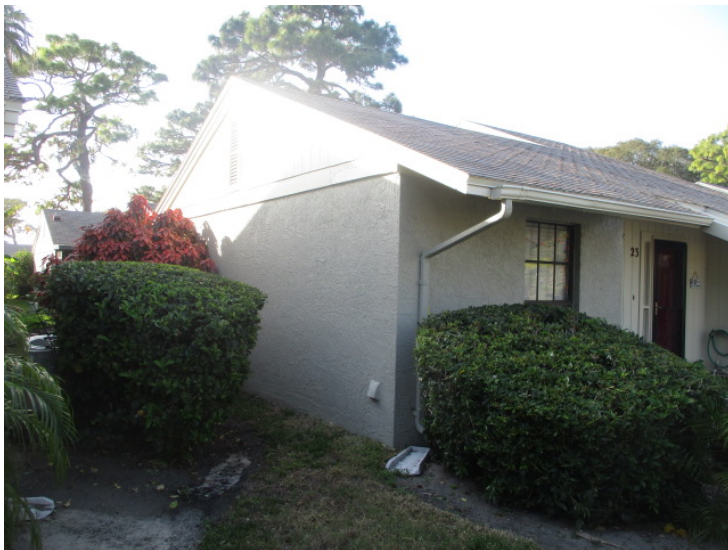
Exterior Elevation

- 4. Roof to Wall Attachment:** **Clips**
Comments: Inspection verified hurricane clips fastened with a minimum of three nails.
- 5. Roof Geometry:** **Other Roof**
Comments: Inspection verified a gable roof shape.

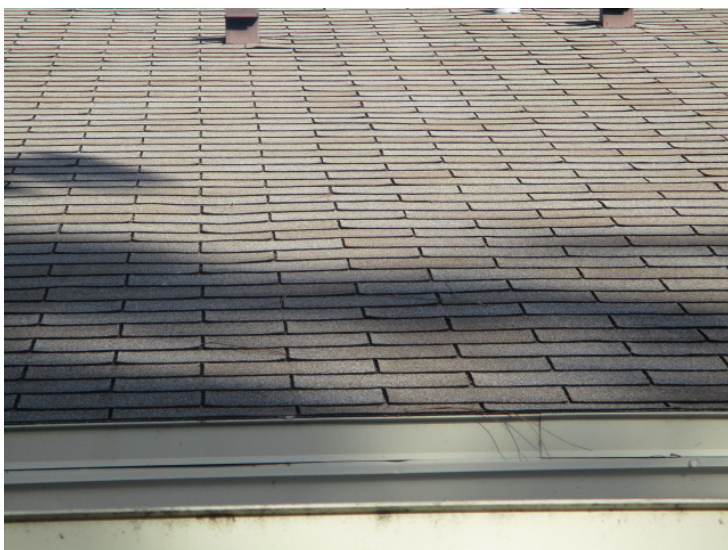
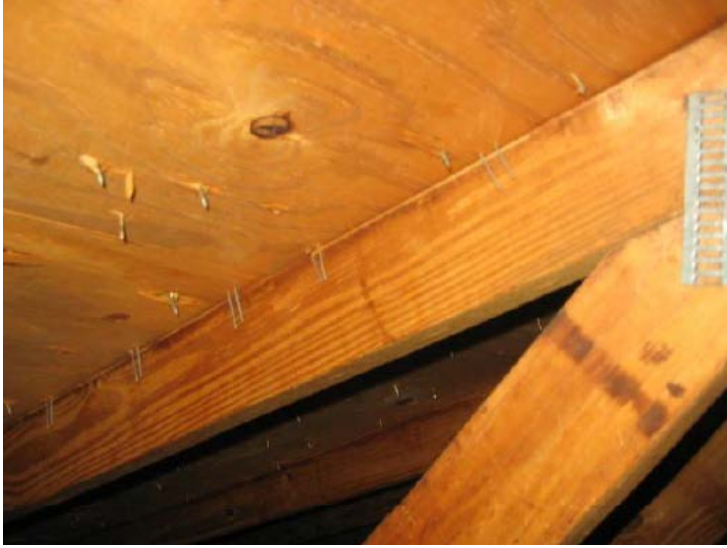
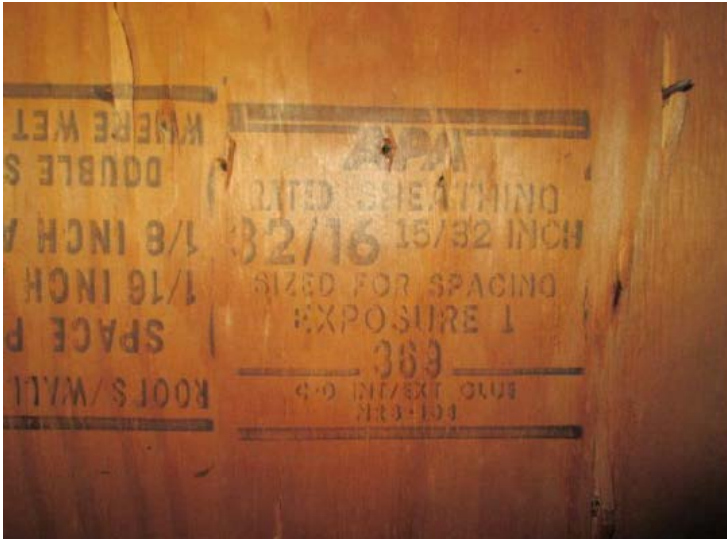
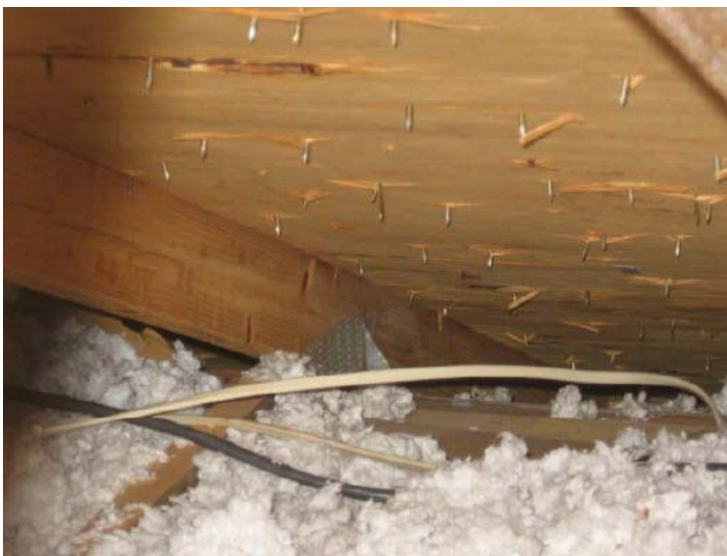
Roof Construction

- 3. Roof Deck Attachment:** **Level A**
Comments: Inspection verified 1/2" plywood roof deck attached with staples at a minimum of 6" on the edge & 12" in the field.
