COMMERCIAL WINDSTORM MITIGATION REPORT (OIR-B1-1802)

Windrush Bay Condominium Association, Inc.

24 Windrush Bay Dr

As of 2/13/2020

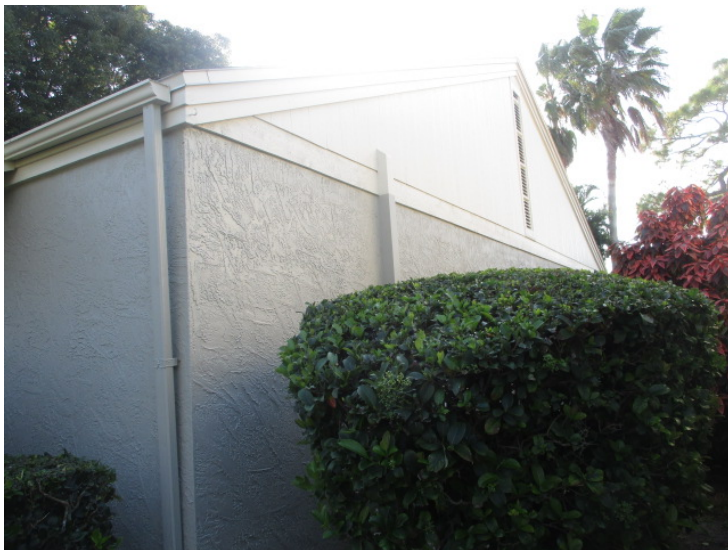
Exterior Elevation

- 4. Roof to Wall Attachment:** **Clips**
Comments: Inspection verified hurricane clips fastened with a minimum of three nails.
- 5. Roof Geometry:** **Other Roof**
Comments: Inspection verified a gable roof shape.

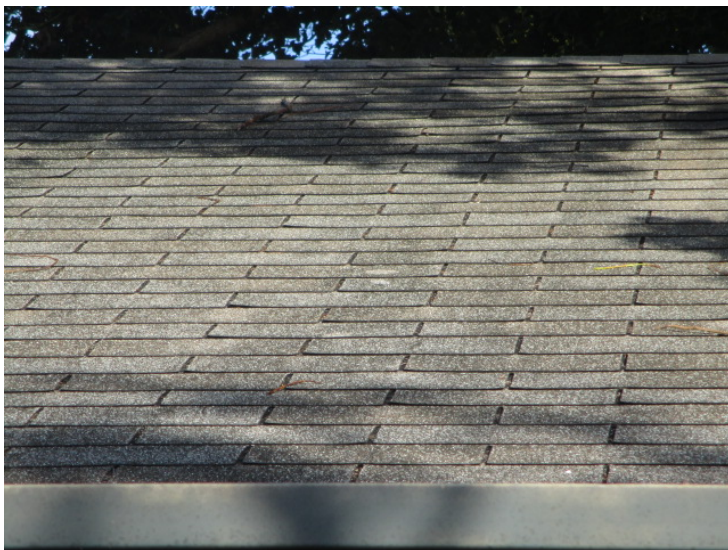
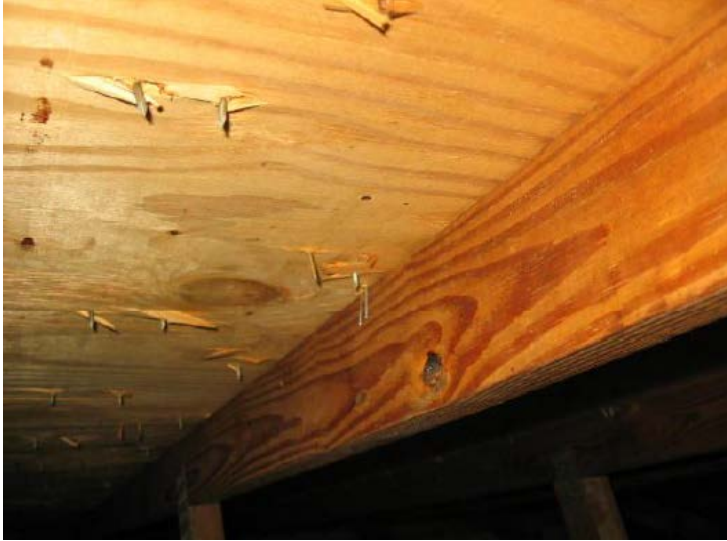
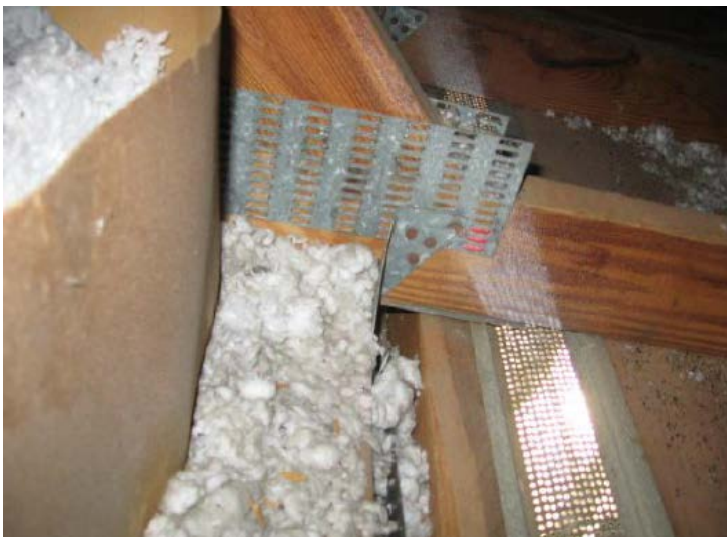
Roof Construction

- 3. Roof Deck Attachment:** **Level A**
Comments: Inspection verified 1/2" plywood roof deck attached with staples at a minimum of 6" on the edge & 12" in the field.
