## COMMERCIAL WINDSTORM MITIGATION REPORT (OIR-B1-1802)

Windrush Bay Condominium Association, Inc.

25 Windrush Bay Dr  
Tarpon Springs, FL 34689

As of 2/13/2020  
FPAT File# MUD2013974

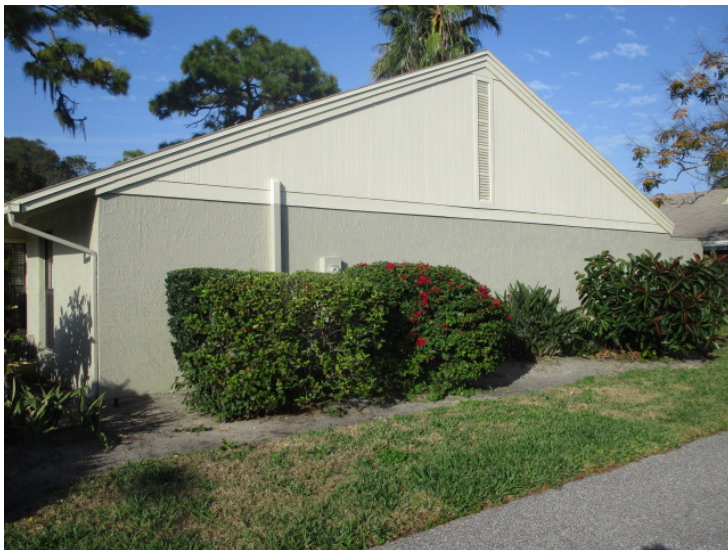
Exterior Elevation

- 5. Roof Geometry:**                      **Other Roof**  
Comments:                                      Inspection verified a gable roof shape.
- 6. SWR:**                                      **No**  
Comments:                                      Inspection verified no secondary water resistance.

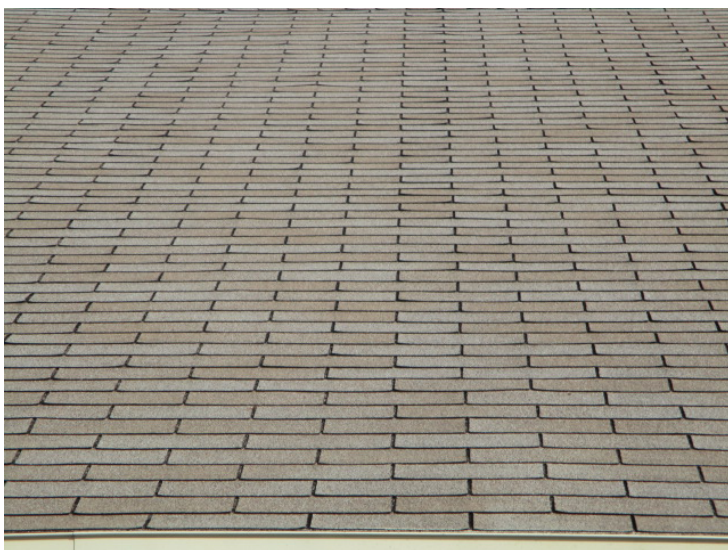
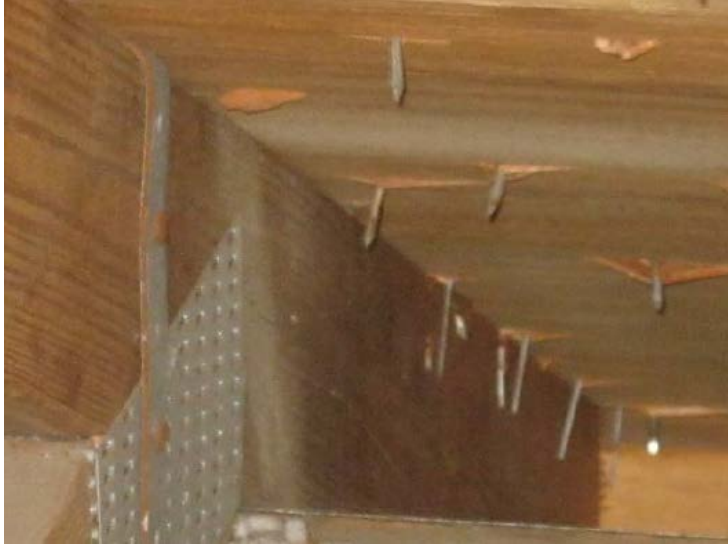
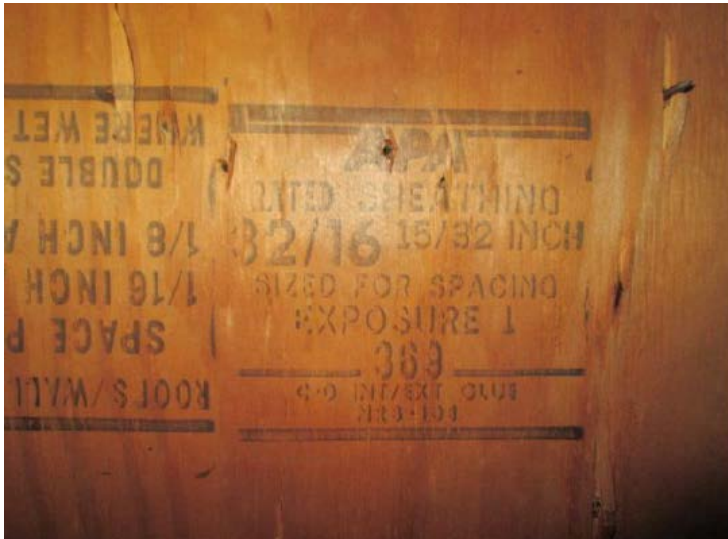
Roof Construction

- 3. Roof Deck Attachment:**        **Level A**  
Comments:                                      Inspection verified 1/2" plywood roof deck attached with staples at a minimum of 6" on the edge & 12" in the field.

- 4. Roof to Wall Attachment:**        **Clips**  
Comments:                                      Inspection verified embedded straps fastened with a minimum of three nails.
