COMMERCIAL WINDSTORM MITIGATION REPORT (OIR-B1-1802)

Windrush Bay Condominium Association, Inc.

28 Windrush Bay Dr

As of 2/13/2020

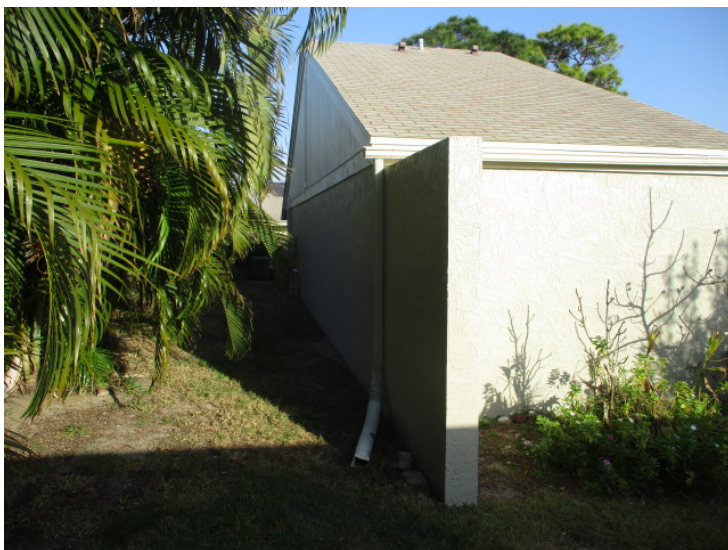
Exterior Elevation

- 4. Roof to Wall Attachment:** **Clips**
Comments: Inspection verified embedded straps fastened with a minimum of three nails.
- 5. Roof Geometry:** **Other Roof**
Comments: Inspection verified a gable roof shape.

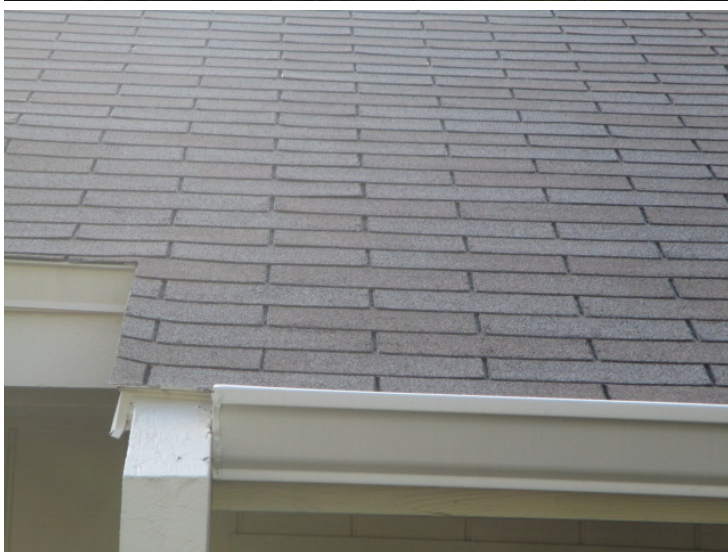
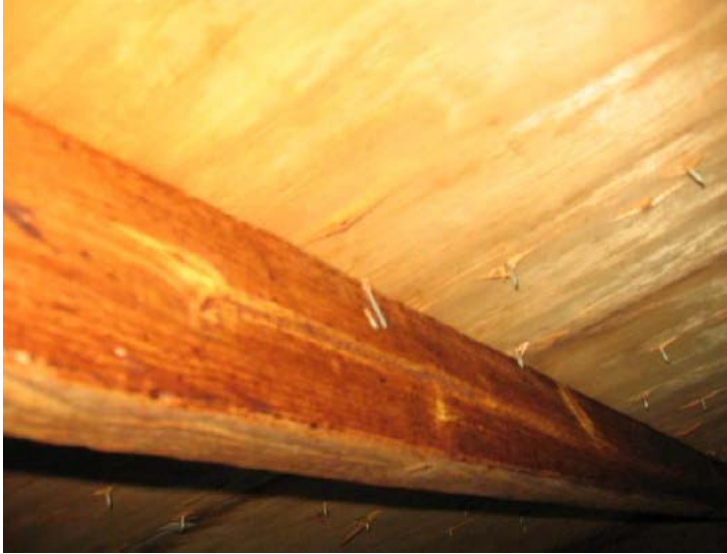
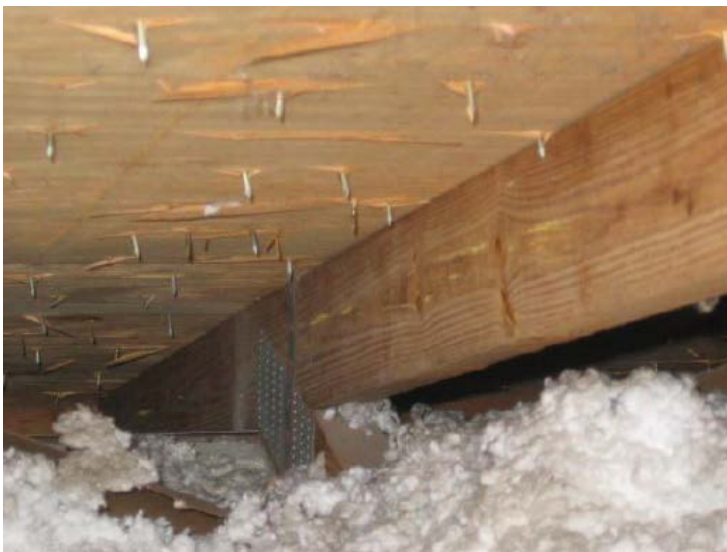
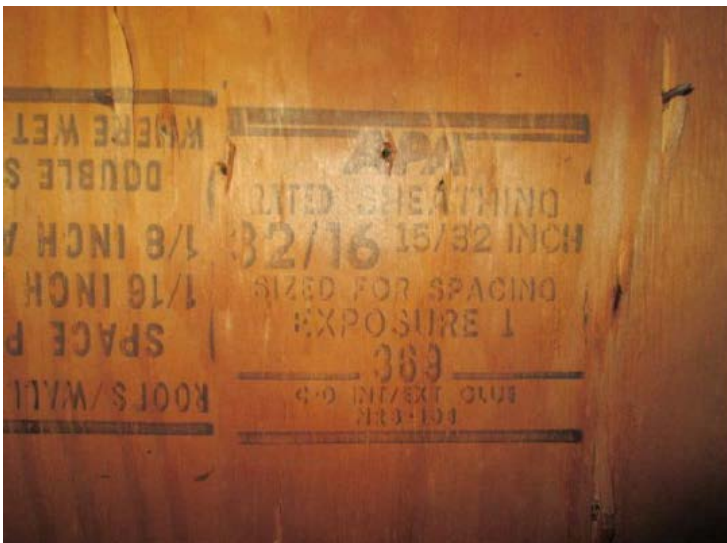
Roof Construction

- 3. Roof Deck Attachment:** **Level A**
Comments: Inspection verified 1/2" plywood roof deck attached with staples at a minimum of 6" on the edge & 12" in the field.
