## COMMERCIAL WINDSTORM MITIGATION REPORT (OIR-B1-1802)

Windrush Bay Condominium Association, Inc.

3 Windrush Bay Dr

As of 2/13/2020

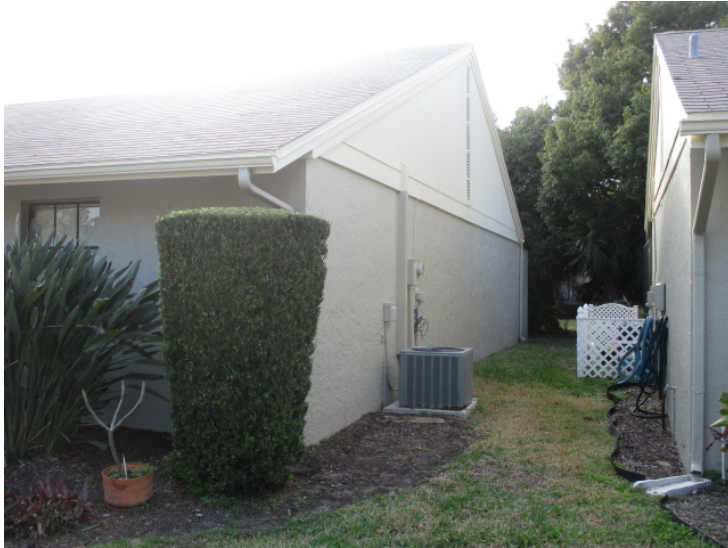
- 5. Roof Geometry:**                      **Other Roof**  
Comments:                                      Inspection verified a gable roof shape.
- 6. SWR:**                                      **No**  
Comments:                                      Inspection verified no secondary water resistance.

Exterior Elevation

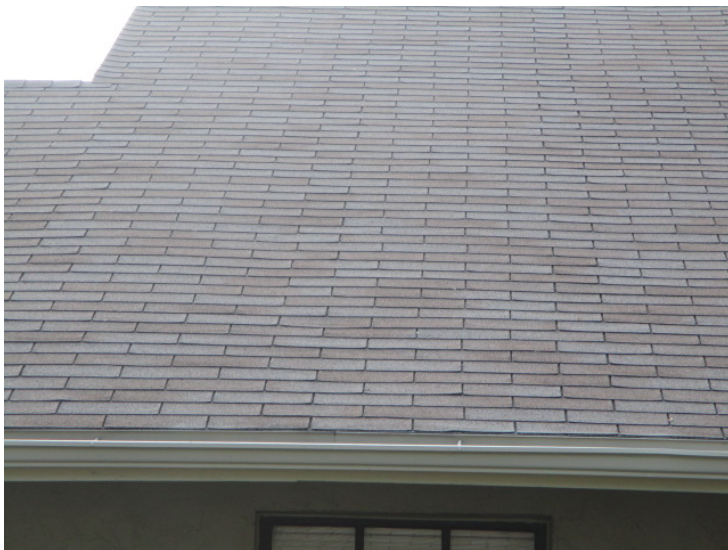
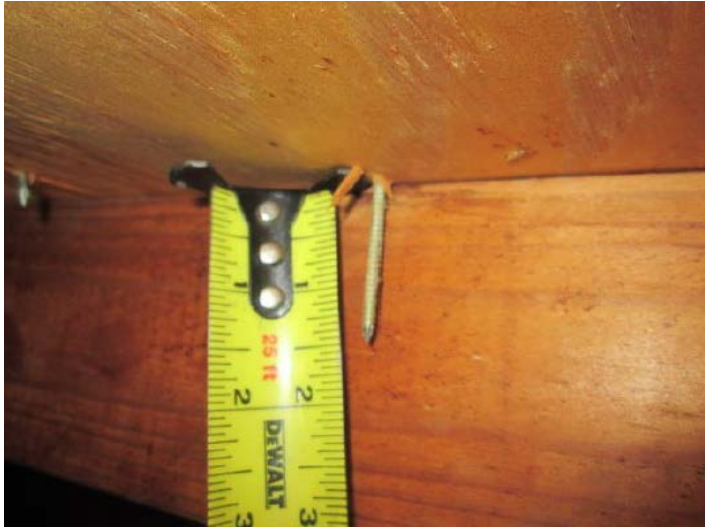
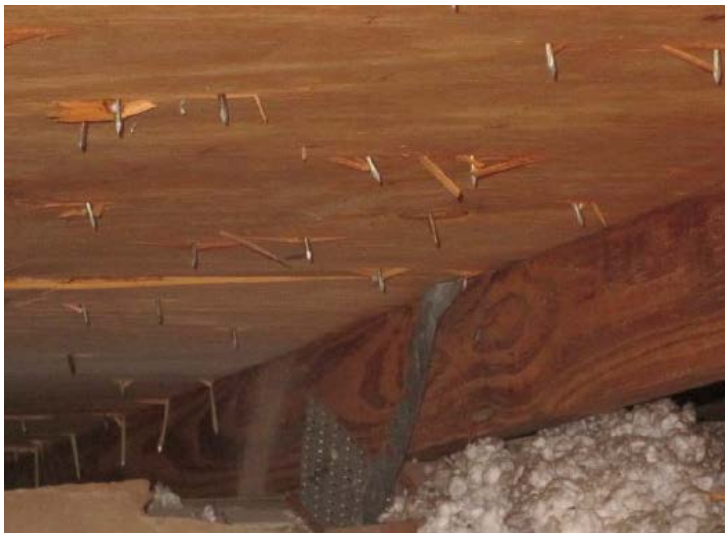
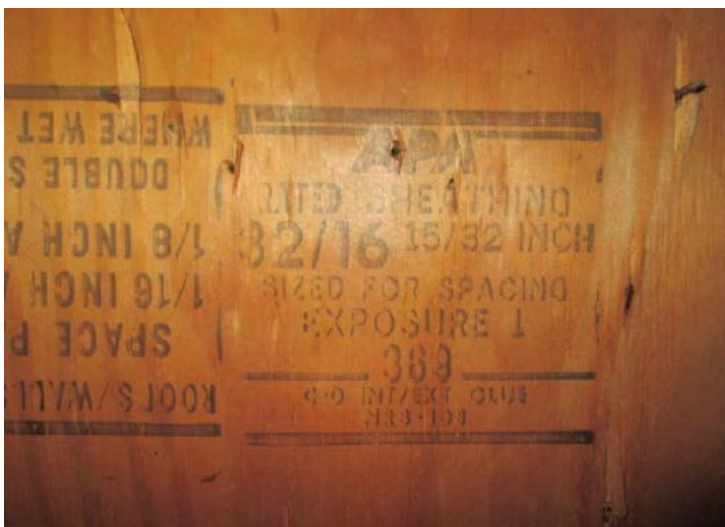
- 3. Roof Deck Attachment:**        **Level A**  
Comments:                                      Inspection verified 1/2" plywood roof deck attached with staples at a minimum of 6" on the edge & 12" in the field.

- 4. Roof to Wall Attachment:**        **Clips**  
Comments:                                      Inspection verified embedded straps fastened with a minimum of three nails.

Roof Construction
