COMMERCIAL WINDSTORM MITIGATION REPORT (OIR-B1-1802)

Windrush Bay Condominium Association, Inc.

30 Windrush Bay Dr
Tarpon Springs, FL 34689

As of 2/13/2020
FPAT File# MUD2013974

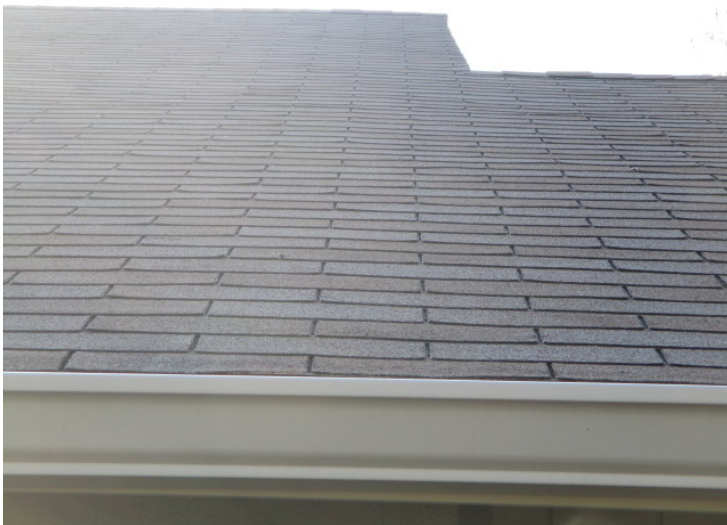
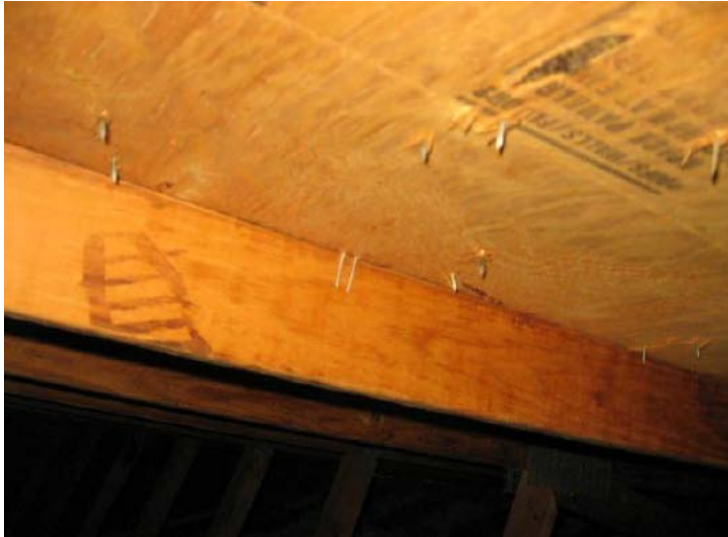
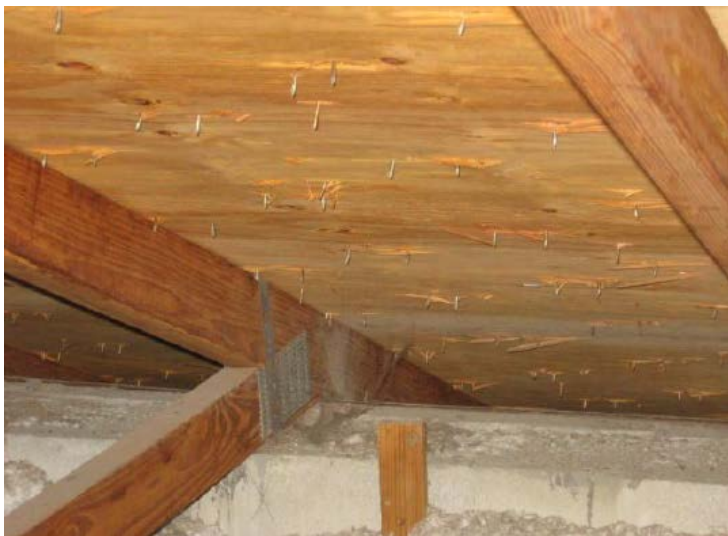
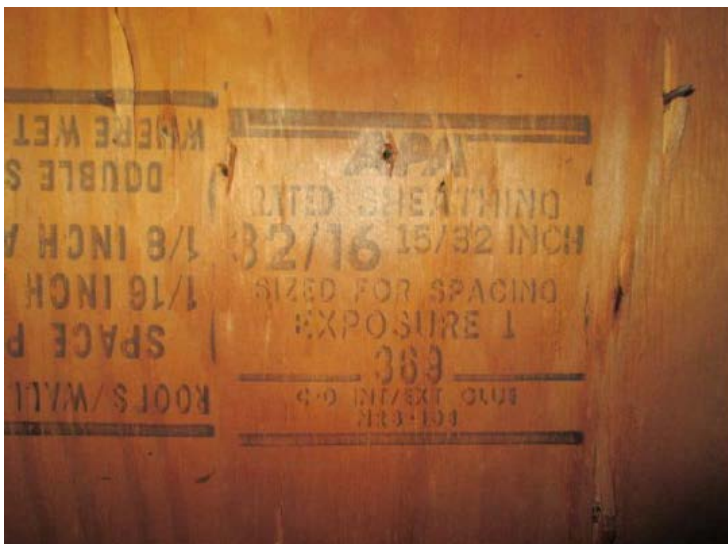
Roof Construction

- 3. Roof Deck Attachment:** **Level A**
Comments: Inspection verified 1/2" plywood roof deck attached with staples at a minimum of 6" on the edge & 12" in the field.

- 4. Roof to Wall Attachment:** **Clips**
Comments: Inspection verified embedded straps fastened with a minimum of three nails.
- 5. Roof Geometry:** **Other Roof**
Comments: Inspection verified a gable roof shape.
