COMMERCIAL WINDSTORM MITIGATION REPORT (OIR-B1-1802)

Windrush Bay Condominium Association, Inc.

31 Windrush Bay Dr
Tarpon Springs, FL 34689

As of 2/13/2020
FPAT File# MUD2013974

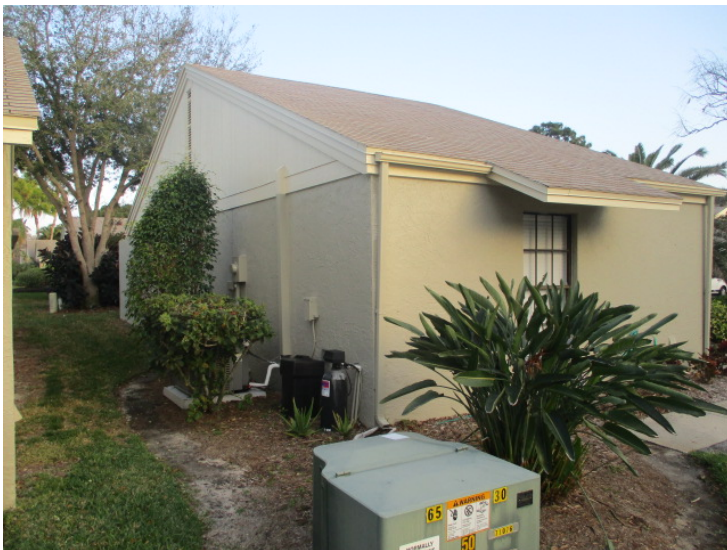
Exterior Elevation

- 4. Roof to Wall Attachment:** **Clips**
Comments: Inspection verified embedded straps fastened with a minimum of three nails.
- 5. Roof Geometry:** **Other Roof**
Comments: Inspection verified a gable roof shape.

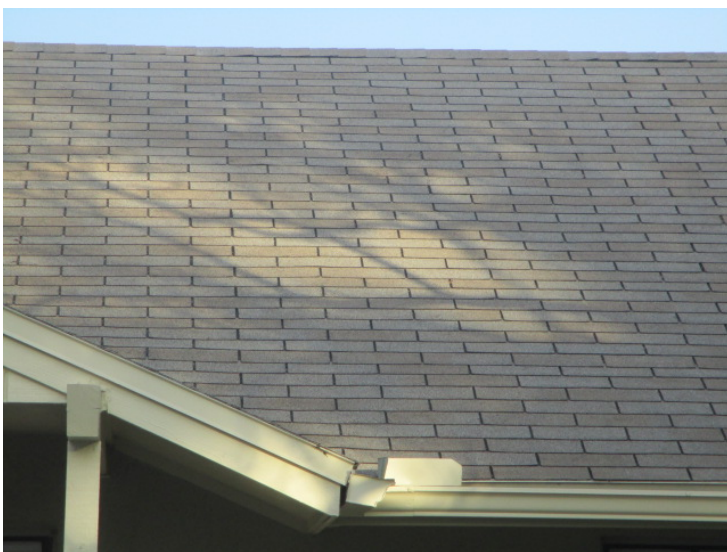
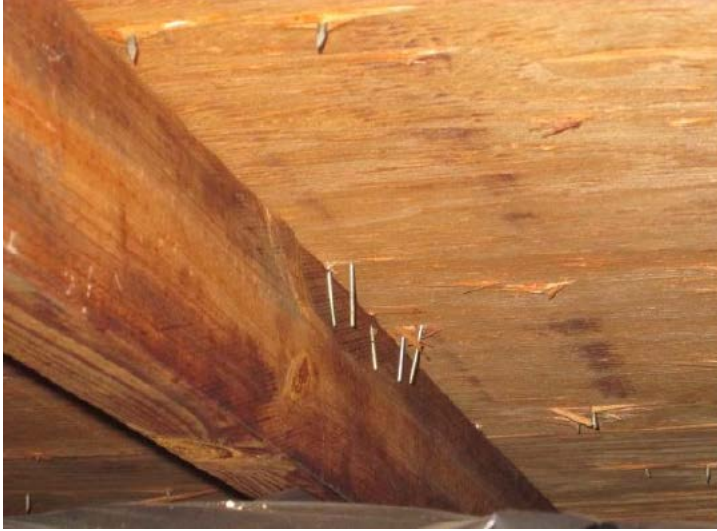
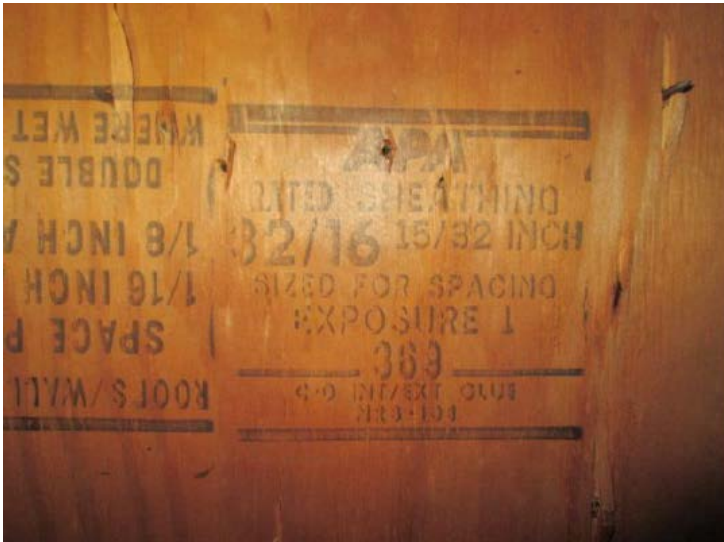
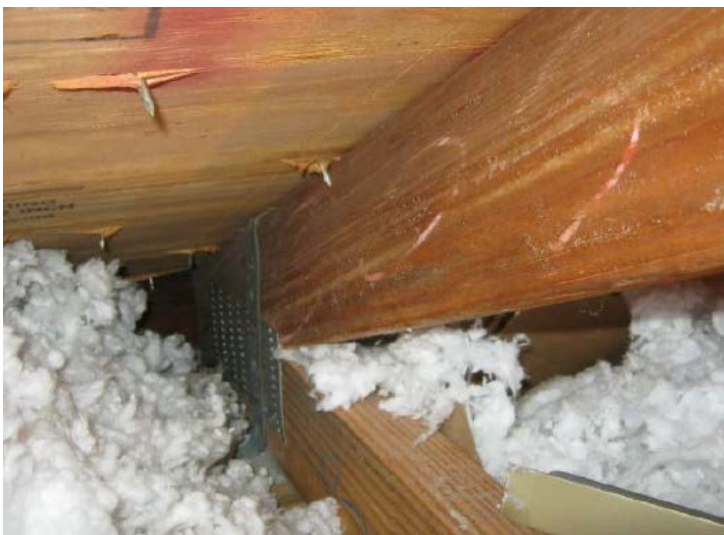
Roof Construction

- 3. Roof Deck Attachment:** **Level A**
Comments: Inspection verified 1/2" plywood roof deck attached with staples at a minimum of 6" on the edge & 12" in the field.

- 6. SWR:** **No**
Comments: Inspection verified no secondary water resistance.
- 7. Opening Protection:** **None or Some Glazed Openings**
Comments: Inspection verified no opening protection.
