COMMERCIAL WINDSTORM MITIGATION REPORT (OIR-B1-1802)

Windrush Bay Condominium Association, Inc.

33 Windrush Bay Dr
Tarpon Springs, FL 34689

As of 2/13/2020
FPAT File# MUD2013974

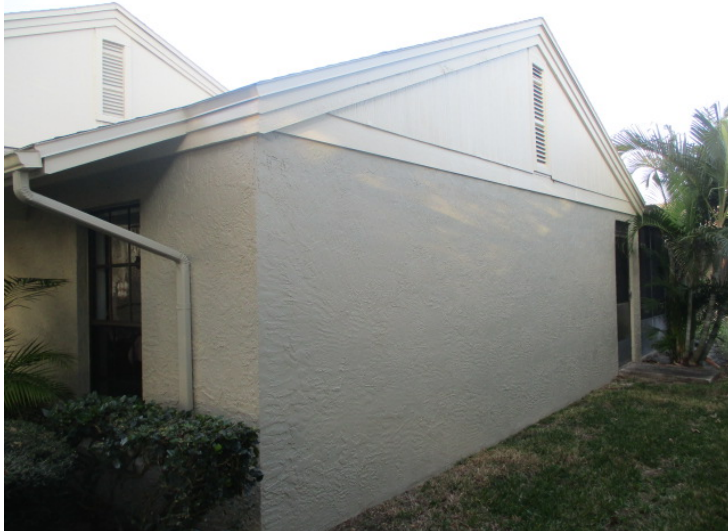
Exterior Elevation

- 4. Roof to Wall Attachment:** **Clips**
Comments: Inspection verified embedded straps fastened with a minimum of three nails.
- 5. Roof Geometry:** **Other Roof**
Comments: Inspection verified a gable roof shape.

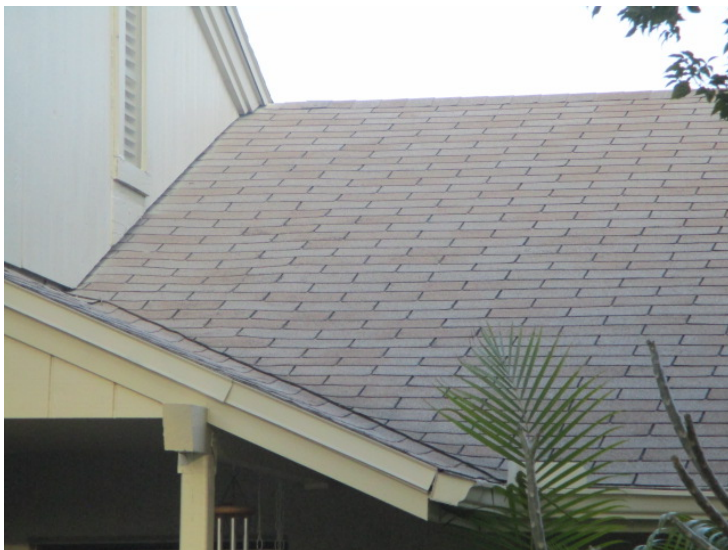
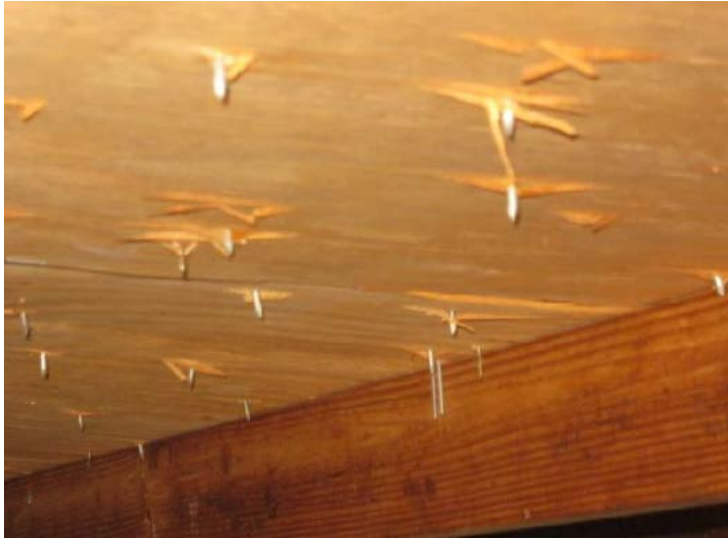
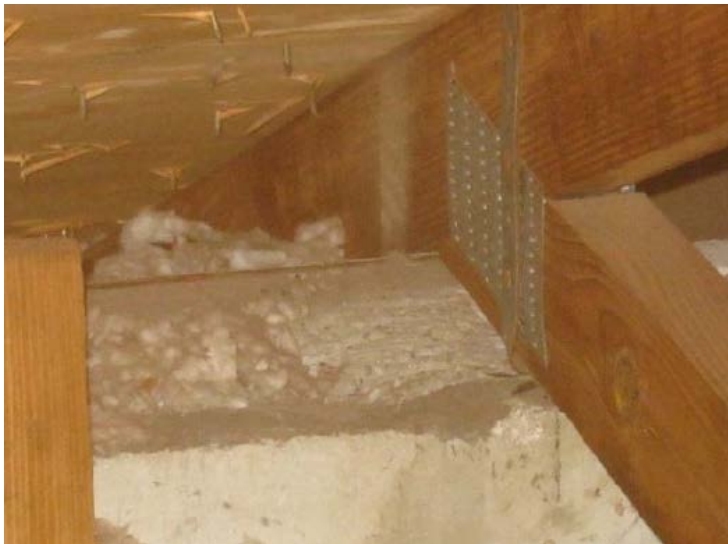
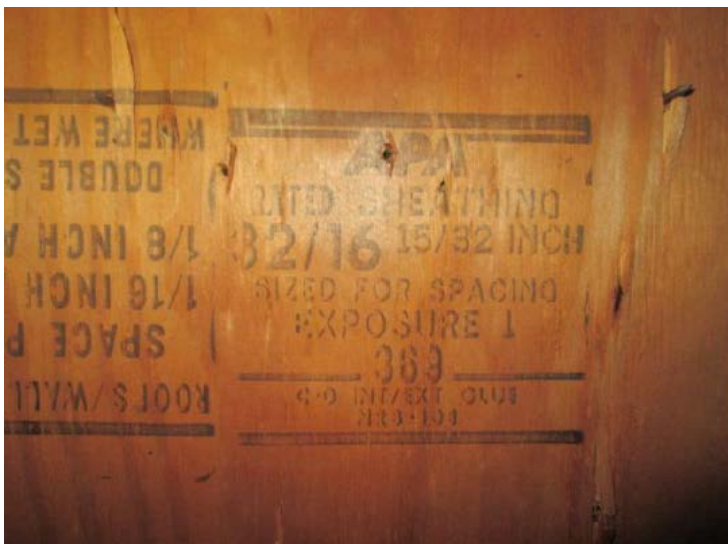
Roof Construction

- 3. Roof Deck Attachment:** **Level A**
Comments: Inspection verified 1/2" plywood roof deck attached with staples at a minimum of 6" on the edge & 12" in the field.
