COMMERCIAL WINDSTORM MITIGATION REPORT (OIR-B1-1802)

Windrush Bay Condominium Association, Inc.

34 Windrush Bay Dr
Tarpon Springs, FL 34689

As of 2/13/2020
FPAT File# MUD2013974

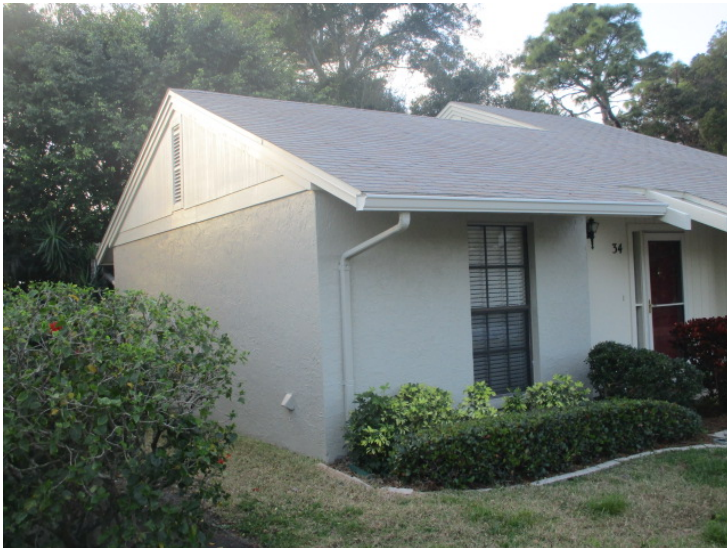
Exterior Elevation

- 4. Roof to Wall Attachment:** **Clips**
Comments: Inspection verified embedded straps fastened with a minimum of three nails.
- 5. Roof Geometry:** **Other Roof**
Comments: Inspection verified a gable roof shape.

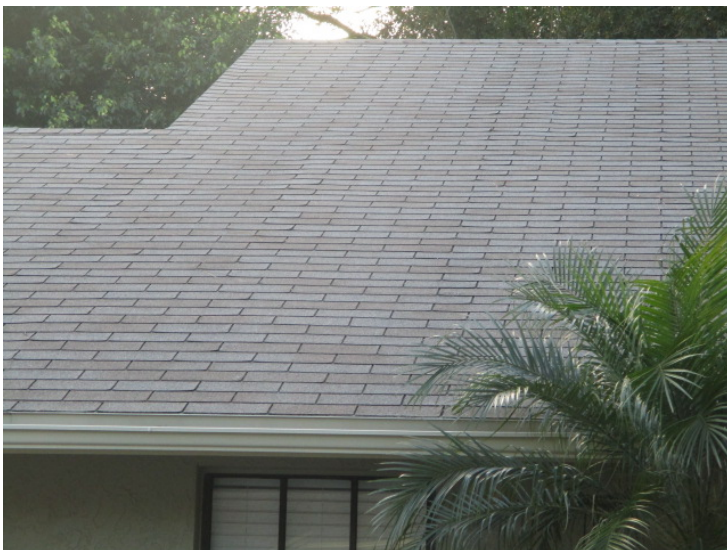
Roof Construction

- 3. Roof Deck Attachment:** **Level A**
Comments: Inspection verified 1/2" plywood roof deck attached with staples at a minimum of 6" on the edge & 12" in the field.
