COMMERCIAL WINDSTORM MITIGATION REPORT (OIR-B1-1802)

Windrush Bay Condominium Association, Inc.

35 Windrush Bay Dr  
Tarpon Springs, FL 34689

As of 2/13/2020  
FPAT File# MUD2013974

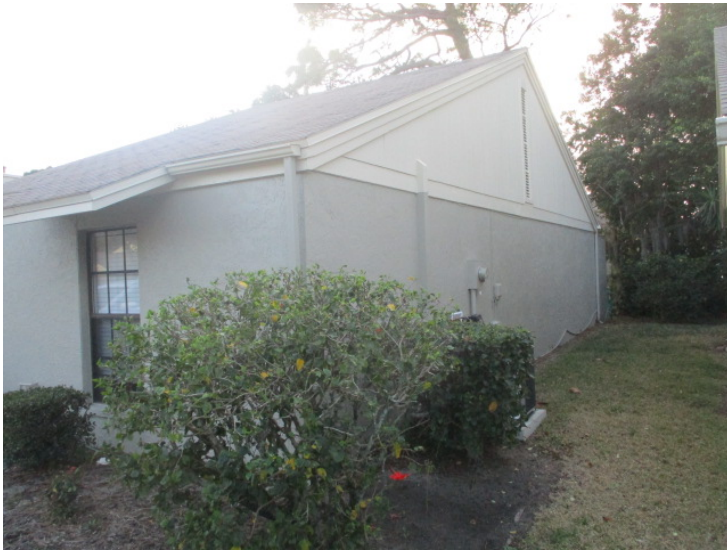
Exterior Elevation

| <b>5. <u>Roof Geometry:</u></b><br>Comments: | <b>Other Roof</b><br>Inspection verified a gable roof shape. |

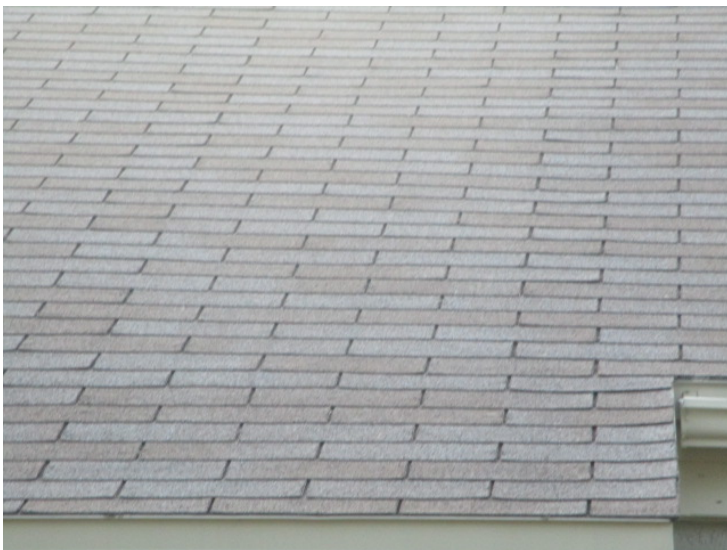
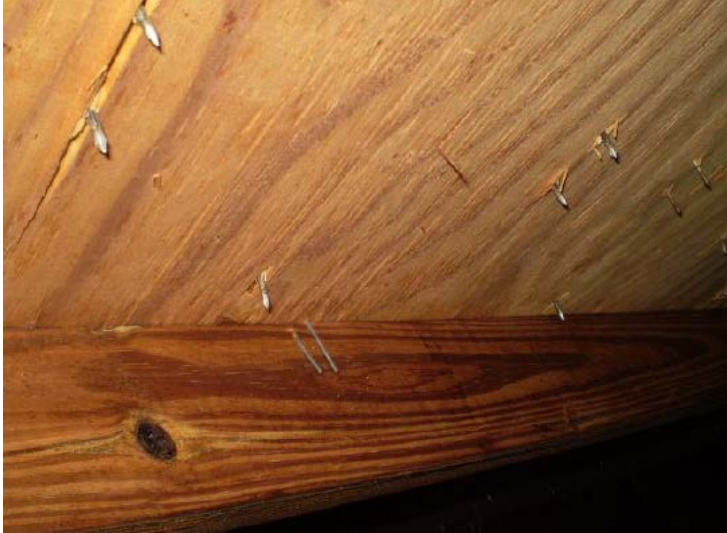
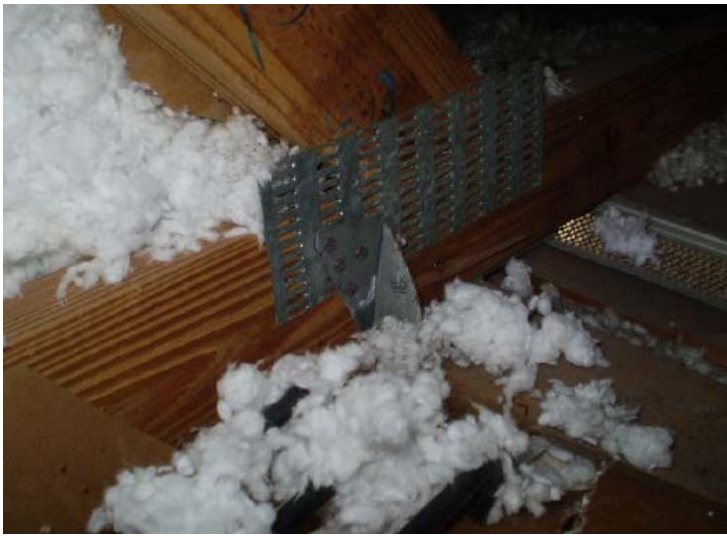
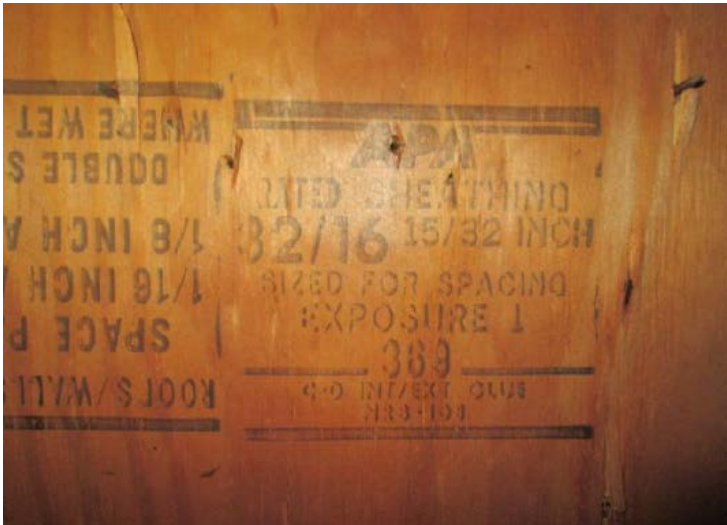
Roof Construction

| <b>3. <u>Roof Deck Attachment:</u></b><br>Comments: | <b>Level A</b><br>Inspection verified 1/2" plywood roof deck attached with staples at a minimum of 6" on the edge & 12" in the field. |
| <b>4. <u>Roof to Wall Attachment:</u></b><br>Comments: | <b>Clips</b><br>Inspection verified hurricane clips fastened with a minimum of three nails. |
| <b>6. <u>SWR:</u></b><br>Comments: | <b>No</b><br>Inspection verified no secondary water resistance. |
