## COMMERCIAL WINDSTORM MITIGATION REPORT (OIR-B1-1802)

Windrush Bay Condominium Association, Inc.

36 Windrush Bay Dr  
Tarpon Springs, FL 34689

As of 2/13/2020  
FPAT File# MUD2013974

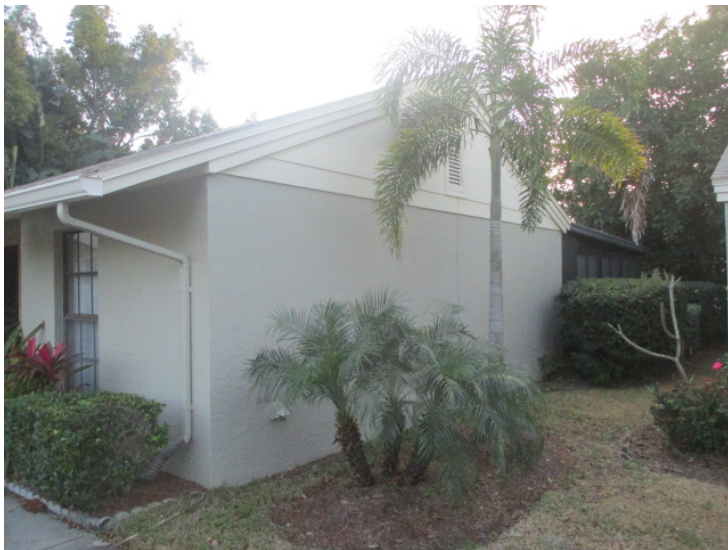
Exterior Elevation

- 5. Roof Geometry:**                      **Other Roof**  
Comments:                                      Inspection verified a gable roof shape.
- 6. SWR:**                                      **No**  
Comments:                                      Inspection verified no secondary water resistance.

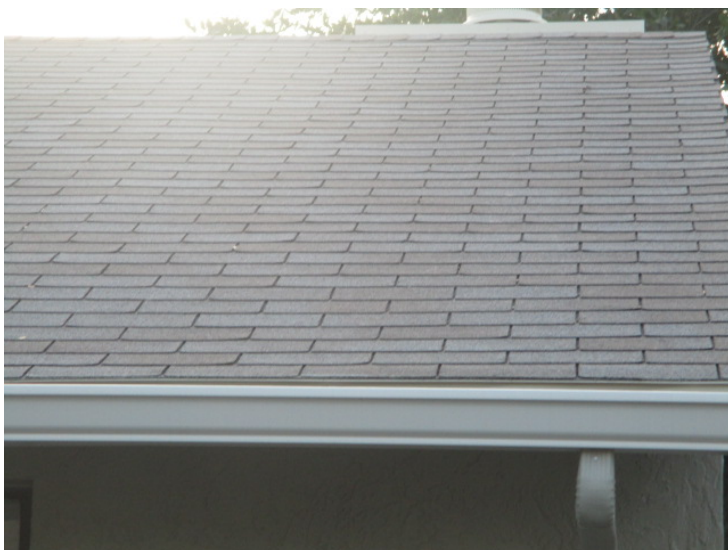
Roof Construction

- 3. Roof Deck Attachment:**        **Level A**  
Comments:                                      Inspection verified 1/2" plywood roof deck attached with staples at a minimum of 6" on the edge & 12" in the field.

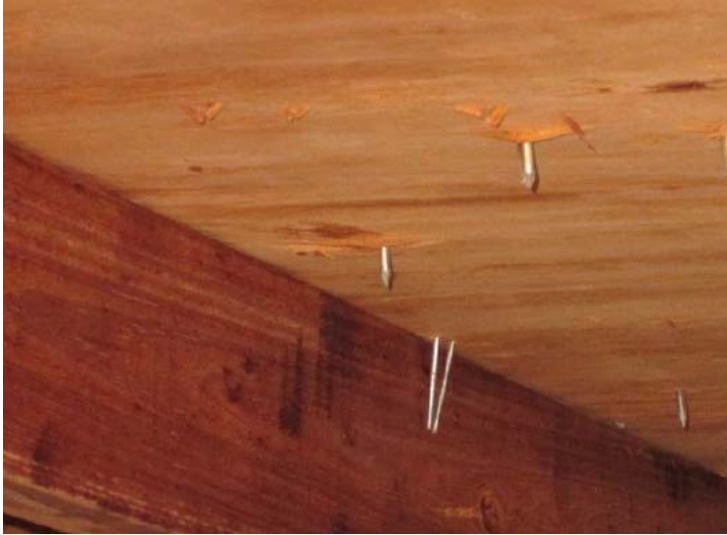
Roof Construction

- 4. Roof to Wall Attachment:**        **Clips**  
Comments:                                      Inspection verified embedded straps fastened with a minimum of three nails.
