COMMERCIAL WINDSTORM MITIGATION REPORT (OIR-B1-1802)

Windrush Bay Condominium Association, Inc.

37 Windrush Bay Dr  
Tarpon Springs, FL 34689

As of 2/13/2020  
FPAT File# MUD2013974

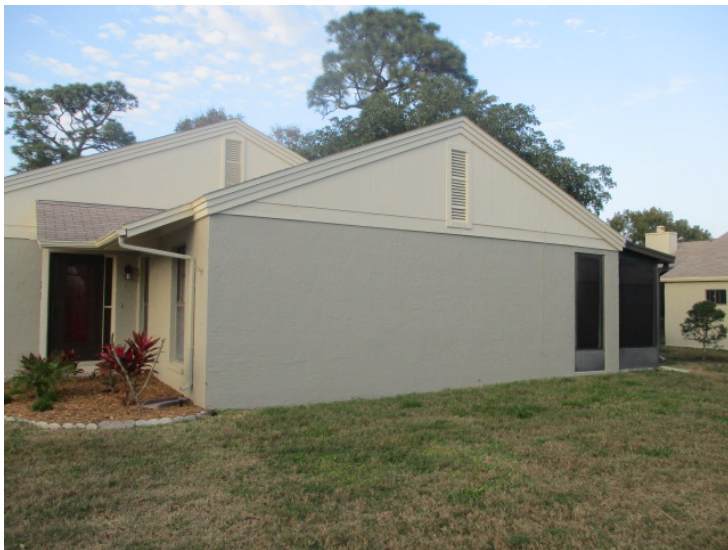
Exterior Elevation

- 5. Roof Geometry:**                      **Other Roof**  
Comments:                                      Inspection verified a gable roof shape.
- 6. SWR:**                                      **No**  
Comments:                                      Inspection verified no secondary water resistance.

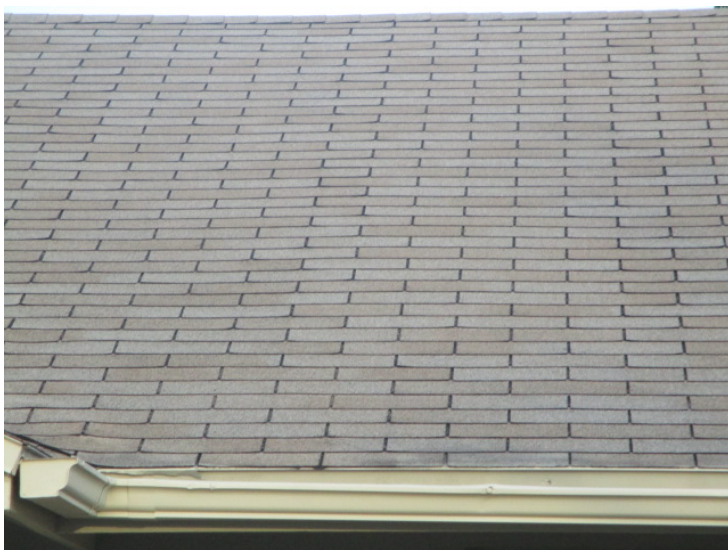
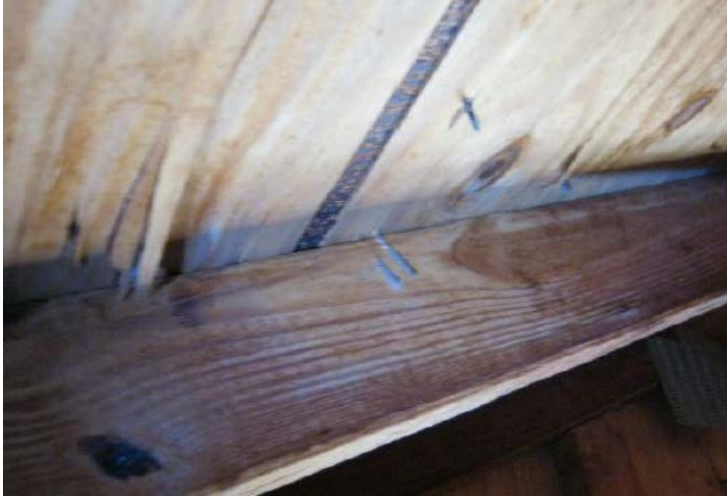
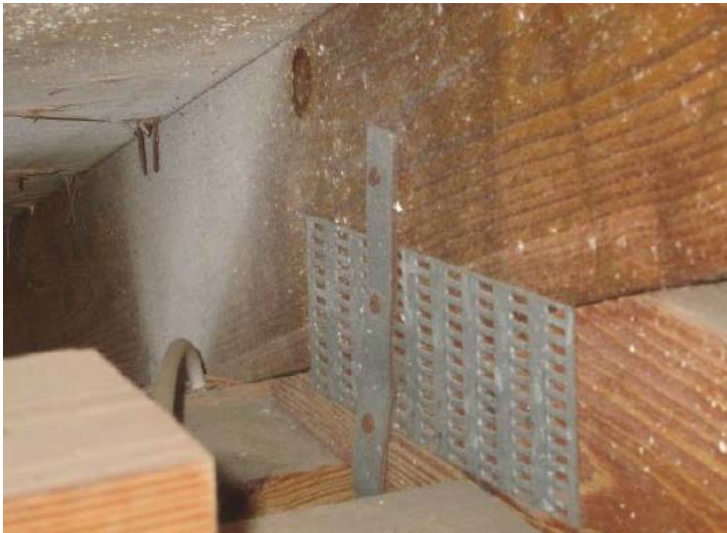
Roof Construction

- 3. Roof Deck Attachment:**        **Level A**  
Comments:                                      Inspection verified 1/2" plywood roof deck attached with staples at a minimum of 6" on the edge & 12" in the field.

- 4. Roof to Wall Attachment:**        **Clips**  
Comments:                                      Inspection verified embedded straps fastened with a minimum of three nails.
