COMMERCIAL WINDSTORM MITIGATION REPORT (OIR-B1-1802)

Windrush Bay Condominium Association, Inc.

38 Windrush Bay Dr
Tarpon Springs, FL 34689

As of 2/13/2020
FPAT File# MUD2013974

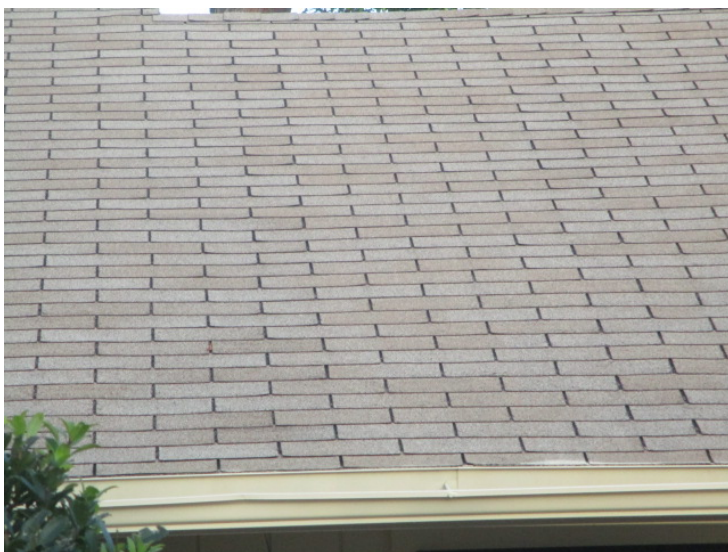
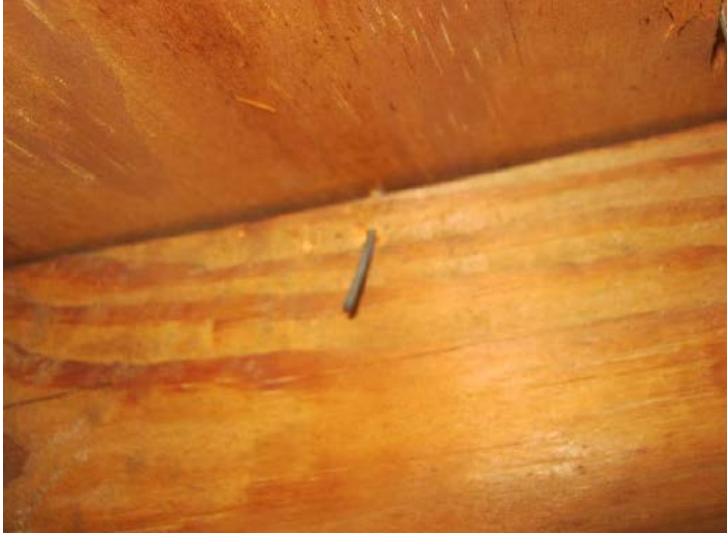
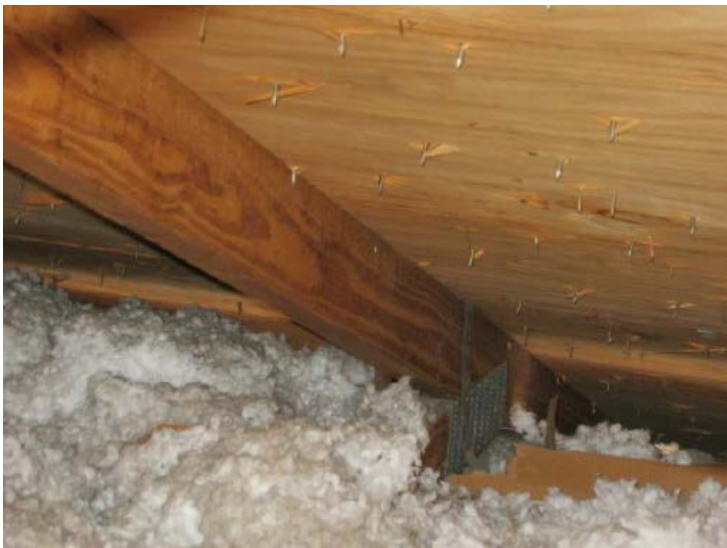
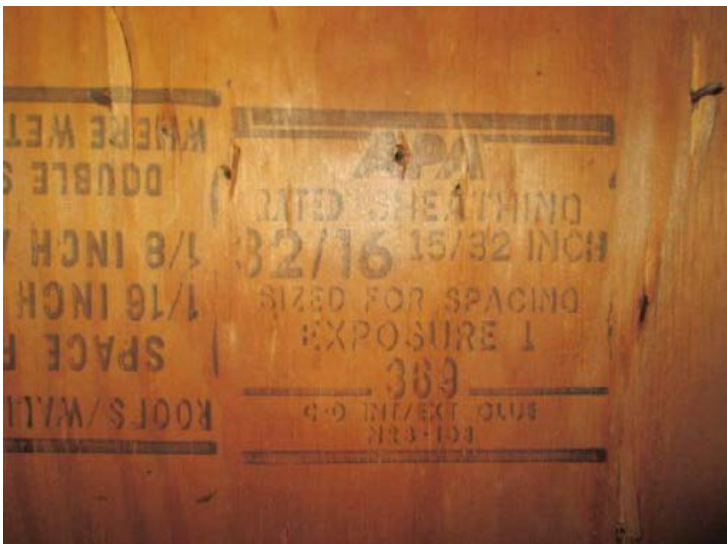
Roof Construction

- 3. Roof Deck Attachment:** **Level A**
Comments: Inspection verified 1/2" plywood roof deck attached with staples at a minimum of 6" on the edge & 12" in the field.

- 4. Roof to Wall Attachment:** **Clips**
Comments: Inspection verified embedded straps fastened with a minimum of three nails.
- 5. Roof Geometry:** **Other Roof**
Comments: Inspection verified a gable roof shape.
