COMMERCIAL WINDSTORM MITIGATION REPORT (OIR-B1-1802)

Windrush Bay Condominium Association, Inc.

39 Windrush Bay Dr
Tarpon Springs, FL 34689

As of 2/13/2020
FPAT File# MUD2013974

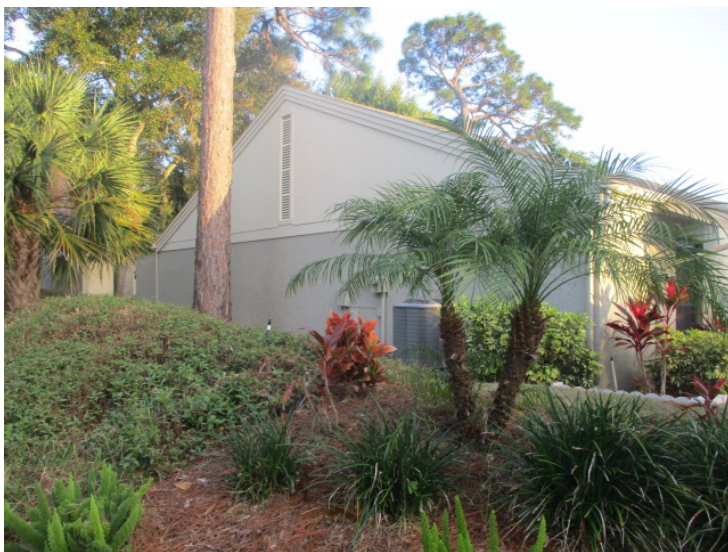
Exterior Elevation

- 4. Roof to Wall Attachment:** **Clips**
Comments: Inspection verified embedded straps fastened with a minimum of three nails.
- 5. Roof Geometry:** **Other Roof**
Comments: Inspection verified a gable roof shape.

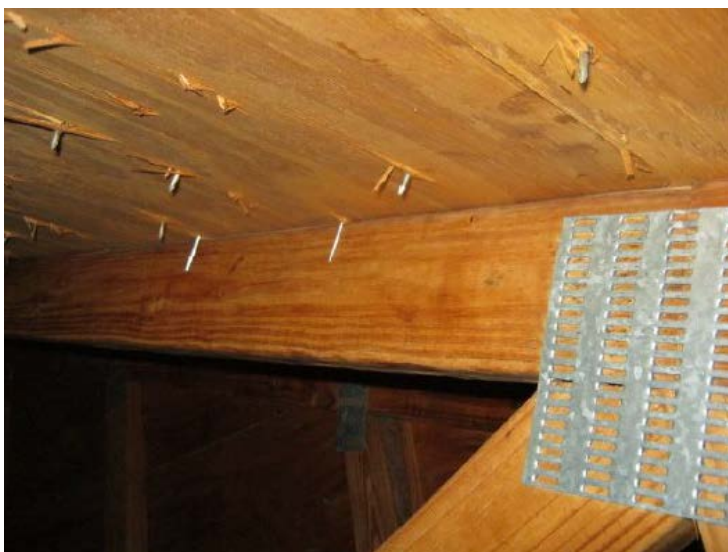
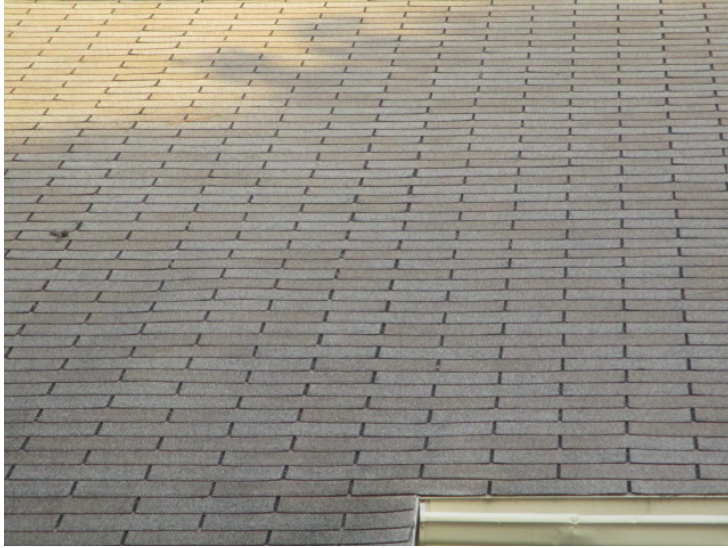
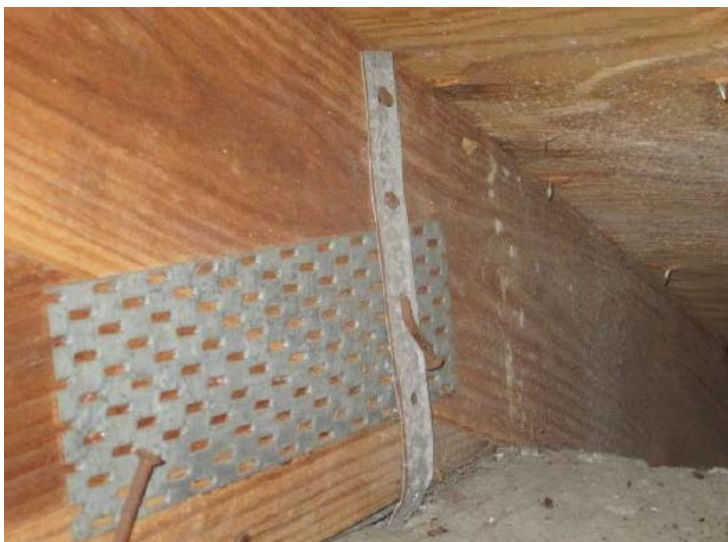
Roof Construction

- 3. Roof Deck Attachment:** **Level A**
Comments: Inspection verified 1/2" plywood roof deck attached with staples at a minimum of 6" on the edge & 12" in the field.

- 6. SWR:** **No**
Comments: Inspection verified no secondary water resistance.
- 7. Opening Protection:** **None or Some Glazed Openings**
Comments: Inspection verified no opening protection.
