COMMERCIAL WINDSTORM MITIGATION REPORT (OIR-B1-1802)

Windrush Bay Condominium Association, Inc.

4 Windrush Bay Dr

As of 2/13/2020

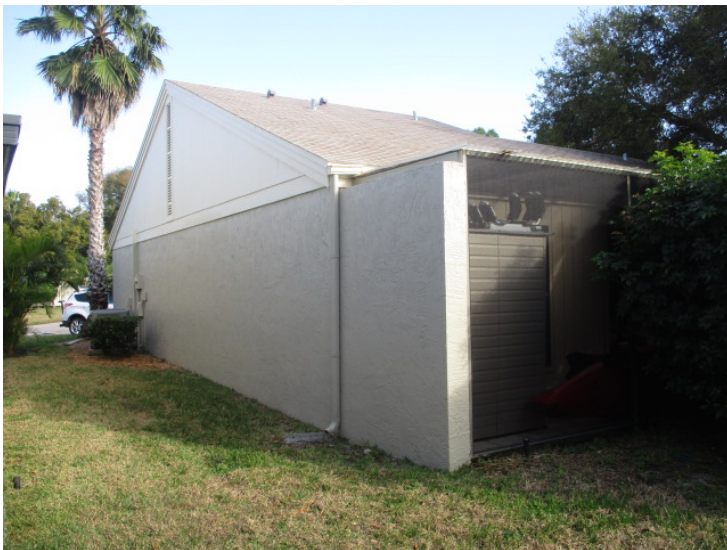
Exterior Elevation

- 4. Roof to Wall Attachment:** **Clips**
Comments: Inspection verified embedded straps fastened with a minimum of three nails.
- 5. Roof Geometry:** **Other Roof**
Comments: Inspection verified a gable roof shape.

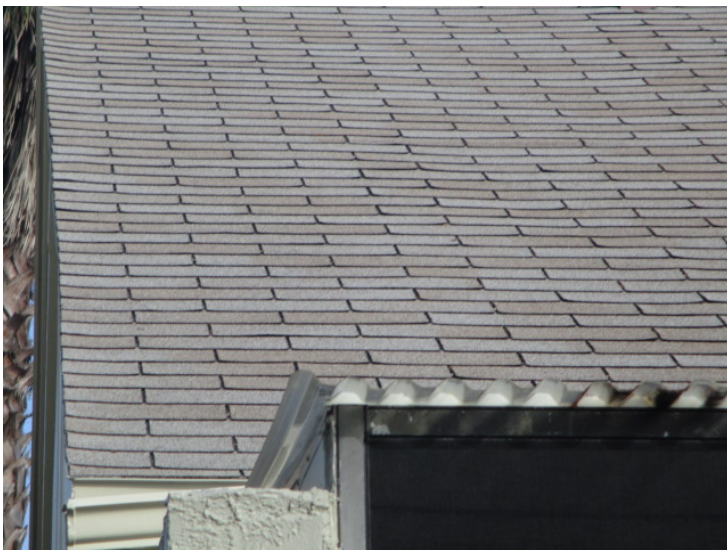
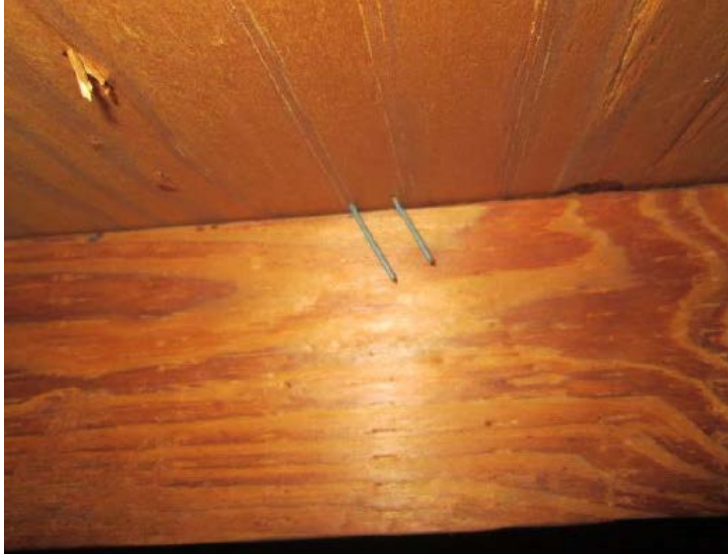
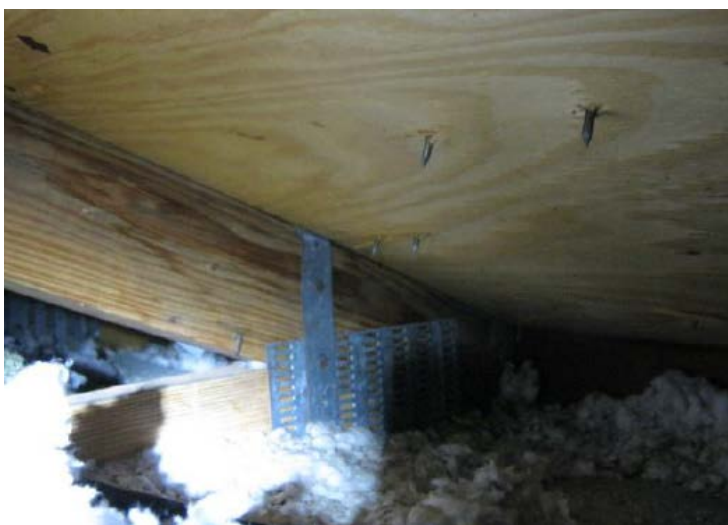
Roof Construction

- 3. Roof Deck Attachment:** **Level A**
Comments: Inspection verified 1/2" plywood roof deck attached with staples at a minimum of 6" on the edge & 12" in the field.

- 6. SWR:** **No**
Comments: Inspection verified no secondary water resistance.
- 7. Opening Protection:** **None or Some Glazed Openings**
Comments: Inspection verified no opening protection.
