COMMERCIAL WINDSTORM MITIGATION REPORT (OIR-B1-1802)

Windrush Bay Condominium Association, Inc.

5 Windrush Bay Dr

As of 2/13/2020

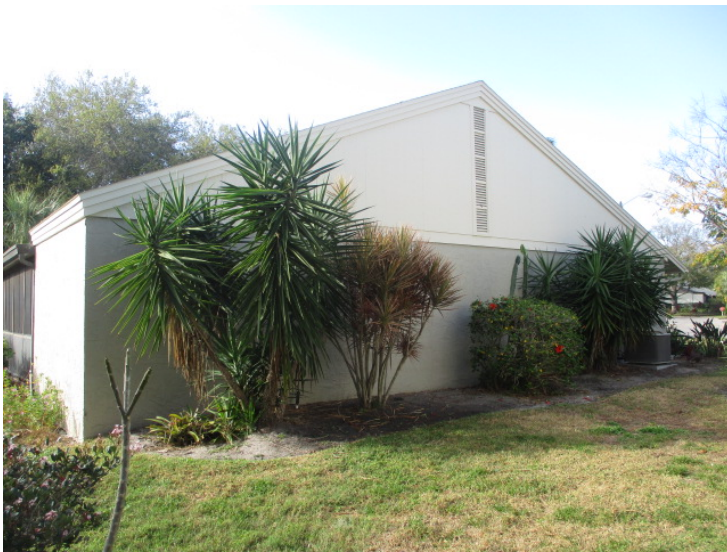
Exterior Elevation

- 5. Roof Geometry:**                      **Other Roof**  
Comments:                                      Inspection verified a gable roof shape.
- 6. SWR:**                                      **No**  
Comments:                                      Inspection verified no secondary water resistance.

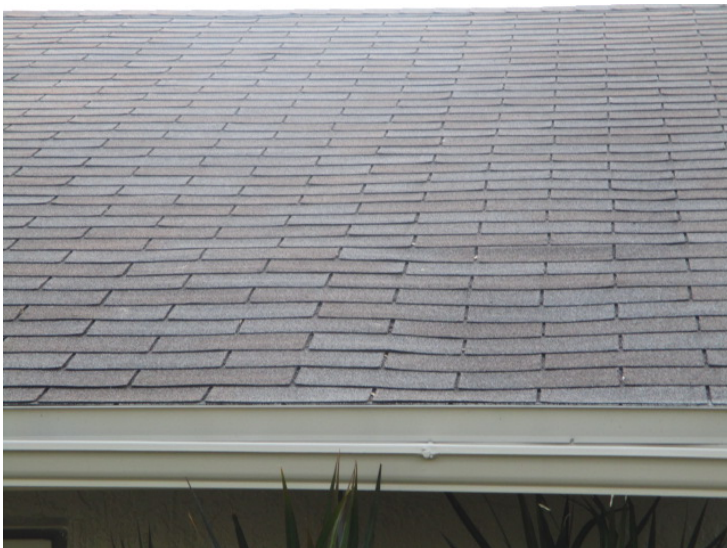
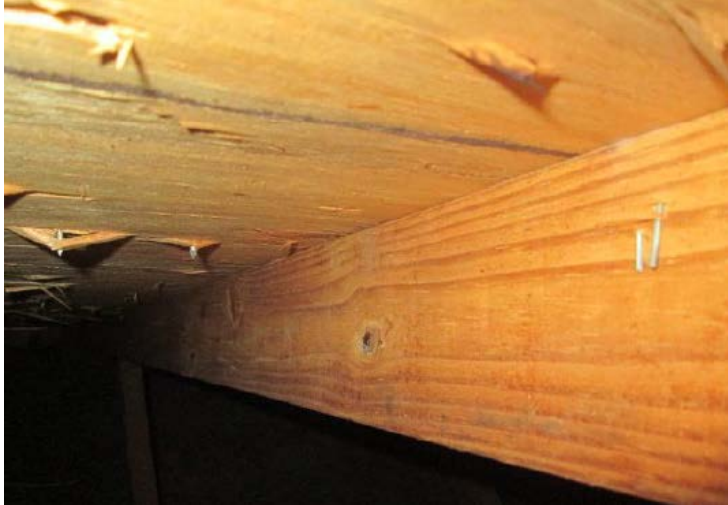
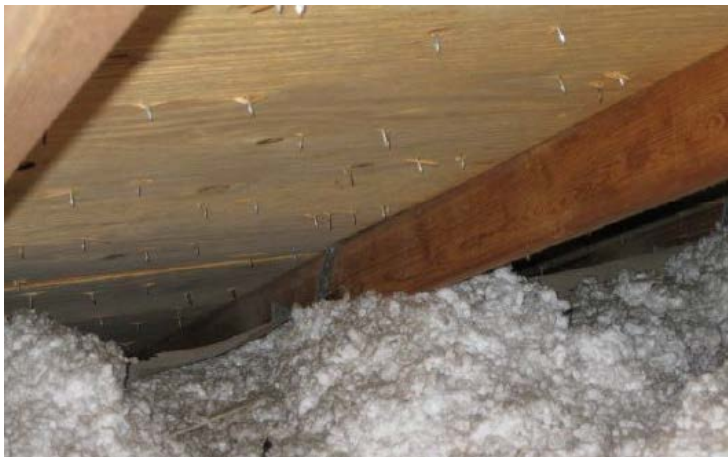
Roof Construction

- 3. Roof Deck Attachment:**        **Level A**  
Comments:                                      Inspection verified 1/2" plywood roof deck attached with staples at a minimum of 6" on the edge & 12" in the field.

- 4. Roof to Wall Attachment:**        **Clips**  
Comments:                                      Inspection verified embedded straps fastened with a minimum of three nails.
