COMMERCIAL WINDSTORM MITIGATION REPORT (OIR-B1-1802)

Windrush Bay Condominium Association, Inc.

6 Windrush Bay Dr

As of 2/13/2020

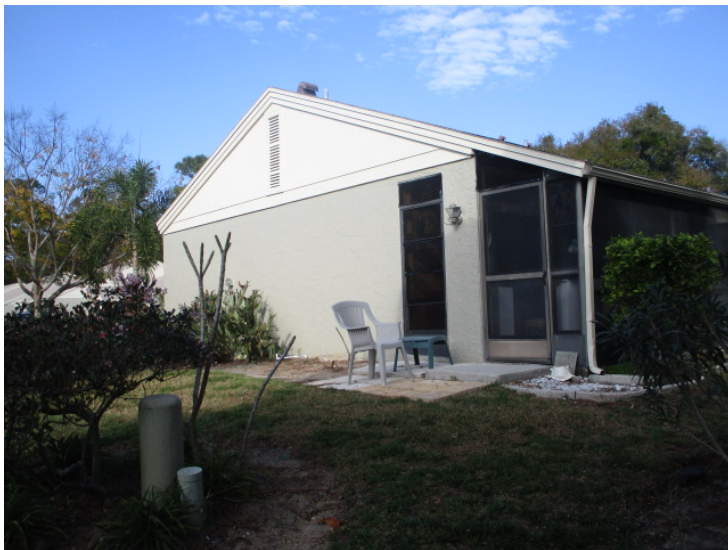
Exterior Elevation

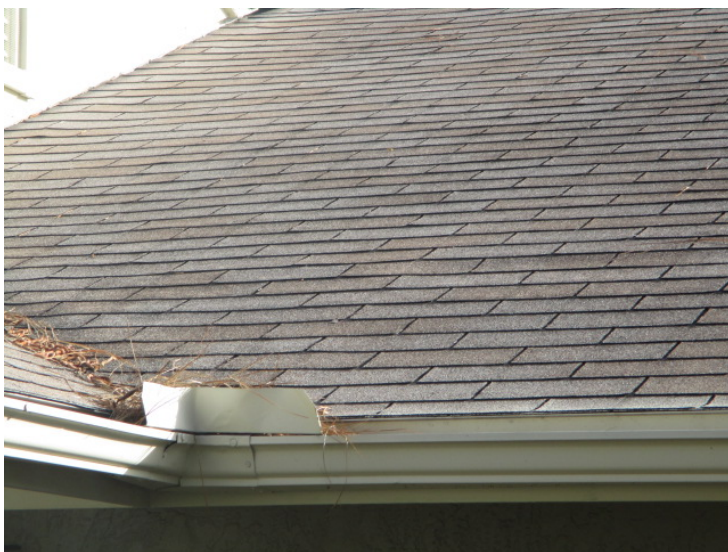
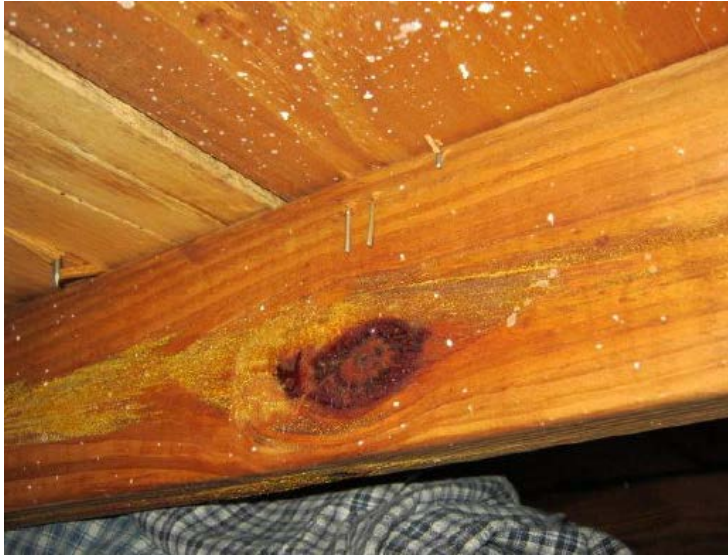
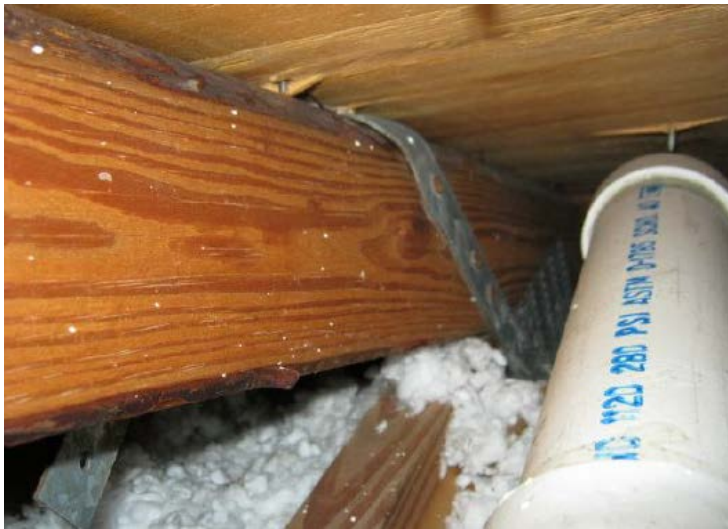
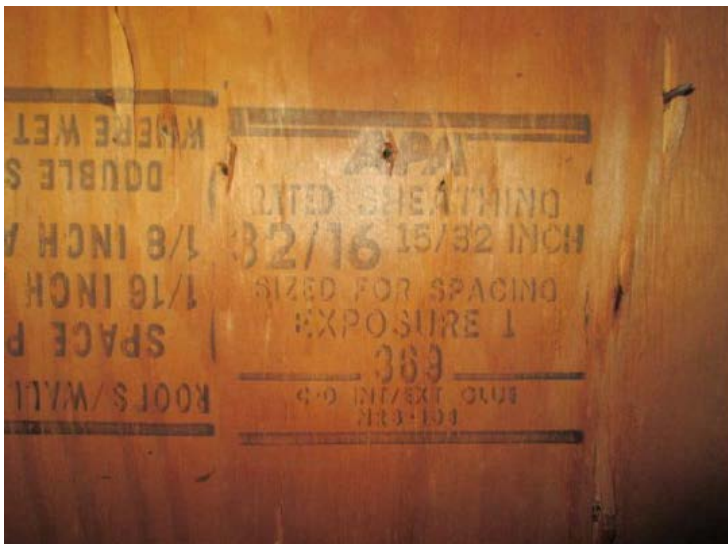
- 3. Roof Deck Attachment:** **Level A**
Comments: Inspection verified 1/2" plywood roof deck attached with staples at a minimum of 6" on the edge & 12" in the field.

- 4. Roof to Wall Attachment:** **Clips**
Comments: Inspection verified embedded straps fastened with a minimum of three nails.
- 5. Roof Geometry:** **Other Roof**
Comments: Inspection verified a gable roof shape.

Roof Construction
