**COMMERCIAL WINDSTORM MITIGATION REPORT (OIR-B1-1802)**

Windrush Bay Condominium Association, Inc.

7 Windrush Bay Dr

As of 2/13/2020

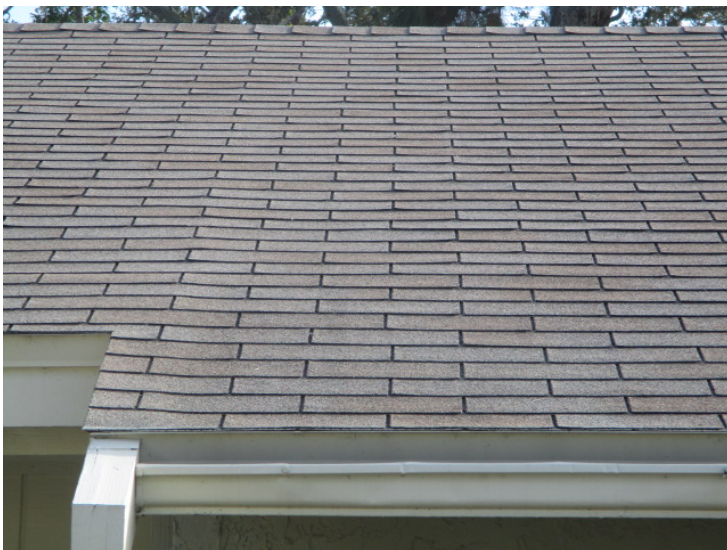
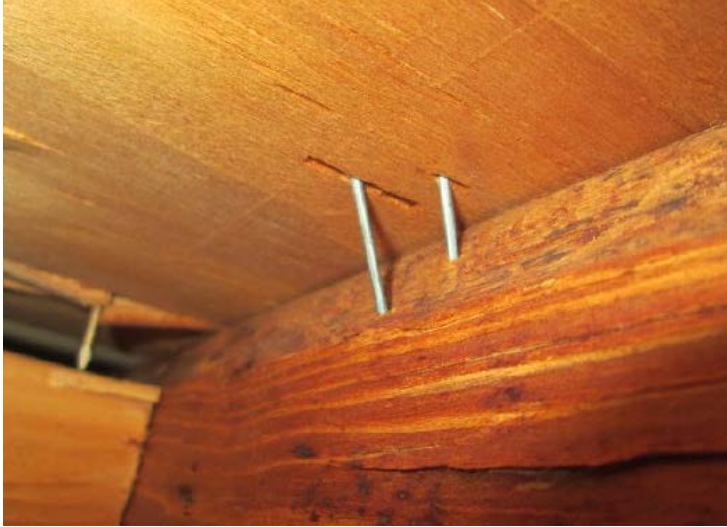
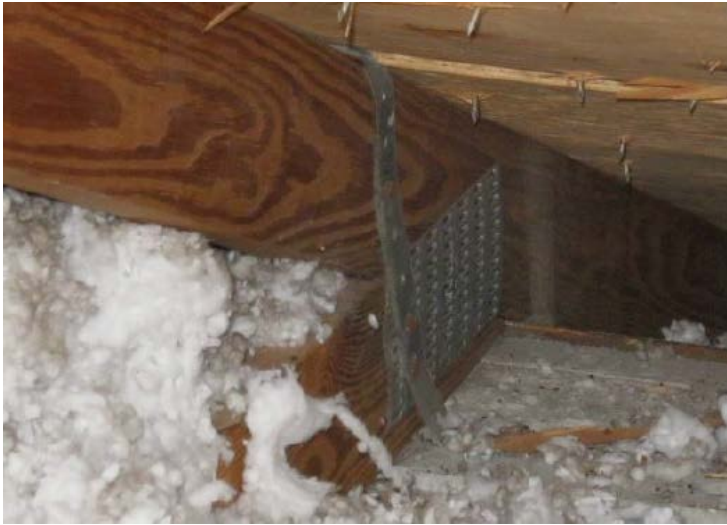
Roof Construction

- 3. Roof Deck Attachment:**        **Level A**  
Comments:                                      Inspection verified 1/2" plywood roof deck attached with staples at a minimum of 6" on the edge & 12" in the field.

- 4. Roof to Wall Attachment:**        **Clips**  
Comments:                                      Inspection verified embedded straps fastened with a minimum of three nails.

- 5. Roof Geometry:**                      **Other Roof**  
Comments:                                      Inspection verified a gable roof shape.
- 6. SWR:**                                      **No**  
Comments:                                      Inspection verified no secondary water resistance.
