COMMERCIAL WINDSTORM MITIGATION REPORT (OIR-B1-1802)

Windrush Bay Condominium Association, Inc.

8 Windrush Bay Dr

As of 2/13/2020

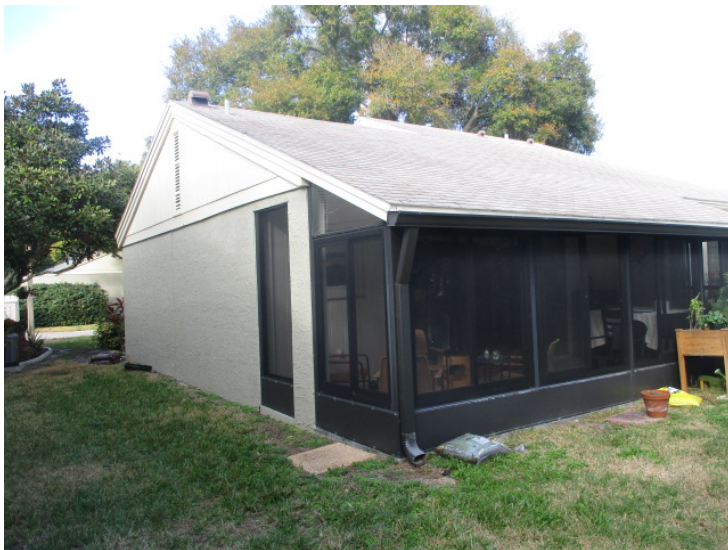
Exterior Elevation

- 4. Roof to Wall Attachment:** **Clips**
Comments: Inspection verified embedded straps fastened with a minimum of three nails.
- 5. Roof Geometry:** **Other Roof**
Comments: Inspection verified a gable roof shape.

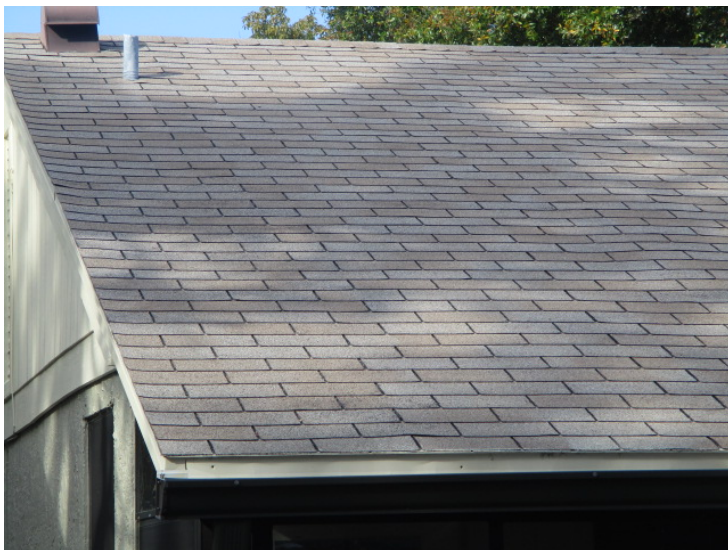
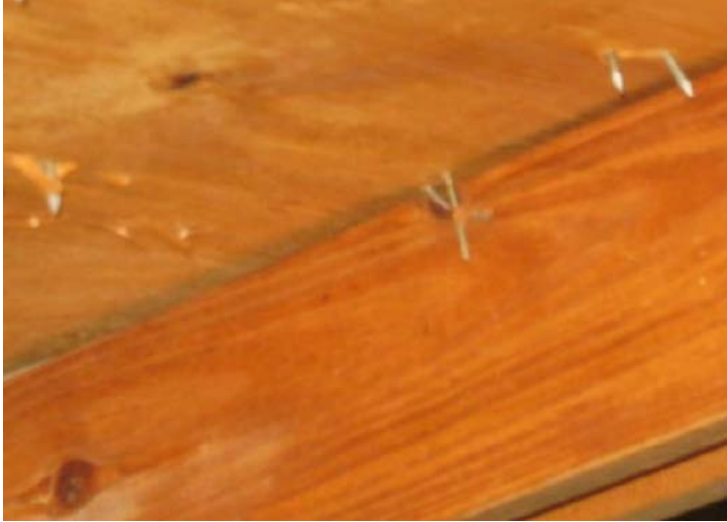
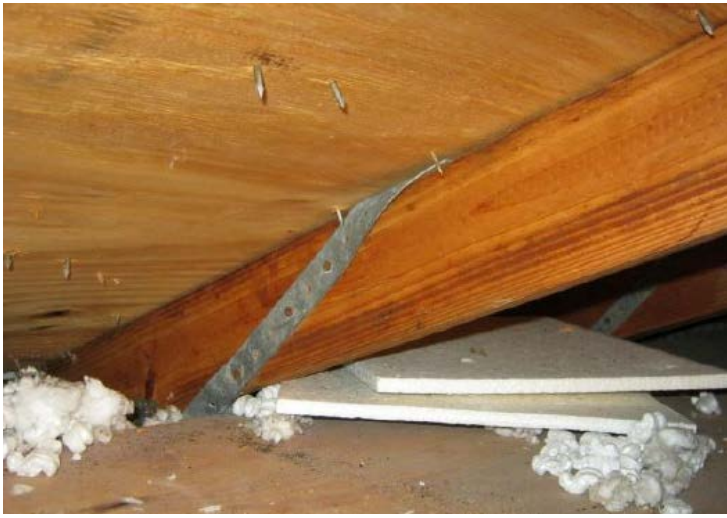
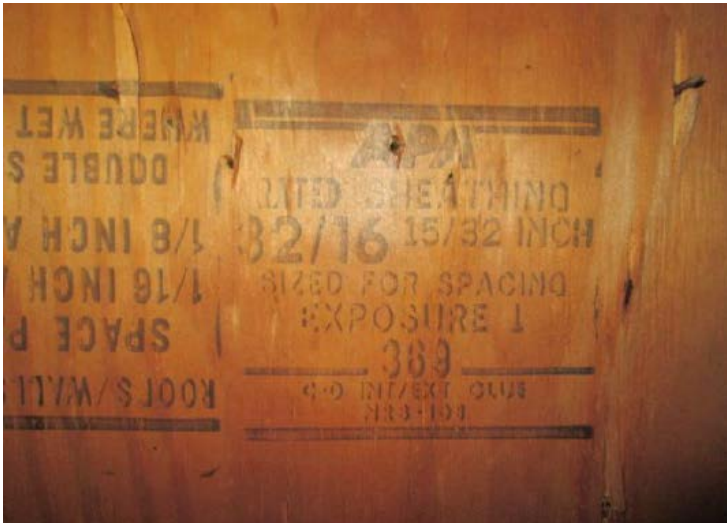
Roof Construction

- 3. Roof Deck Attachment:** **Level A**
Comments: Inspection verified 1/2" plywood roof deck attached with staples at a minimum of 6" on the edge & 12" in the field.

- 6. SWR:** **No**
Comments: Inspection verified no secondary water resistance.
- 7. Opening Protection:** **None or Some Glazed Openings**
Comments: Inspection verified no opening protection.
