COMMERCIAL WINDSTORM MITIGATION REPORT (OIR-B1-1802)

Windrush Bay Condominium Association, Inc.

9 Windrush Bay Dr

As of 2/13/2020

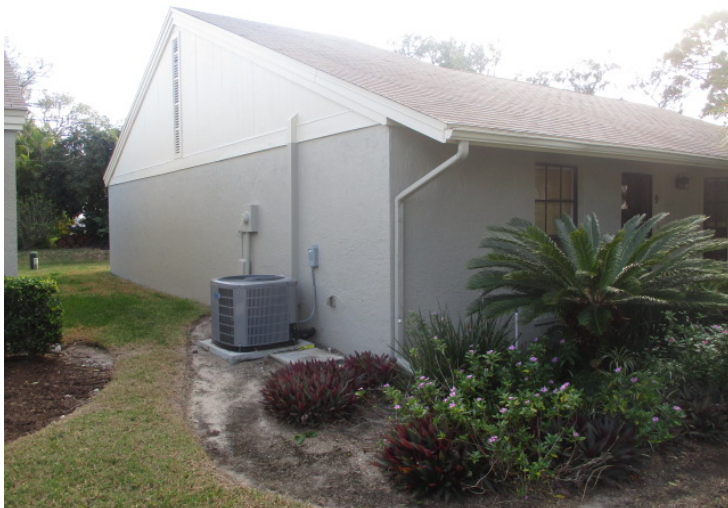
Exterior Elevation

- 5. Roof Geometry:**                      **Other Roof**  
Comments:                                      Inspection verified a gable roof shape.
- 6. SWR:**                                      **No**  
Comments:                                      Inspection verified no secondary water resistance.

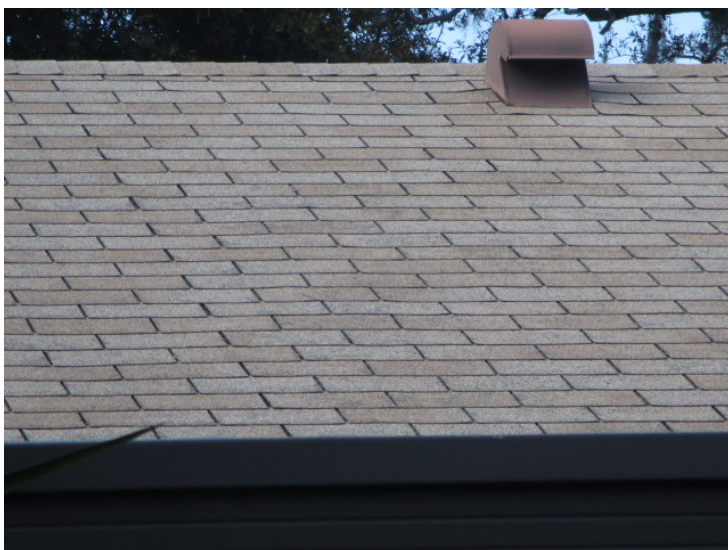
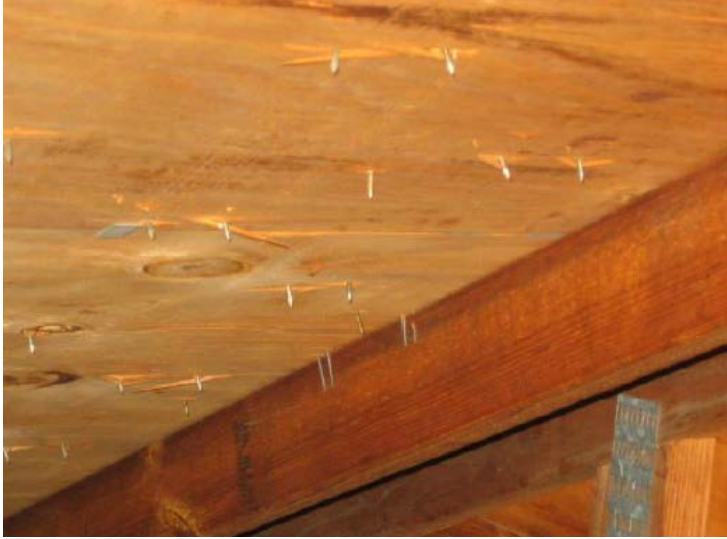
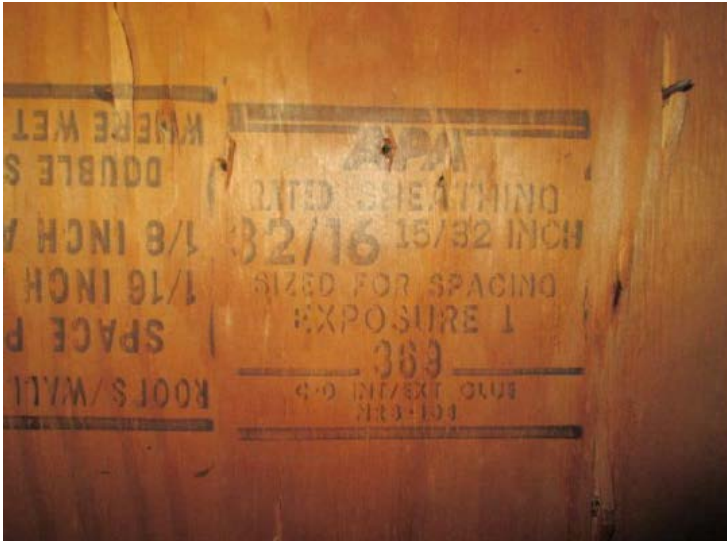
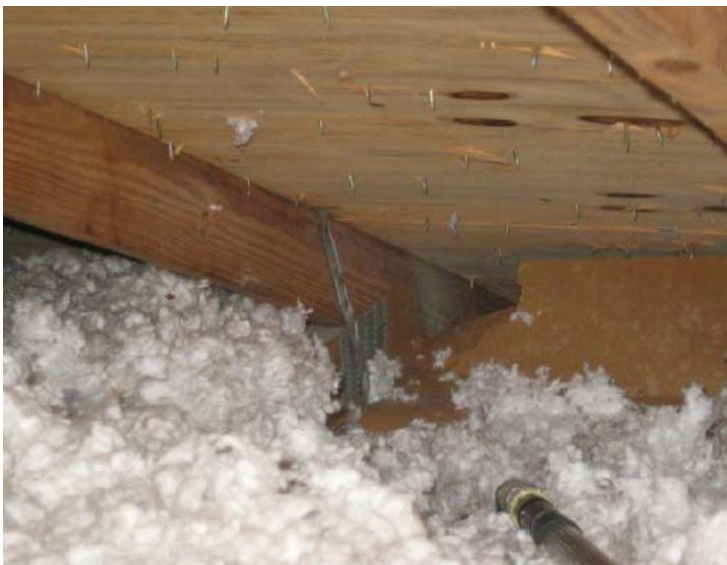
Roof Construction

- 3. Roof Deck Attachment:**        **Level A**  
Comments:                                      Inspection verified 1/2" plywood roof deck attached with staples at a minimum of 6" on the edge & 12" in the field.

- 4. Roof to Wall Attachment:**        **Clips**  
Comments:                                      Inspection verified embedded straps fastened with a minimum of three nails.
