## COMMERCIAL WINDSTORM MITIGATION INSPECTION REPORT (OIR-B1-1802)

Windrush Bay Condominium Association, Inc.  
405-412 Windrush Bay Dr (Building B)  
Tarpon Springs, FL 34689

As of 10/5/2015

**RECAPITULATION OF MITIGATION FEATURES**  
**For 405-412 Windrush Bay Dr (Building B)**

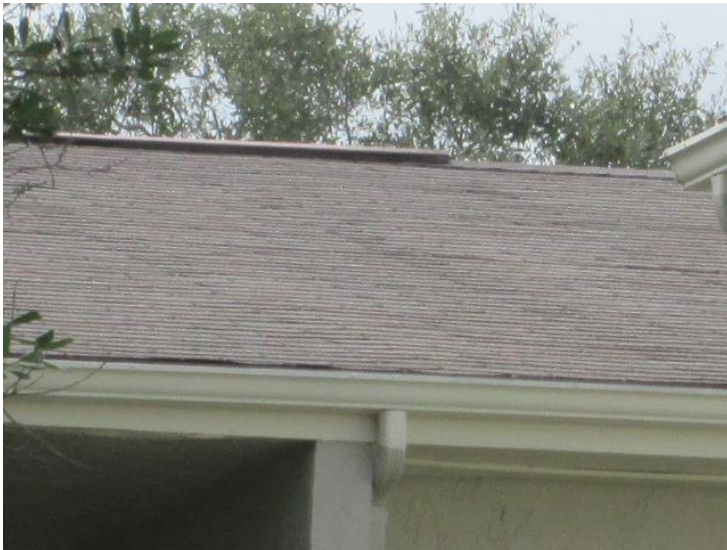
Roof Covering (Section 2)

| <b>2. <u>Roof Covering:</u></b><br>Comments: | <b>No roof coverings meet the minimum requirements</b><br>The roof covering was replaced in 2001. The roof permit was confirmed and the permit number is 01-357. This roof was verified as not meeting the building code requirements outlined on the mitigation affidavit. |

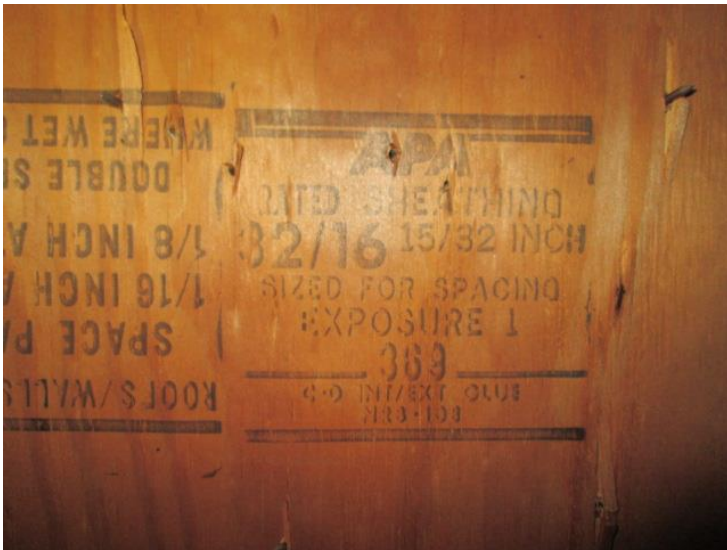
Roof Deck Material (Section 3)

| <b>3. <u>Roof Deck Attachment:</u></b><br>Comments: | <b>Level A</b><br>Inspection verified 1/2" plywood roof deck attached with 6d nails at a minimum of 6" on the edge & 12" in the field. |

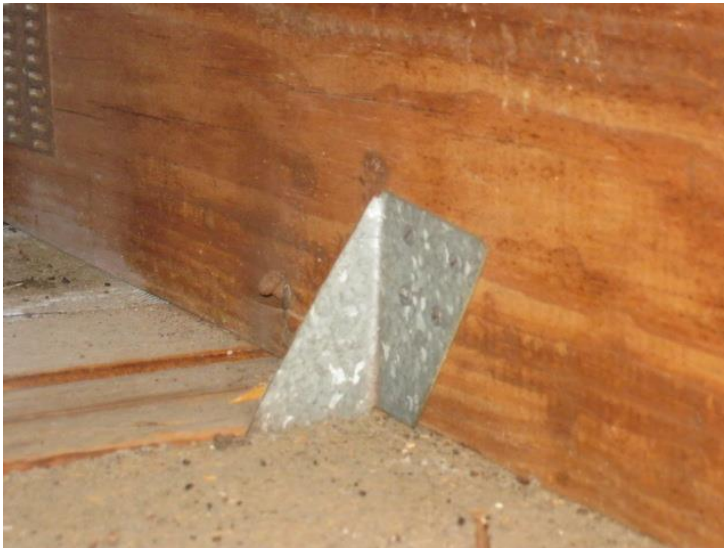
Roof to Wall Attachment  
(Section 4)

| <b>4. <u>Roof to Wall Attachment:</u></b><br>Comments: | <b>Clips</b><br>Inspection verified hurricane clips fastened with a minimum of three nails. |

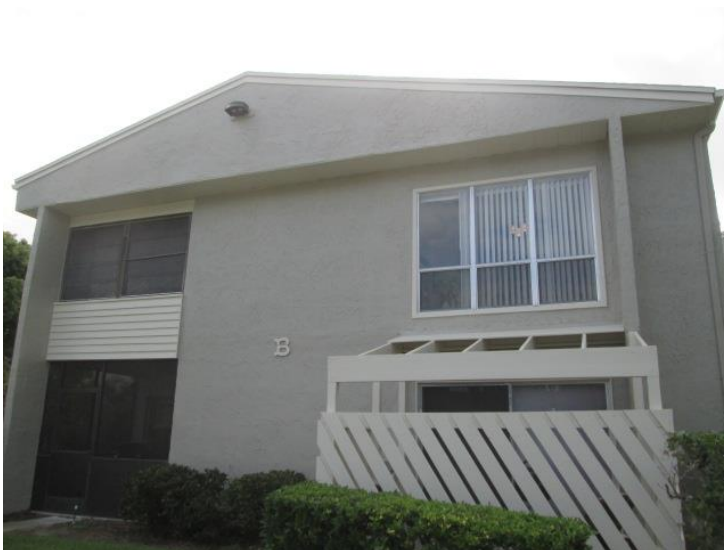
Roof Shape (Section 5)

| <b>5. <u>Roof Geometry:</u></b><br>Comments: | <b>Other Roof</b><br>Inspection verified a gable roof shape. |
