## COMMERCIAL WINDSTORM MITIGATION INSPECTION REPORT (OIR-B1-1802)

Windrush Bay Condominium Association, Inc.  
421-428 Windrush Bay Dr (Building D)  
Tarpon Springs, FL 34689

As of 10/5/2015

**RECAPITULATION OF MITIGATION FEATURES**  
**For 421-428 Windrush Bay Dr (Building D)**

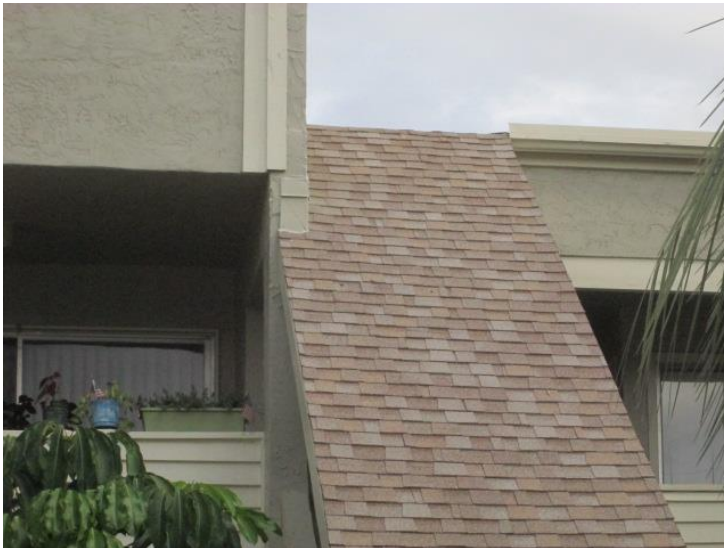
Roof Covering (Section 2)

| <b>2. <u>Roof Covering:</u></b><br>Comments: | <b>FBC Equivalent</b><br>The roof covering was replaced in 2014. The roof permit was confirmed and the permit number is 14-1514. This roof was verified as meeting the building code requirements outlined on the mitigation affidavit. |

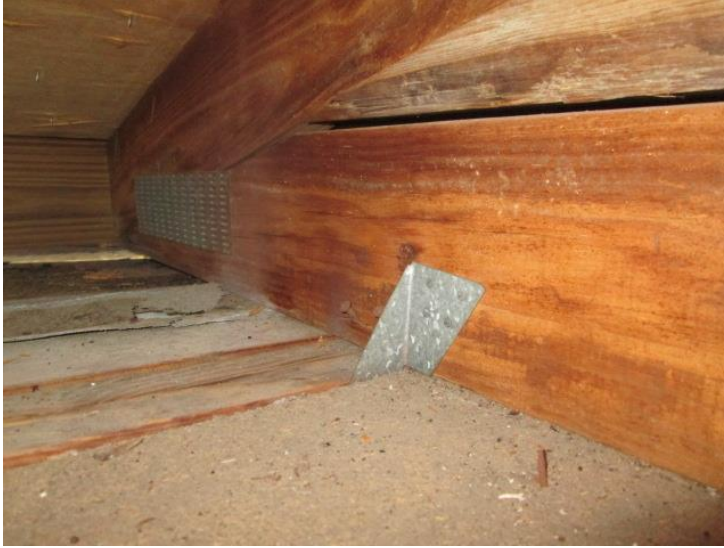
Roof to Wall Attachment  
(Section 4)

| <b>4. <u>Roof to Wall Attachment:</u></b><br>Comments: | <b>Clips</b><br>Inspection verified hurricane clips fastened with a minimum of three nails. |

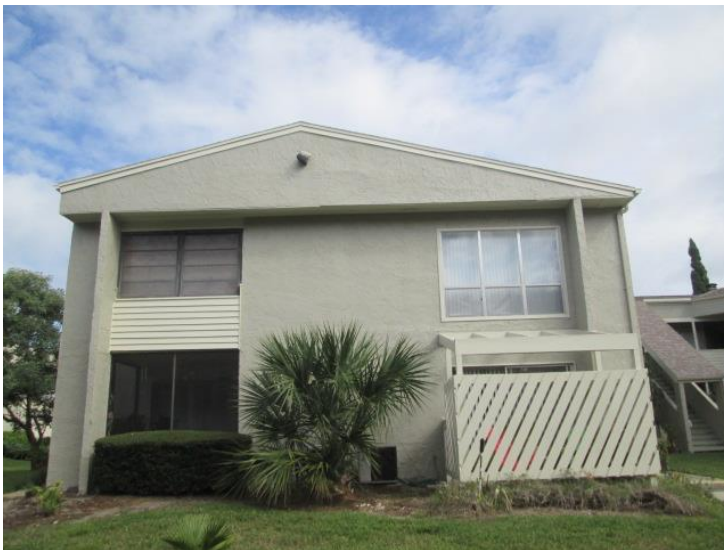
Roof Shape (Section 5)

| <b>5. <u>Roof Geometry:</u></b><br>Comments: | <b>Other Roof</b><br>Inspection verified a gable roof shape. |
