COMMERCIAL WINDSTORM MITIGATION INSPECTION REPORT (OIR-B1-1802)

Windrush Bay Condominium Association, Inc.

601-608 Windrush Bay Dr (Building G)

As of 10/5/2015

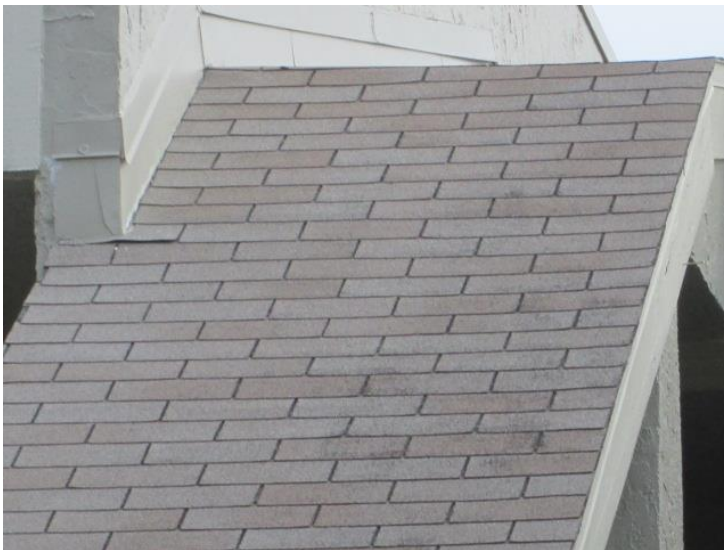
Roof Covering (Section 2)

Comments: | No roof coverings meet the minimum requirements
The roof covering was replaced in 2001. The roof permit was confirmed and the permit number is 01-362. This roof was verified as not meeting the building code requirements outlined on the mitigation affidavit. |

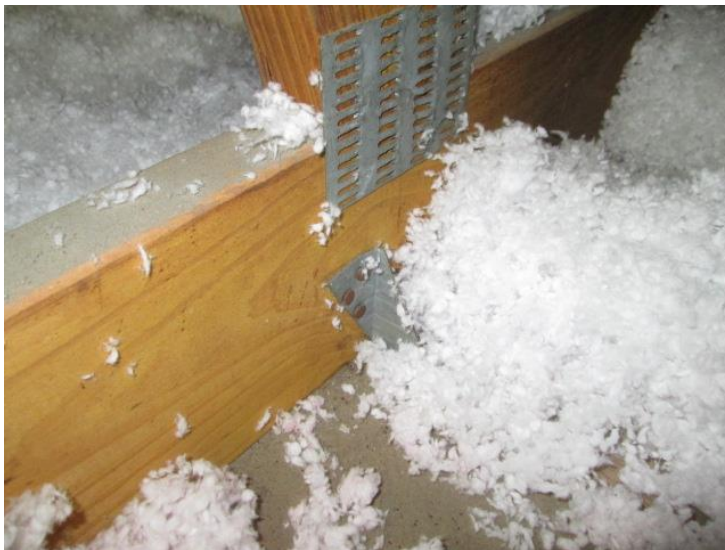
Roof to Wall Attachment
(Section 4)

Comments: | Clips
Inspection verified hurricane clips fastened with a minimum of three nails. |

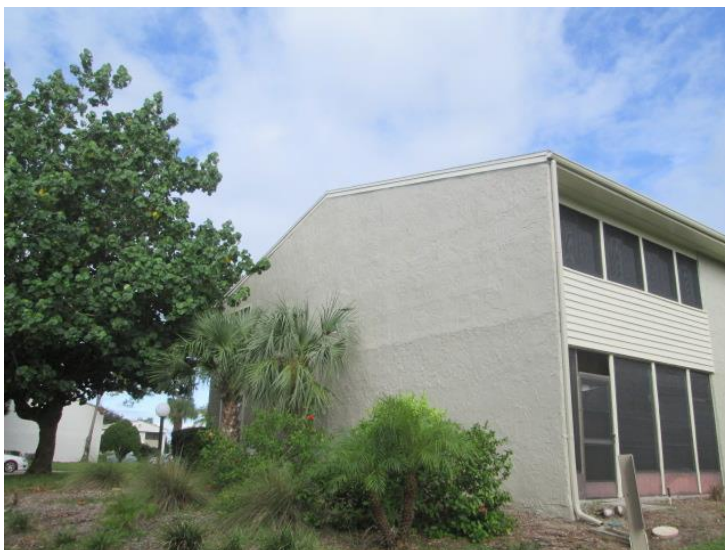
Roof Shape (Section 5)

Comments: | Other Roof
Inspection verified a gable roof shape. |
