COMMERCIAL WINDSTORM MITIGATION INSPECTION REPORT (OIR-B1-1802)

Windrush Bay Condominium Association, Inc.

609-616 Windrush Bay Dr (Building H)

As of 10/5/2015

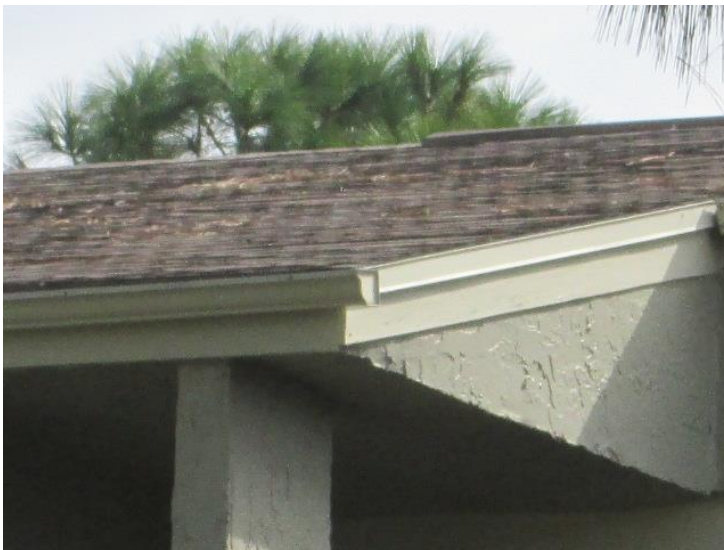
Roof Covering (Section 2)

Comments: | No roof coverings meet the minimum requirements
The roof covering was replaced in 2001. The roof permit was confirmed and the permit number is 01-363. This roof was verified as not meeting the building code requirements outlined on the mitigation affidavit. |

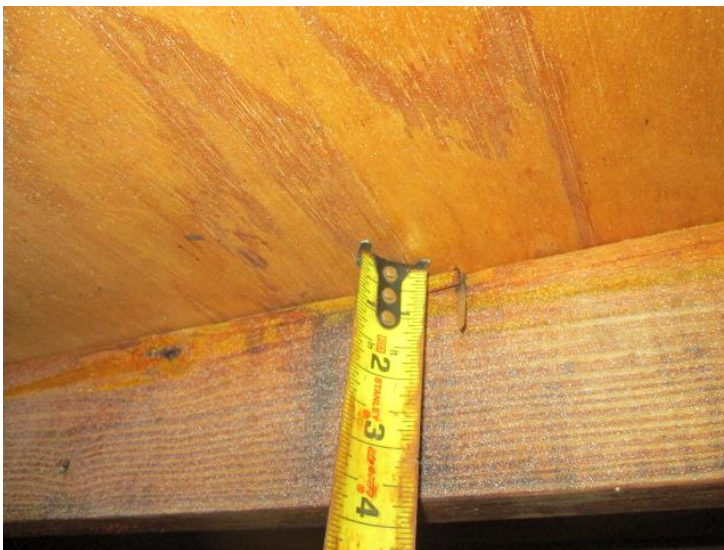
Roof Deck Attachment
(Section 3)

Comments: | Level A
Inspection verified 1/2" plywood roof deck attached with 6d nails at a minimum of 6" on the edge & 12" in the field. |

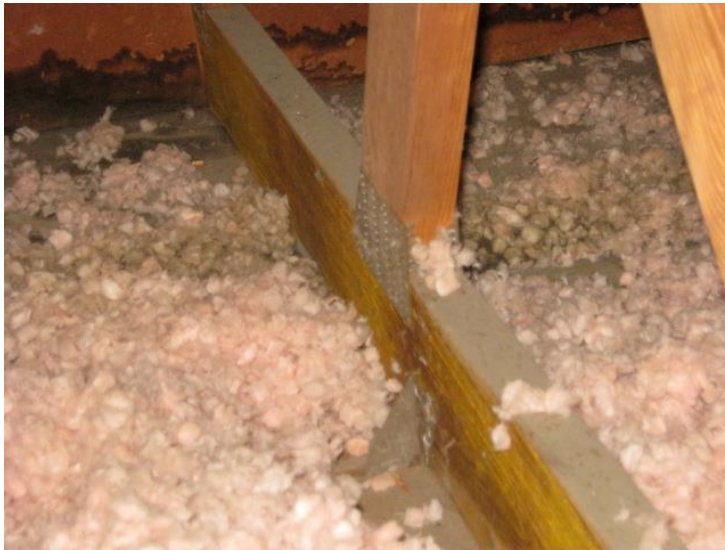
Roof to Wall Attachment (Section 4)

Comments: | Clips
Inspection verified hurricane clips fastened with a minimum of three nails. |

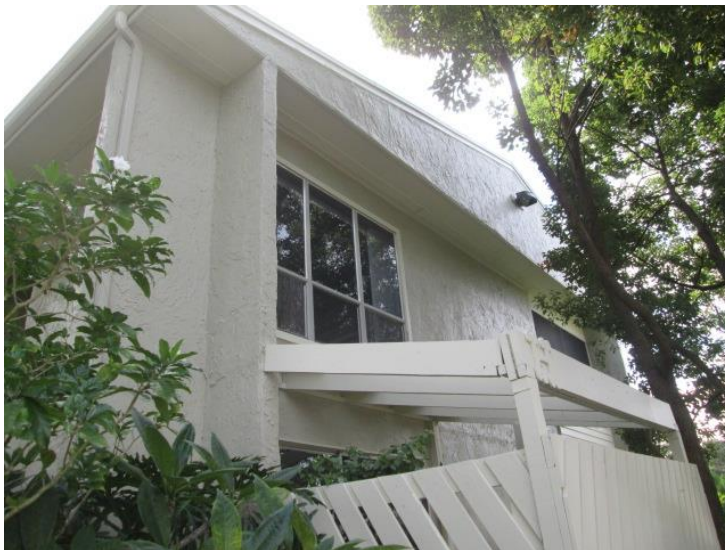
Roof Shape (Section 5)

Comments: | Other Roof
Inspection verified a gable roof shape. |
