COMMERCIAL WINDSTORM MITIGATION INSPECTION REPORT (OIR-B1-1802)

Windrush Bay Condominium Association, Inc.
617-620 Windrush Bay Dr (Building J)
Tarpon Springs, FL 34689

As of 10/5/2015

RECAPITULATION OF MITIGATION FEATURES
For 617-620 Windrush Bay Dr (Building J)

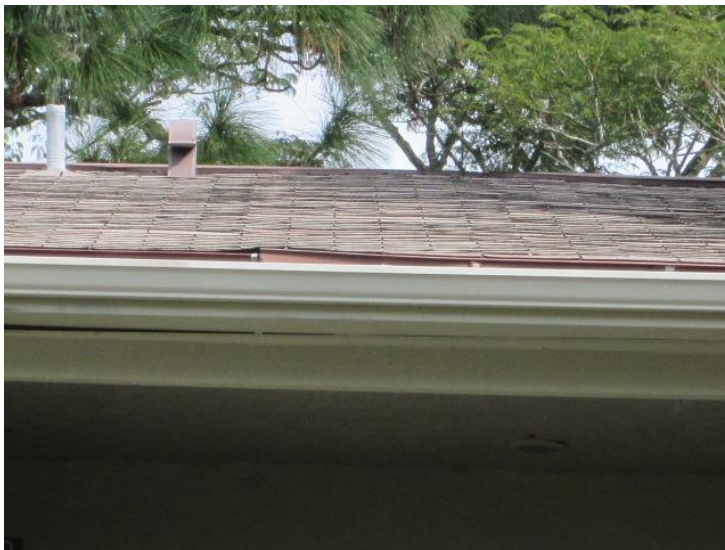
Roof Covering (Section 2)

Comments: | No roof coverings meet the minimum requirements
The roof covering was replaced in 2001. The roof permit was confirmed and the permit number is 01-2284. This roof was verified as not meeting the building code requirements outlined on the mitigation affidavit. |

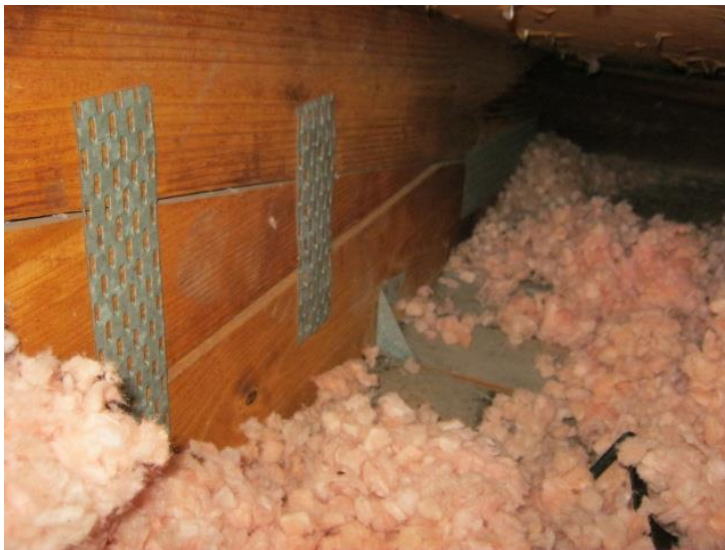
Roof to Wall Attachment
(Section 4)

Comments: | Clips
Inspection verified hurricane clips fastened with a minimum of three nails. |

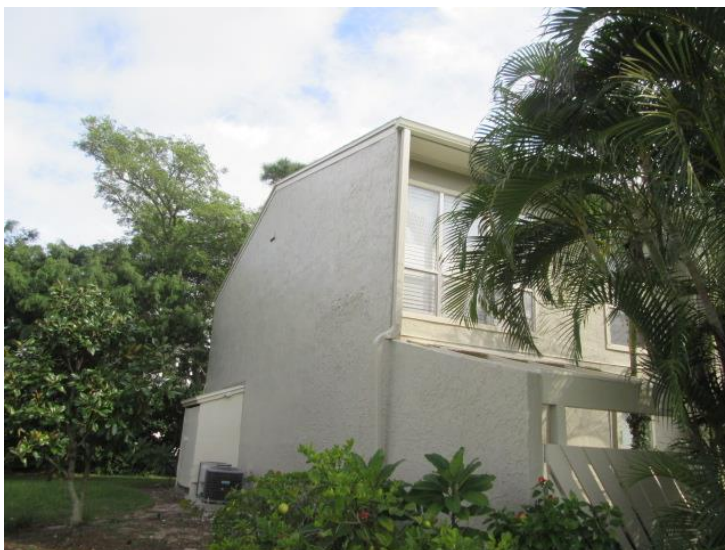
Roof Shape (Section 5)

Comments: | Other Roof
Inspection verified a gable roof shape. |
