COMMERCIAL WINDSTORM MITIGATION INSPECTION REPORT (OIR-B1-1802)

Windrush Bay Condominium Association, Inc.
621-628 Windrush Bay Dr (Building K)
Tarpon Springs, FL 34689

As of 10/5/2015

RECAPITULATION OF MITIGATION FEATURES
For 621-628 Windrush Bay Dr (Building K)

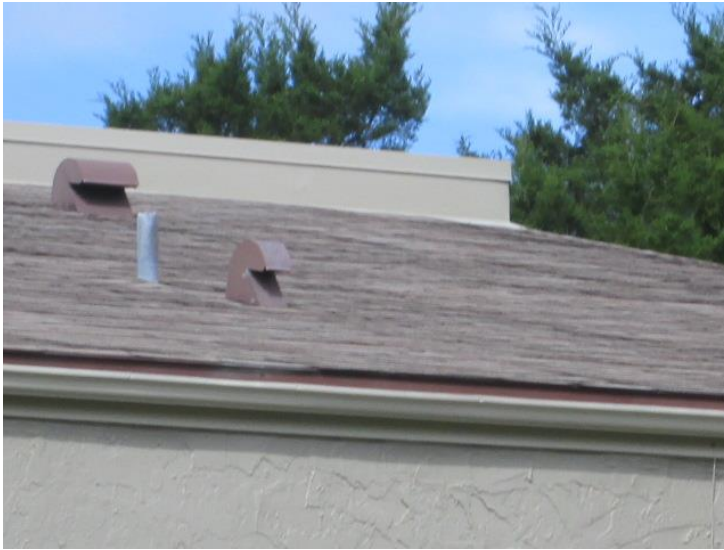
Roof Covering (Section 2)

Comments: | No roof coverings meet the minimum requirements
The roof covering was replaced in 2001. The roof permit was confirmed and the permit number is 01-2285. This roof was verified as not meeting the building code requirements outlined on the mitigation affidavit. |

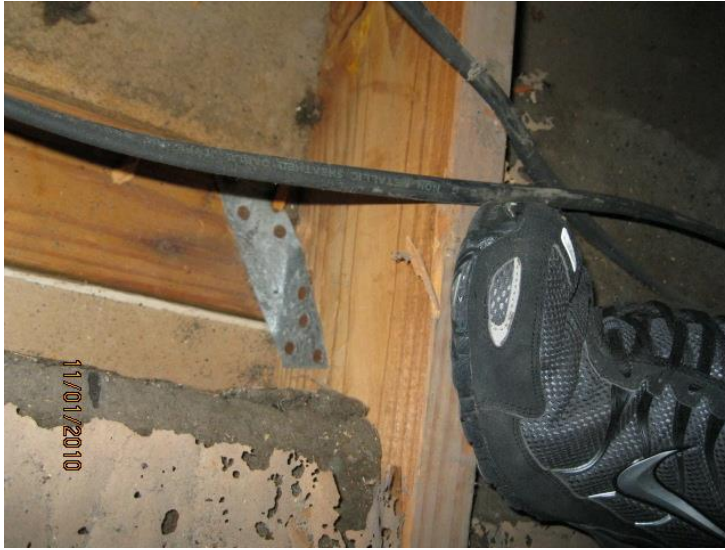
Roof to Wall Attachment
(Section 4)

Comments: | Clips
Inspection verified hurricane clips fastened with a minimum of three nails. |

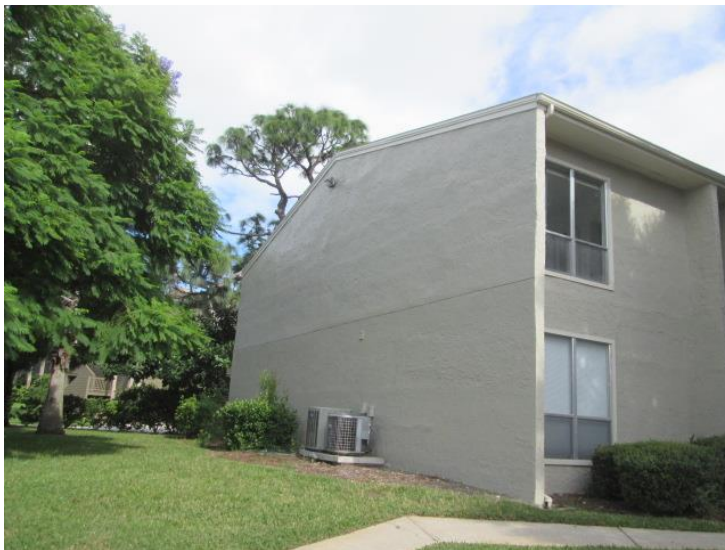
Roof Shape (Section 5)

Comments: | Other Roof
Inspection verified a gable roof shape. |
