## COMMERCIAL WINDSTORM MITIGATION INSPECTION REPORT (OIR-B1-1802)

Windrush Bay Condominium Association, Inc.  
629-636 Windrush Bay Dr (Building L)  
Tarpon Springs, FL 34689

As of 10/5/2015

FPAT File #MUD157124

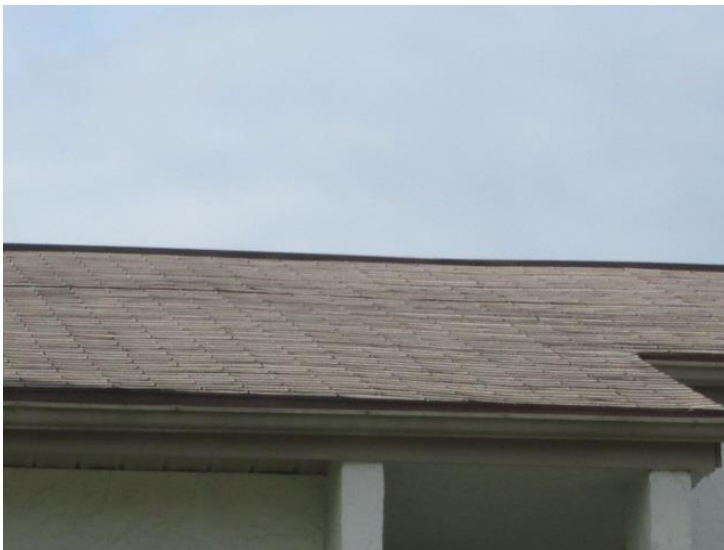
Roof Covering (Section 2)

2. **Roof Covering:**                      **No roof coverings meet the minimum requirements**  
Comments:                                      The roof covering was replaced in 2001. The roof permit was confirmed and the permit number is 01-2283. This roof was verified as not meeting the building code requirements outlined on the mitigation affidavit.

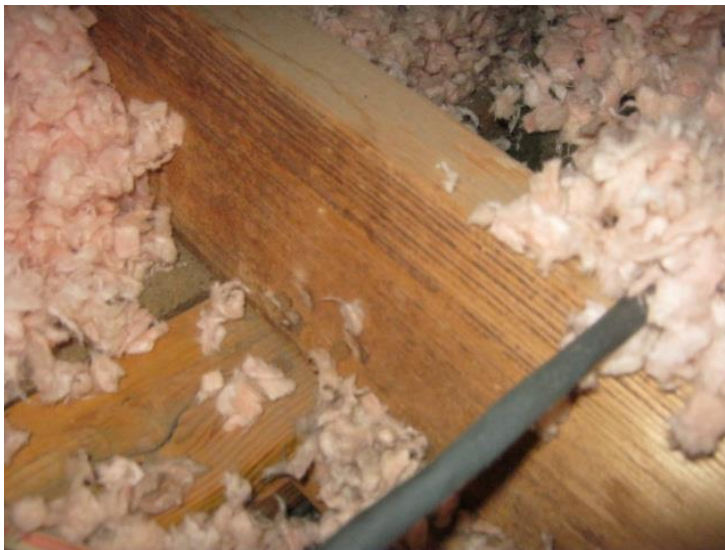
Roof to Wall Attachment  
(Section 4)

4. **Roof to Wall Attachment:**        **Toe Nails**  
Comments:                                      Toe nails were verified during our attic inspection as the roof wall connection.

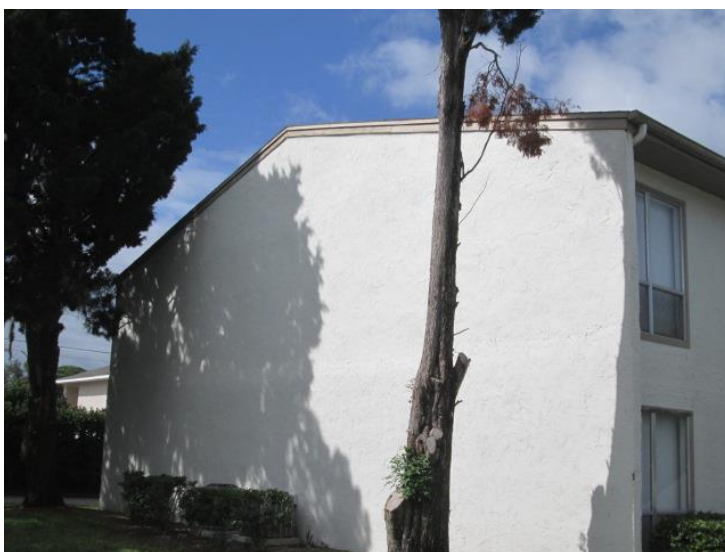
Roof Shape (Section 5)

5. **Roof Geometry:**                      **Other Roof**  
Comments:                                      Inspection verified a gable roof shape.
6. **SWR:**                                      **No**  
Comments:                                      Inspection verified no secondary water resistance.
