## COMMERCIAL WINDSTORM MITIGATION INSPECTION REPORT (OIR-B1-1802)

Windrush Bay Condominium Association, Inc.

637-644 Windrush Bay Dr (Building M)

As of 10/5/2015

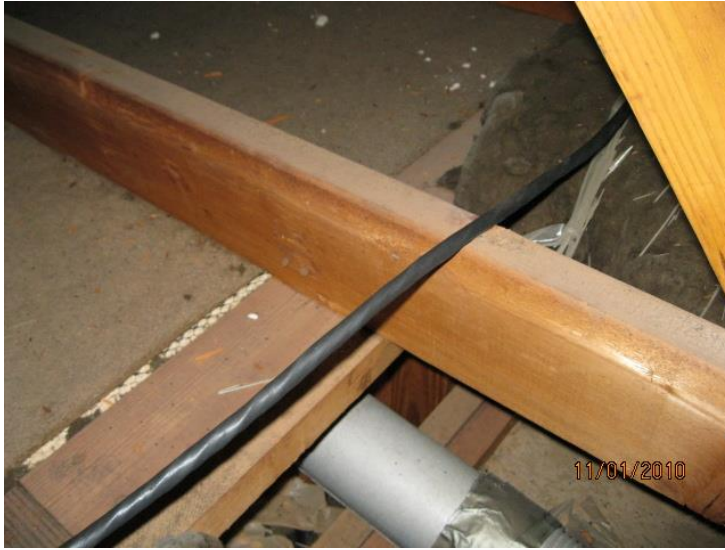
Roof to Wall Attachment  
(Section 4)

| <b>4. <u>Roof to Wall Attachment:</u></b><br>Comments: | <b>Toe Nails</b><br>Toe nails were verified during our attic inspection as the roof wall connection. |

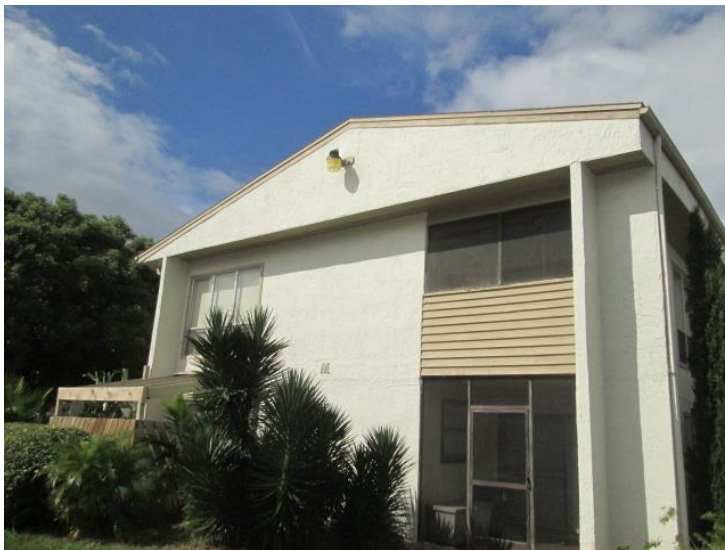
Roof Shape (Section 5)

| <b>5. <u>Roof Geometry:</u></b><br>Comments: | <b>Other Roof</b><br>Inspection verified a gable roof shape. |
