COMMERCIAL WINDSTORM MITIGATION INSPECTION REPORT (OIR-B1-1802)

Windrush Bay Condominium Association, Inc.

645-648 Windrush Bay Dr (Building N)

As of 10/5/2015

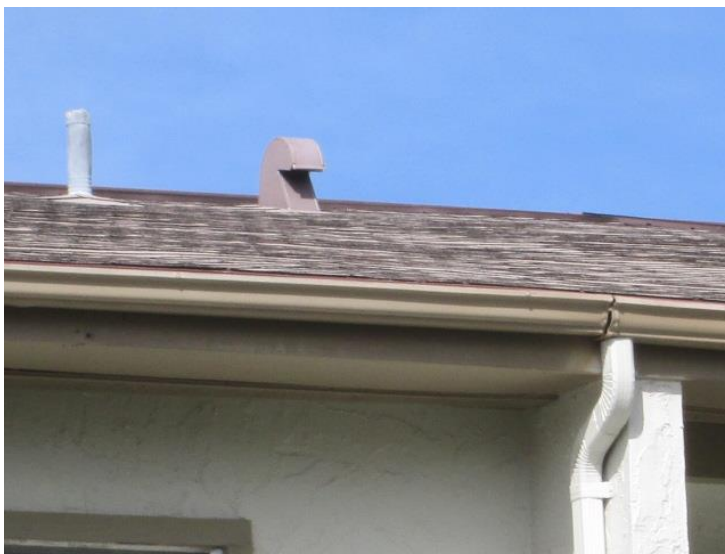
Roof Covering (Section 2)

Comments: | No roof coverings meet the minimum requirements
The roof covering was replaced in 2001. The roof permit was confirmed and the permit number is 01-2287. This roof was verified as not meeting the building code requirements outlined on the mitigation affidavit. |

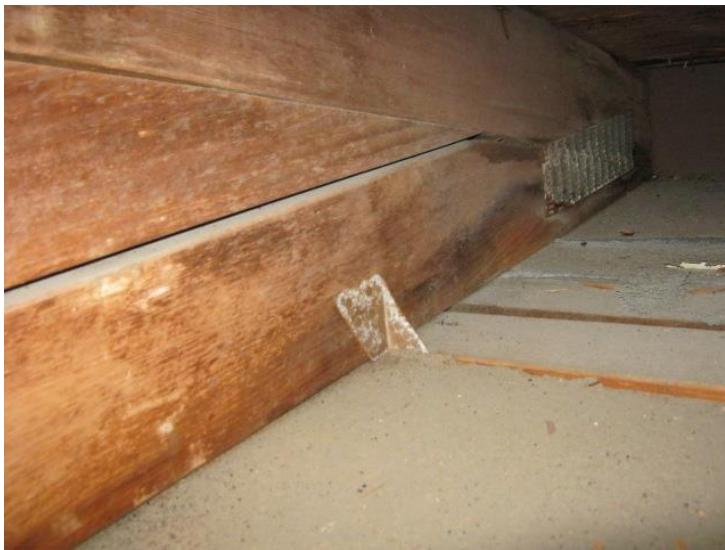
Roof to Wall Attachment
(Section 4)

Comments: | Clips
Inspection verified hurricane clips fastened with a minimum of three nails. |

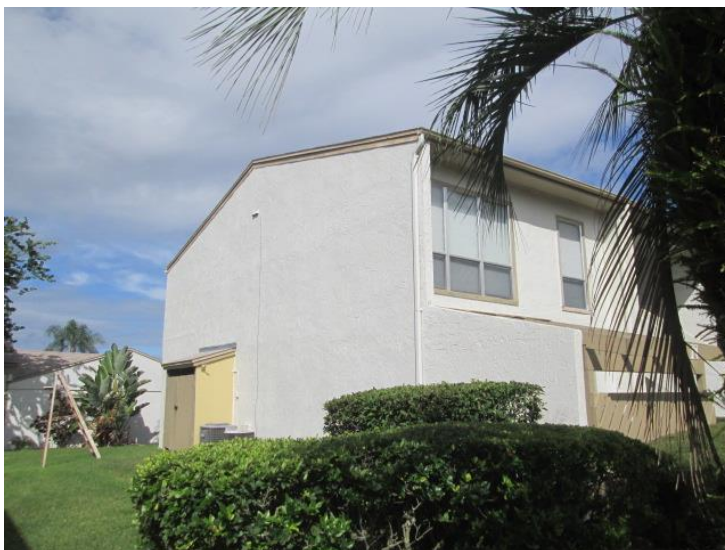
Roof Shape (Section 5)

Comments: | Other Roof
Inspection verified a gable roof shape. |
