Windrush Bay Condos Wind Mitigation 645-648

Wind Mitigation Inspection Report

By: Fair Wind Inspections Inc.

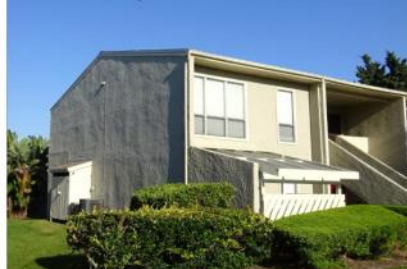
Geometry Picture

Roof Geometry: Non-Hip
Total Non-Hip: N/A Total Perimeter: N/A
Less Than 2:12: N/A Total Area: N/A

Gable end walls and/or non-hip features are greater than 10% of total perimeter

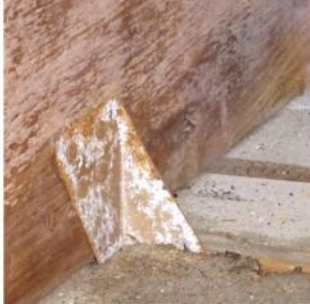
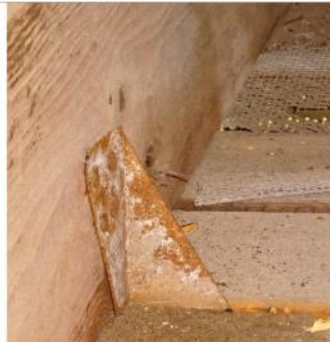
Roof to Wall Attachment:

- ☒ B. Clips
 - ☒ Metal connectors that do not wrap over the top of the truss/rafter, **or**
 - ☒ Metal connectors with a minimum of 1 strap that wraps over the top of the truss/rafter and does not meet the nail position requirements of C or D, but is secured with a minimum of 3 nails.

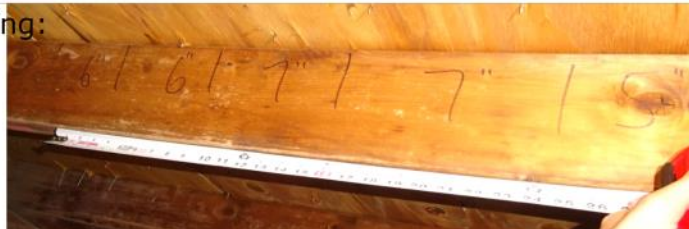
Underside of roof is in good condition

- ☒ C. Plywood/OSB roof sheathing with a minimum thickness of 7/16" inch attached to the roof truss/rafter (spaced a maximum of 24" inches o.c.) by 8d common nails spaced a maximum of 6" inches in the field. -OR- Dimensional lumber/Tongue Groove decking with a minimum of 2 nails per board (or 1 nail per board if each board is equal to or less than 6 inches in width). -OR- Any system of screws, nails, adhesives, other deck fastening system or truss/rafter spacing that is shown to have an equivalent
