COMMERCIAL WINDSTORM MITIGATION INSPECTION REPORT (OIR-B1-1802)

Windrush Bay Condominium Association, Inc.

1 Windrush Bay Dr
Tarpon Springs, FL 34689

As of 10/5/2015

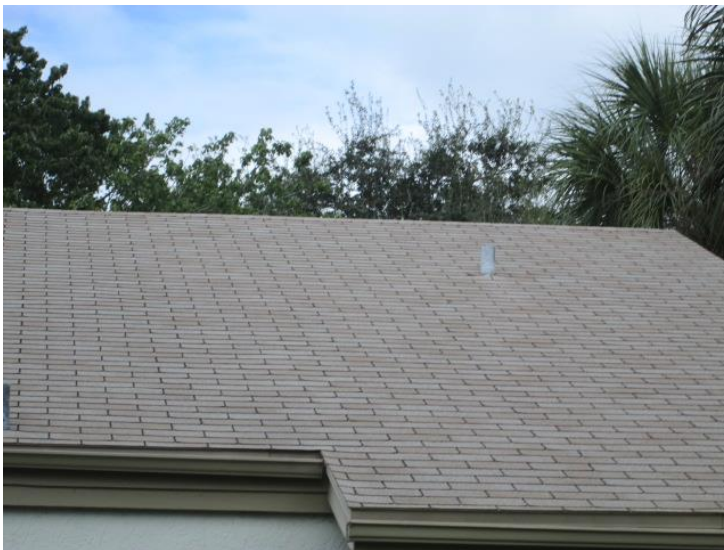
Roof Covering (Section 2)

Comments: | FBC Equivalent
The roof covering was replaced in 2003. The roof permit was confirmed and the permit number is 03-97. This roof was verified as meeting the building code requirements outlined on the mitigation affidavit. |

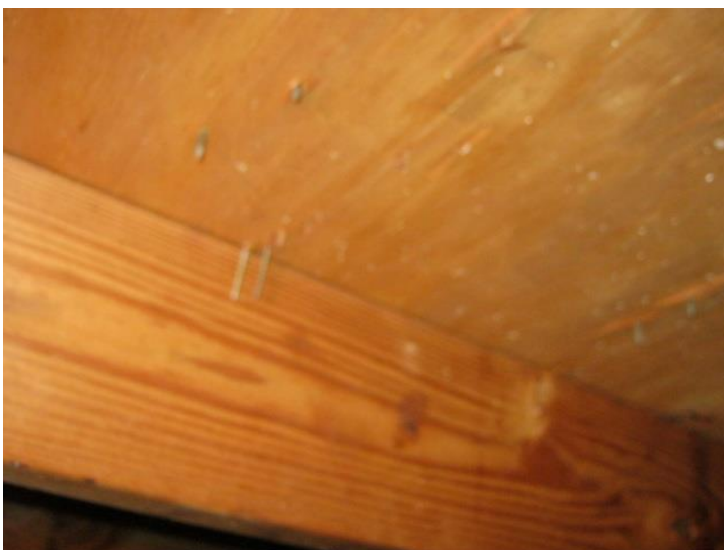
Roof Deck Attachment
(Section 3)

Comments: | Level A
Inspection verified 1/2" plywood roof deck attached with staples at a minimum of 6" on the edge & 12" in the field. |

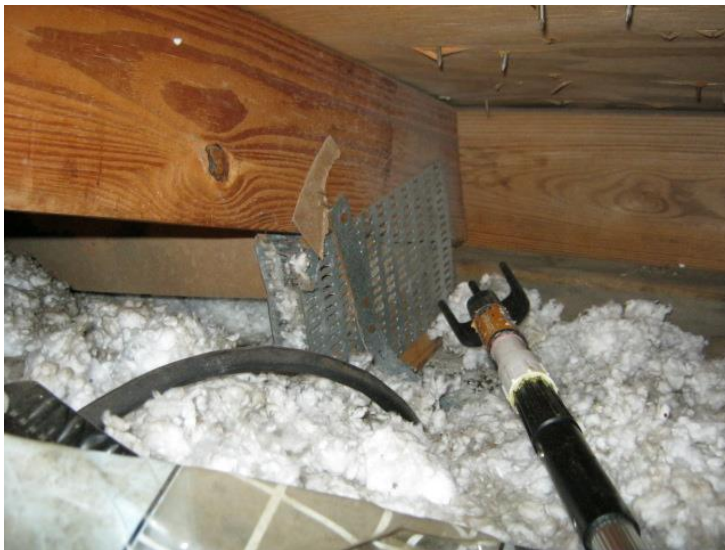
Roof to Wall Attachment (Section 4)

Comments: | Clips
Inspection verified embedded straps fastened with a minimum of three nails. |

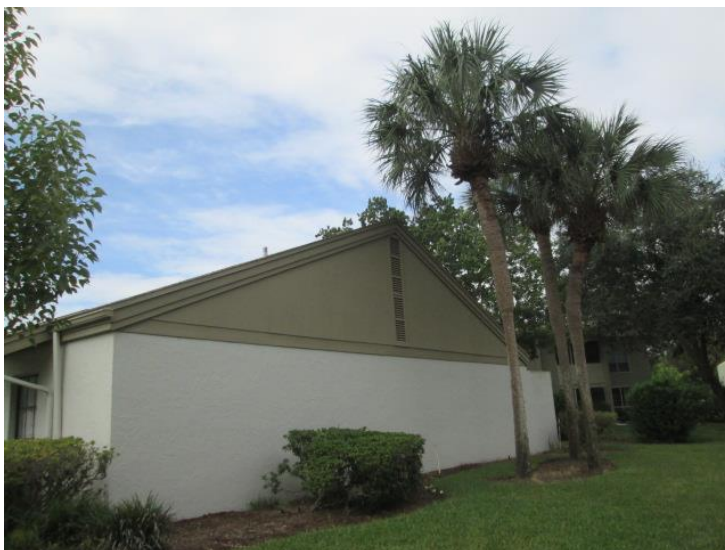
Roof Shape (Section 5)

Comments: | Other Roof
Inspection verified a gable roof shape. |
