COMMERCIAL WINDSTORM MITIGATION INSPECTION REPORT (OIR-B1-1802)

Windrush Bay Condominium Association, Inc.

15 Windrush Bay Dr
Tarpon Springs, FL 34689

As of 10/5/2015

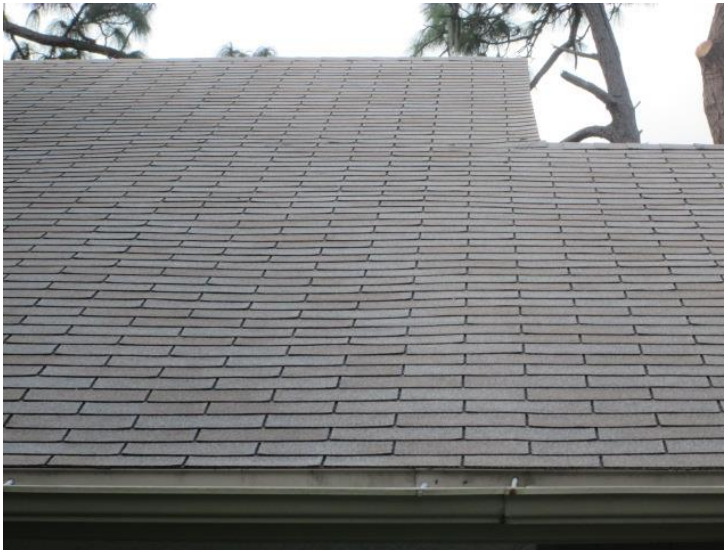
Roof Covering (Section 2)

Comments: | FBC Equivalent
The roof covering was replaced in 2003. The roof permit was confirmed and the permit number is 03-112. This roof was verified as meeting the building code requirements outlined on the mitigation affidavit. |

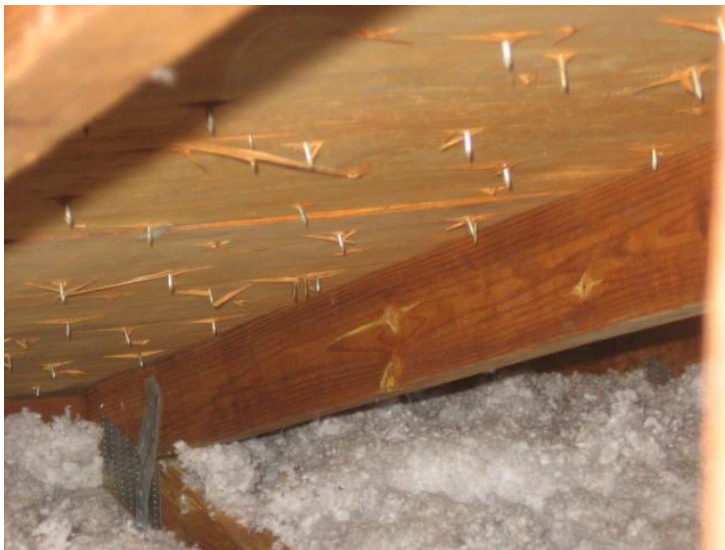
Roof to Wall Attachment (Section 4)

Comments: | Clips
Inspection verified embedded straps fastened with a minimum of three nails. |

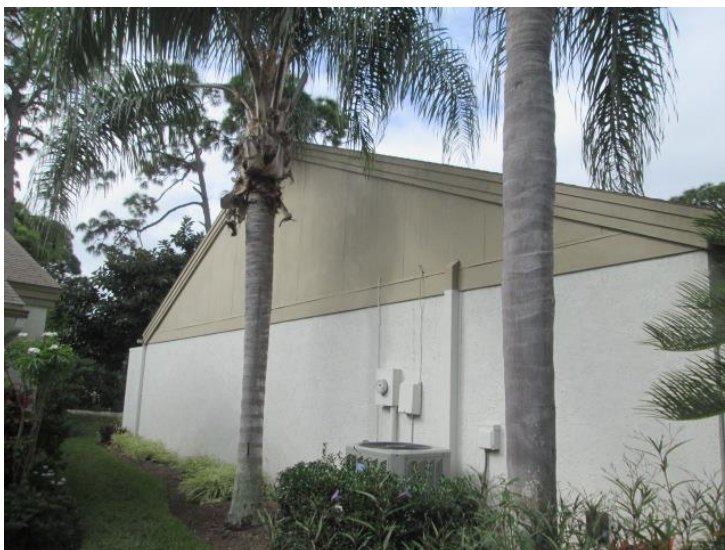
Roof Shape (Section 5)

Comments: | Other Roof
Inspection verified a gable roof shape. |
