COMMERCIAL WINDSTORM MITIGATION INSPECTION REPORT (OIR-B1-1802)

Windrush Bay Condominium Association, Inc.

16 Windrush Bay Dr
Tarpon Springs, FL 34689

As of 10/5/2015

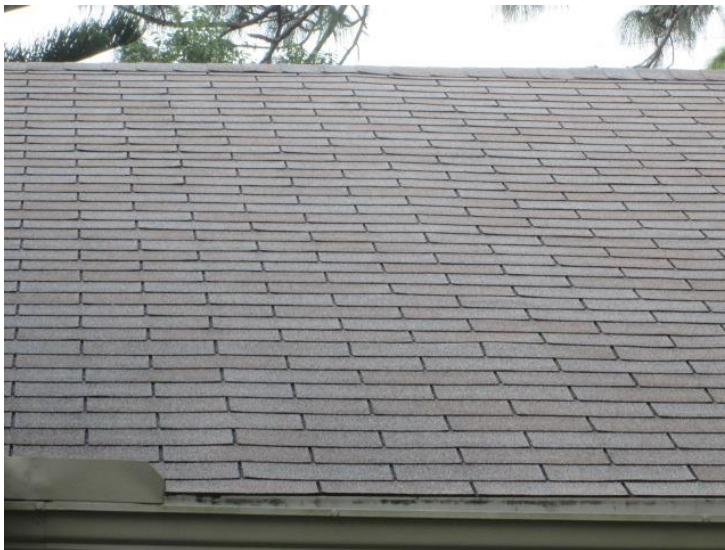
Roof Covering (Section 2)

Comments: | FBC Equivalent
The roof covering was replaced in 2003. The roof permit was confirmed and the permit number is 03-113. This roof was verified as meeting the building code requirements outlined on the mitigation affidavit. |

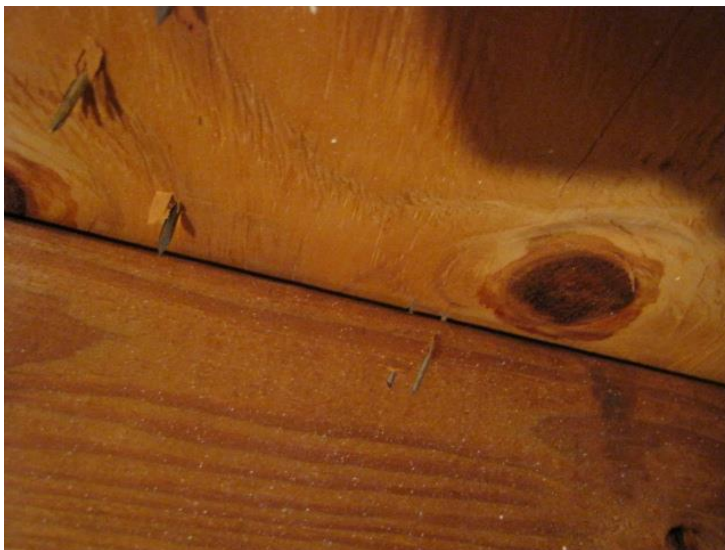
Roof Deck Attachment
(Section 3)

Comments: | Level A
Inspection verified 1/2" plywood roof deck attached with staples at a minimum of 6" on the edge & 12" in the field. |

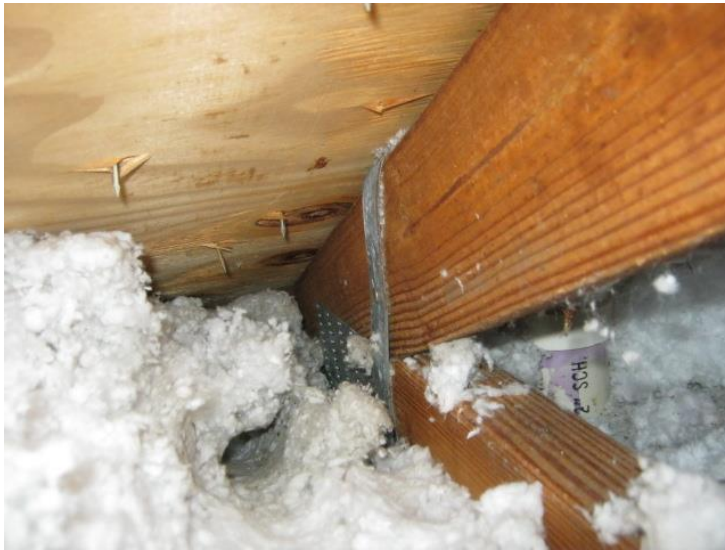
Roof to Wall Attachment (Section 4)

Comments: | Clips
Inspection verified embedded straps fastened with a minimum of three nails. |

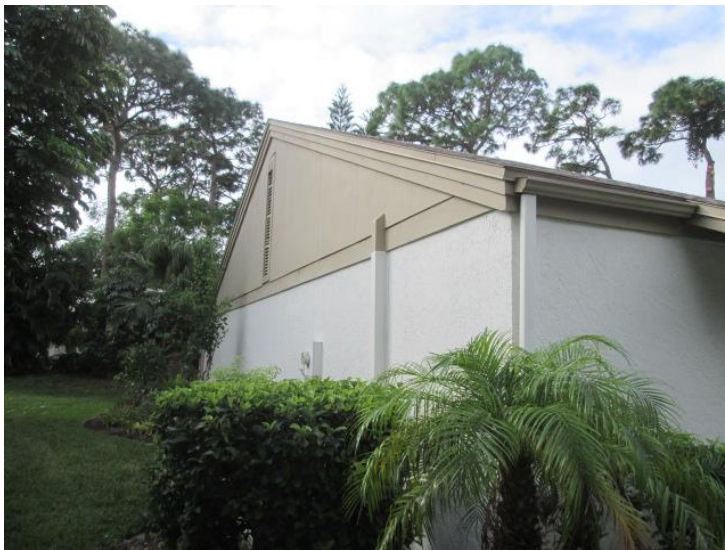
Roof Shape (Section 5)

Comments: | Other Roof
Inspection verified a gable roof shape. |
