COMMERCIAL WINDSTORM MITIGATION INSPECTION REPORT (OIR-B1-1802)

Windrush Bay Condominium Association, Inc.

19 Windrush Bay Dr
Tarpon Springs, FL 34689

As of 10/5/2015

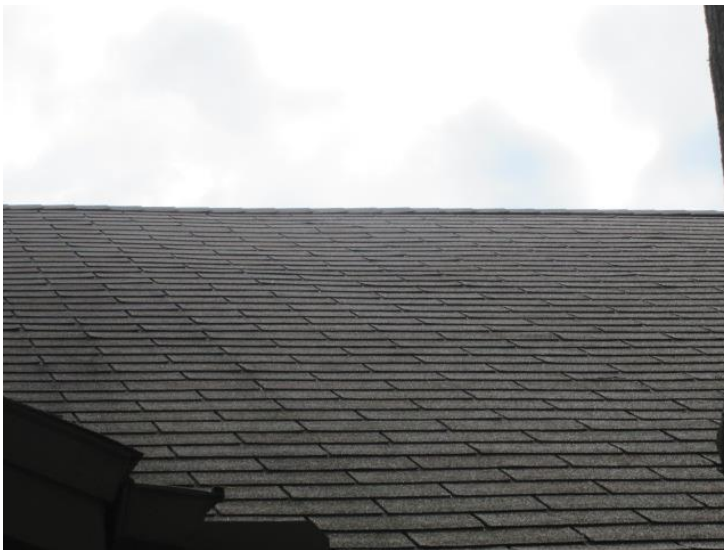
Roof Covering (Section 2)

Comments: | FBC Equivalent
The roof covering was replaced in 2003. The roof permit was confirmed and the permit number is 03-116. This roof was verified as meeting the building code requirements outlined on the mitigation affidavit. |

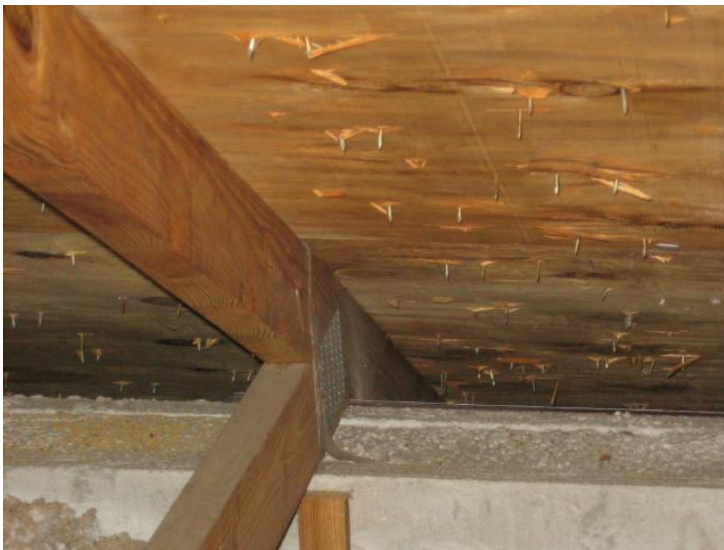
Roof to Wall Attachment
(Section 4)

Comments: | Clips
Inspection verified embedded straps fastened with a minimum of three nails. |

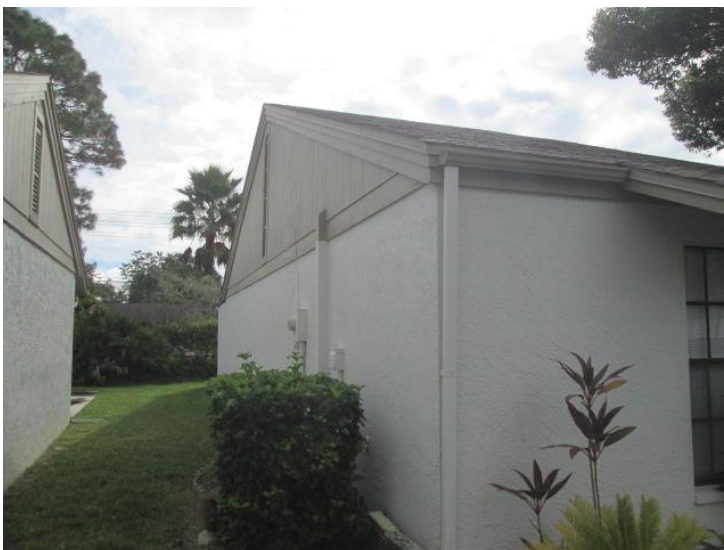
Roof Shape (Section 5)

Comments: | Other Roof
Inspection verified a gable roof shape. |
