COMMERCIAL WINDSTORM MITIGATION INSPECTION REPORT (OIR-B1-1802)

Windrush Bay Condominium Association, Inc.

23 Windrush Bay Dr
Tarpon Springs, FL 34689

As of 10/5/2015

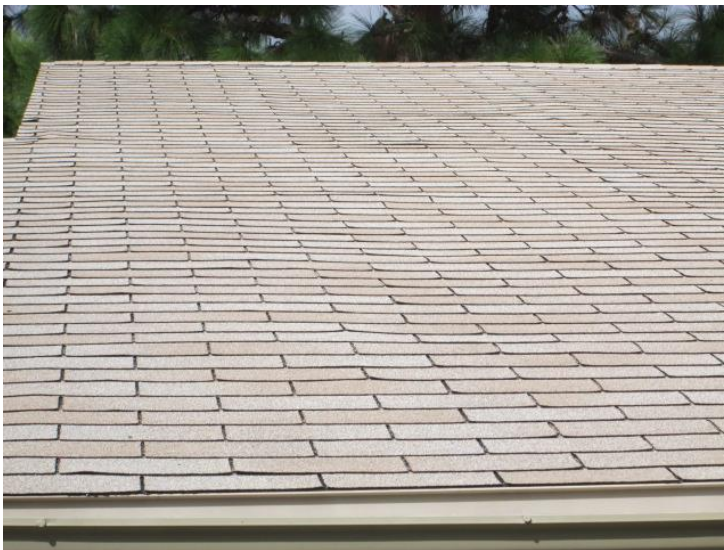
Roof Covering (Section 2)

Comments: | FBC Equivalent
The roof covering was replaced in 2003. The roof permit was confirmed and the permit number is 03-120. This roof was verified as meeting the building code requirements outlined on the mitigation affidavit. |

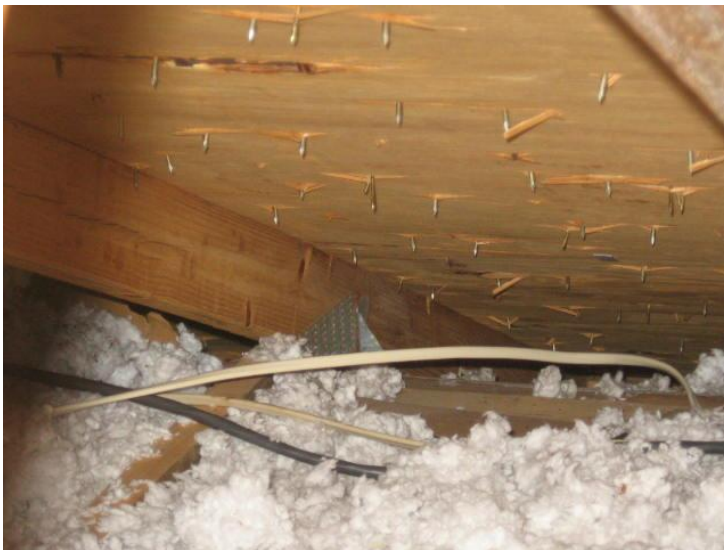
Roof to Wall Attachment
(Section 4)

Comments: | Clips
Inspection verified hurricane clips fastened with a minimum of three nails. |

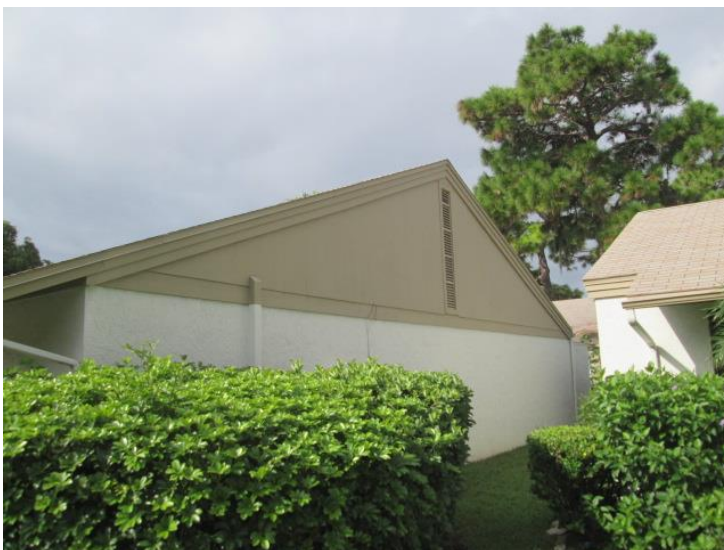
Roof Shape (Section 5)

Comments: | Other Roof
Inspection verified a gable roof shape. |
