COMMERCIAL WINDSTORM MITIGATION INSPECTION REPORT (OIR-B1-1802)

Windrush Bay Condominium Association, Inc.

24 Windrush Bay Dr
Tarpon Springs, FL 34689

As of 10/5/2015

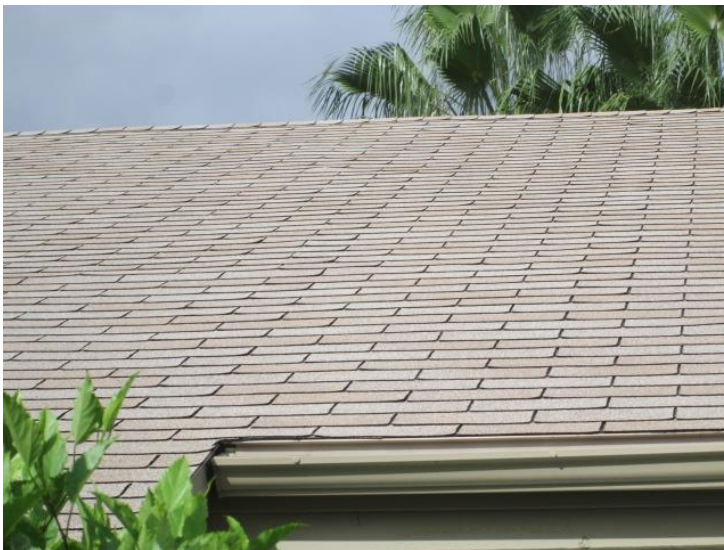
Roof Covering (Section 2)

Comments: | FBC Equivalent
The roof covering was replaced in 2003. The roof permit was confirmed and the permit number is 03-121. This roof was verified as meeting the building code requirements outlined on the mitigation affidavit. |

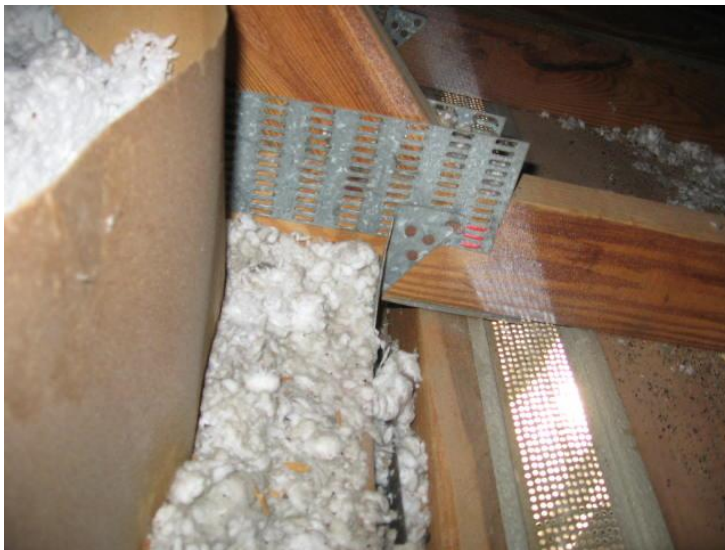
Roof to Wall Attachment
(Section 4)

Comments: | Clips
Inspection verified hurricane clips fastened with a minimum of three nails. |

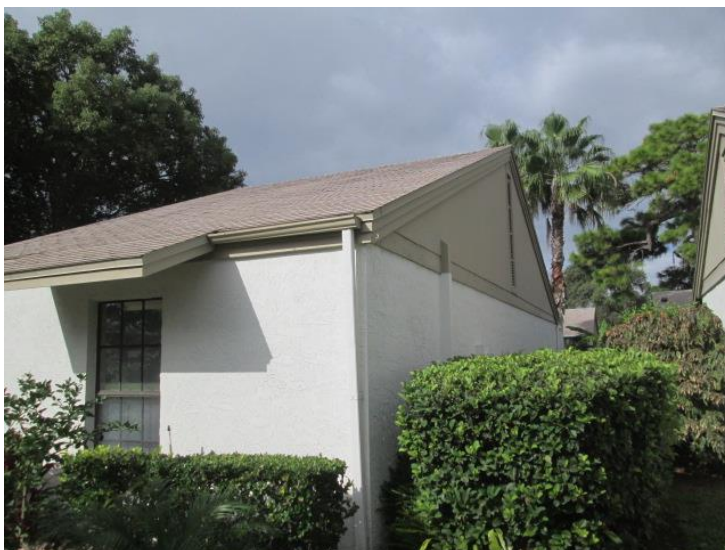
Roof Shape (Section 5)

Comments: | Other Roof
Inspection verified a gable roof shape. |
