## COMMERCIAL WINDSTORM MITIGATION INSPECTION REPORT (OIR-B1-1802)

Windrush Bay Condominium Association, Inc.

26 Windrush Bay Dr  
Tarpon Springs, FL 34689

As of 10/5/2015

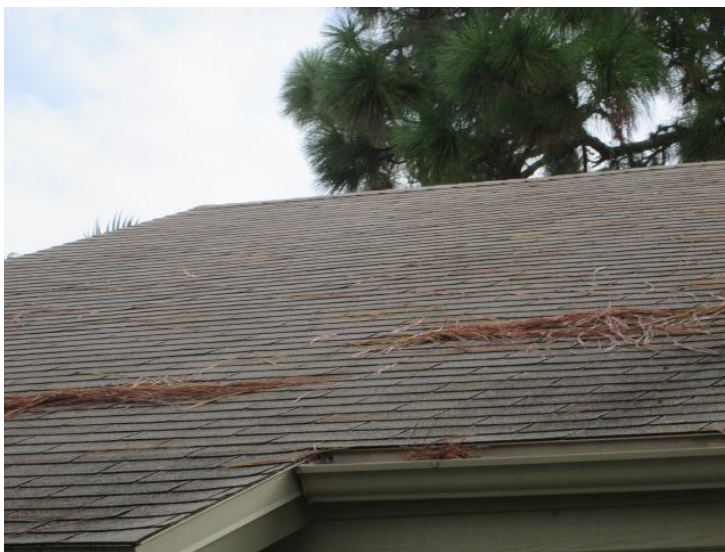
Roof Covering (Section 2)

| <b>2. <u>Roof Covering:</u></b><br>Comments: | <b>FBC Equivalent</b><br>The roof covering was replaced in 2003. The roof permit was confirmed and the permit number is 03-123. This roof was verified as meeting the building code requirements outlined on the mitigation affidavit. |

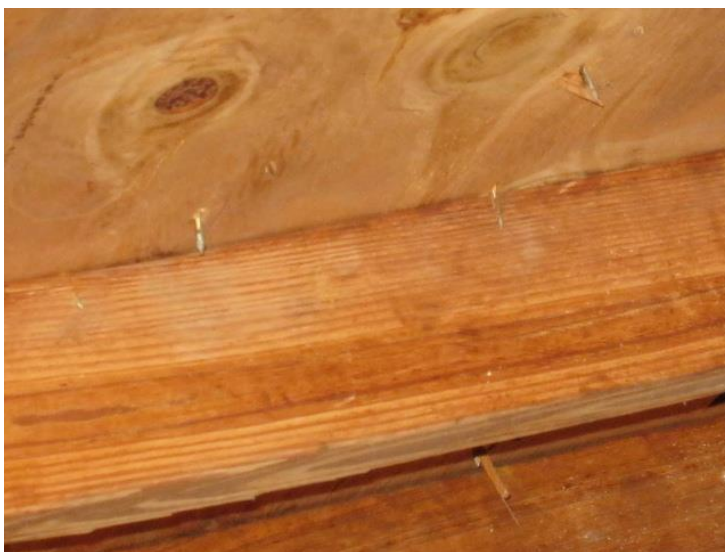
Roof Deck Attachment  
(Section 3)

| <b>3. <u>Roof Deck Attachment:</u></b><br>Comments: | <b>Level A</b><br>Inspection verified 1/2" plywood roof deck attached with staples at a minimum of 6" on the edge & 12" in the field. |

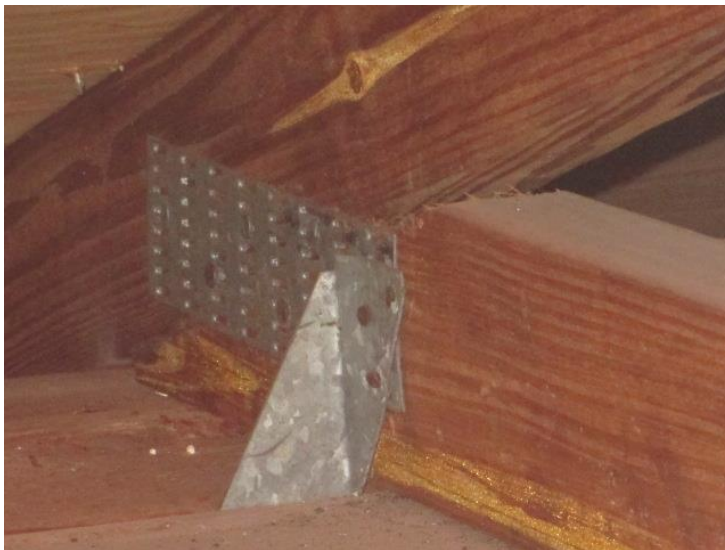
Roof to Wall Attachment (Section 4)

| <b>4. <u>Roof to Wall Attachment:</u></b><br>Comments: | <b>Clips</b><br>Inspection verified hurricane clips fastened with a minimum of three nails. |

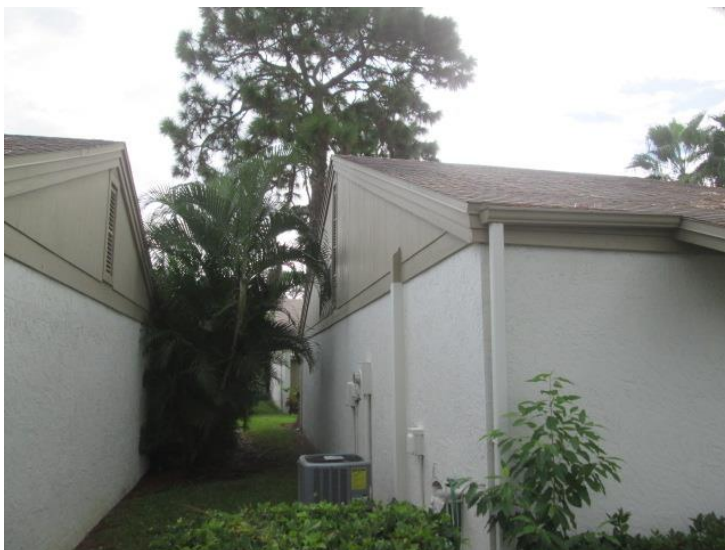
Roof Shape (Section 5)

| <b>5. <u>Roof Geometry:</u></b><br>Comments: | <b>Other Roof</b><br>Inspection verified a gable roof shape. |
