COMMERCIAL WINDSTORM MITIGATION INSPECTION REPORT (OIR-B1-1802)

Windrush Bay Condominium Association, Inc.

28 Windrush Bay Dr
Tarpon Springs, FL 34689

As of 10/5/2015

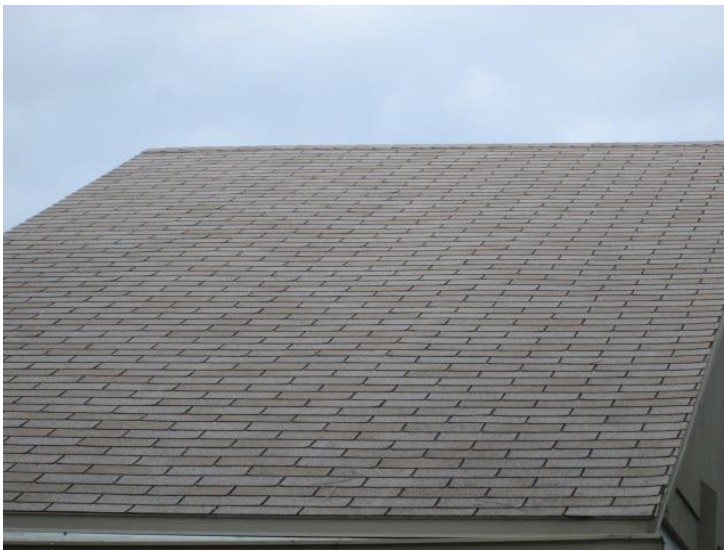
Roof Covering (Section 2)

Comments: | FBC Equivalent
The roof covering was replaced in 2003. The roof permit was confirmed and the permit number is 03-125. This roof was verified as meeting the building code requirements outlined on the mitigation affidavit. |

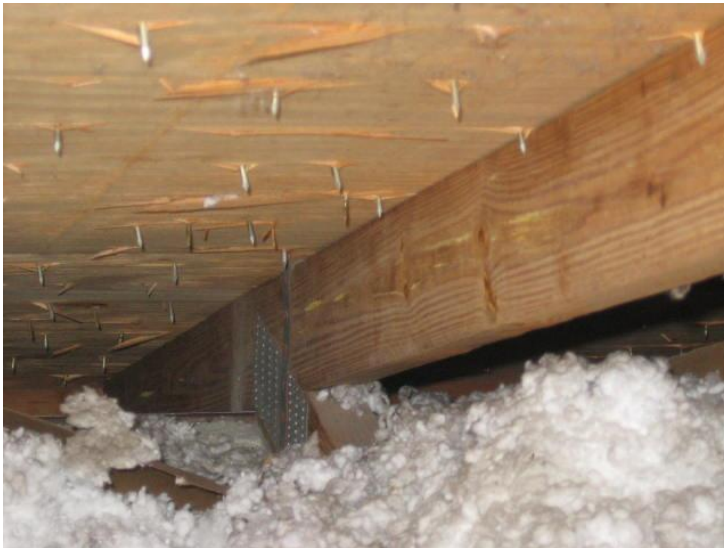
Roof to Wall Attachment
(Section 4)

Comments: | Clips
Inspection verified embedded straps fastened with a minimum of three nails. |

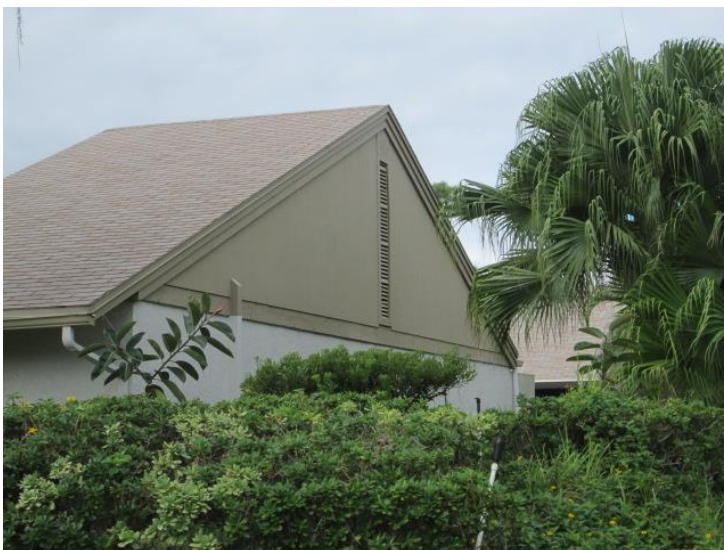
Roof Shape (Section 5)

Comments: | Other Roof
Inspection verified a gable roof shape. |
