COMMERCIAL WINDSTORM MITIGATION INSPECTION REPORT (OIR-B1-1802)

Windrush Bay Condominium Association, Inc.

30 Windrush Bay Dr
Tarpon Springs, FL 34689

As of 10/5/2015

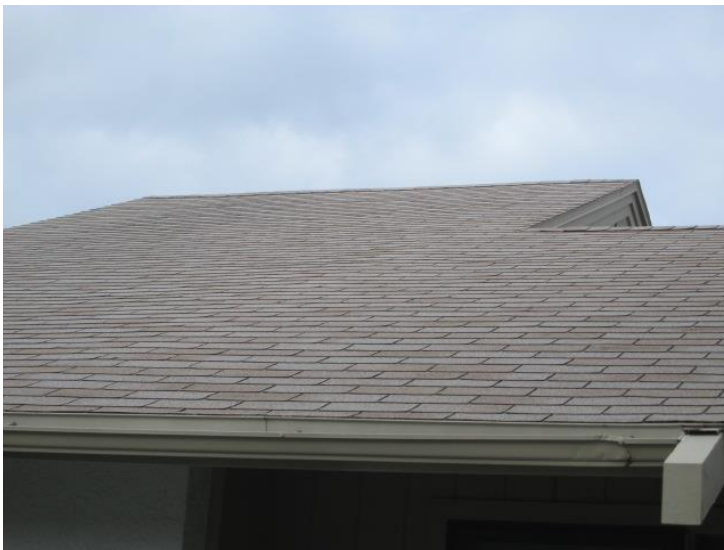
Roof Covering (Section 2)

Comments: | FBC Equivalent
The roof covering was replaced in 2003. The roof permit was confirmed and the permit number is 03-127. This roof was verified as meeting the building code requirements outlined on the mitigation affidavit. |

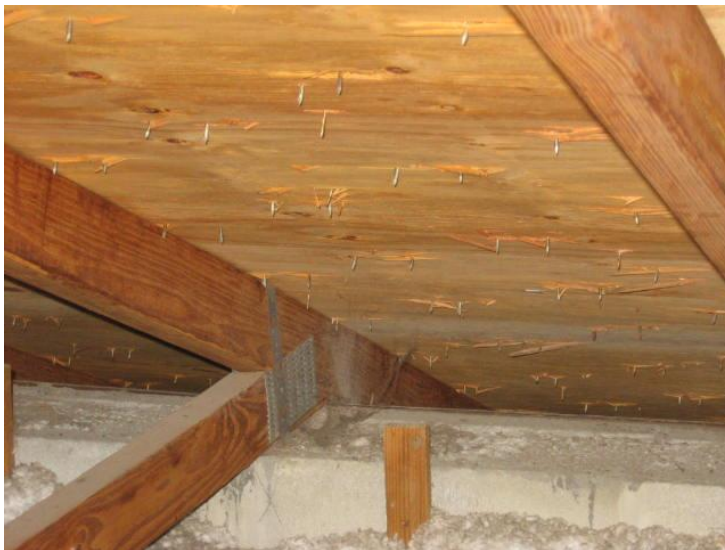
Roof to Wall Attachment
(Section 4)

Comments: | Clips
Inspection verified embedded straps fastened with a minimum of three nails. |

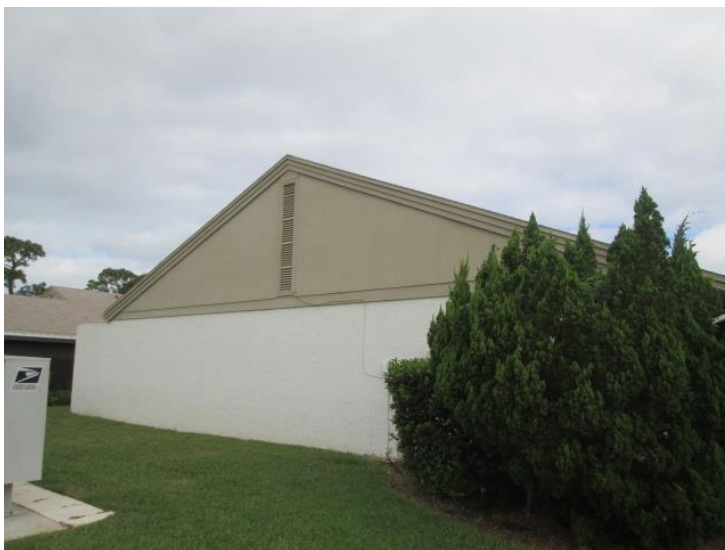
Roof Shape (Section 5)

Comments: | Other Roof
Inspection verified a gable roof shape. |
