COMMERCIAL WINDSTORM MITIGATION INSPECTION REPORT (OIR-B1-1802)

Windrush Bay Condominium Association, Inc.

37 Windrush Bay Dr
Tarpon Springs, FL 34689

As of 10/5/2015

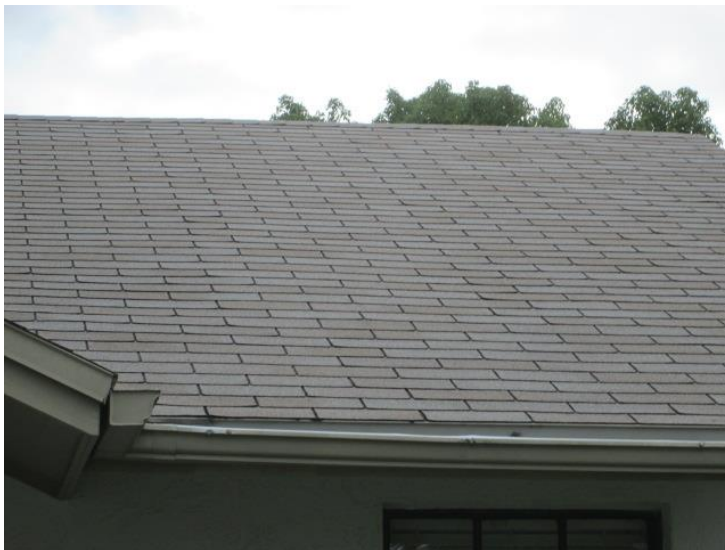
Roof Covering (Section 2)

Comments: | FBC Equivalent
The roof covering was replaced in 2003. The roof permit was confirmed and the permit number is 03-134. This roof was verified as meeting the building code requirements outlined on the mitigation affidavit. |

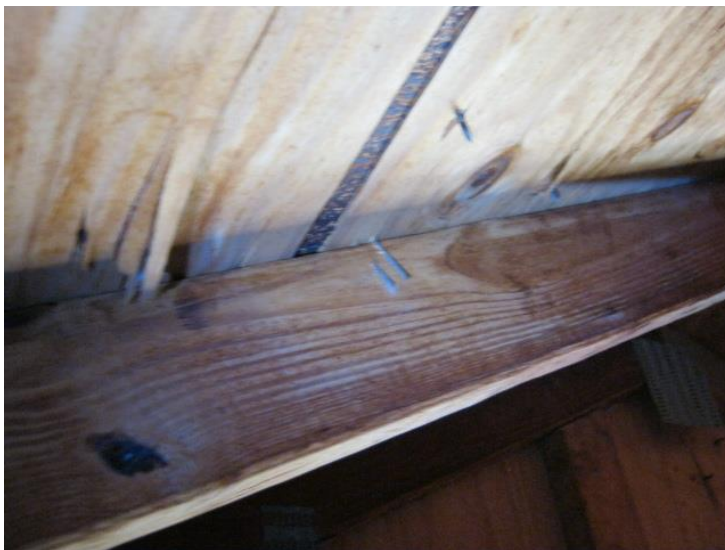
Roof Deck Attachment
(Section 3)

Comments: | Level A
Inspection verified 1/2" plywood roof deck attached with staples at a minimum of 6" on the edge & 12" in the field. |

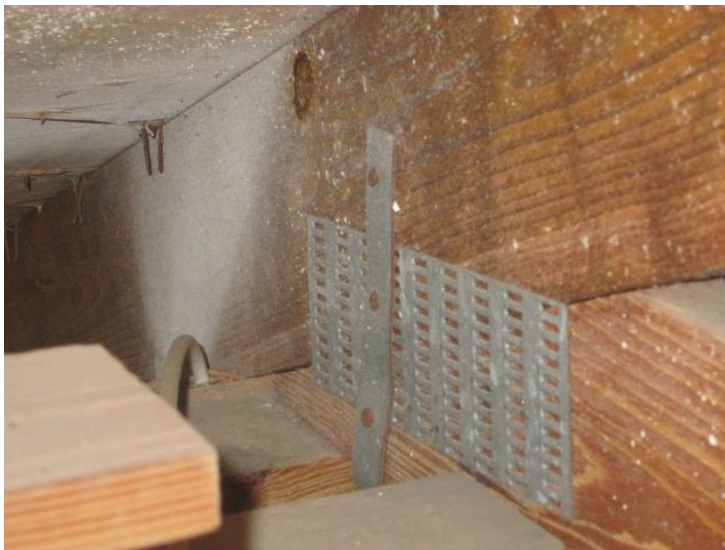
Roof to Wall Attachment (Section 4)

Comments: | Clips
Inspection verified embedded straps fastened with a minimum of three nails. |

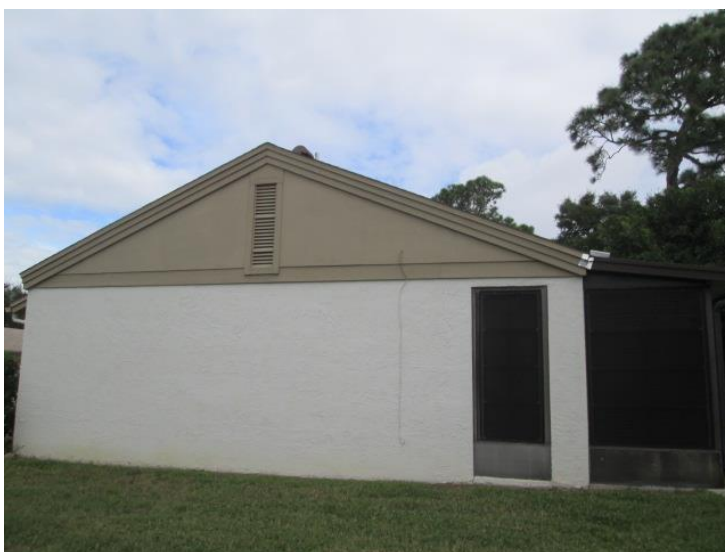
Roof Shape (Section 5)

Comments: | Other Roof
Inspection verified a gable roof shape. |
