COMMERCIAL WINDSTORM MITIGATION INSPECTION REPORT (OIR-B1-1802)

Windrush Bay Condominium Association, Inc.

39 Windrush Bay Dr
Tarpon Springs, FL 34689

As of 10/5/2015

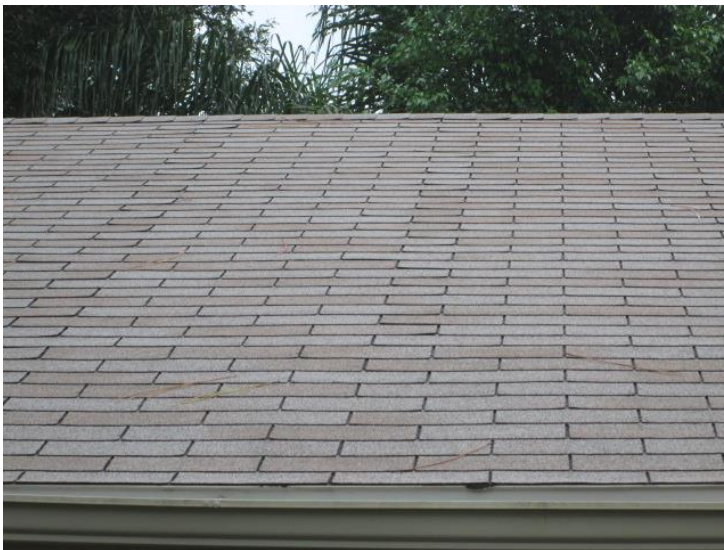
Roof Covering (Section 2)

Comments: | FBC Equivalent
The roof covering was replaced in 2003. The roof permit was confirmed and the permit number is 03-136. This roof was verified as meeting the building code requirements outlined on the mitigation affidavit. |

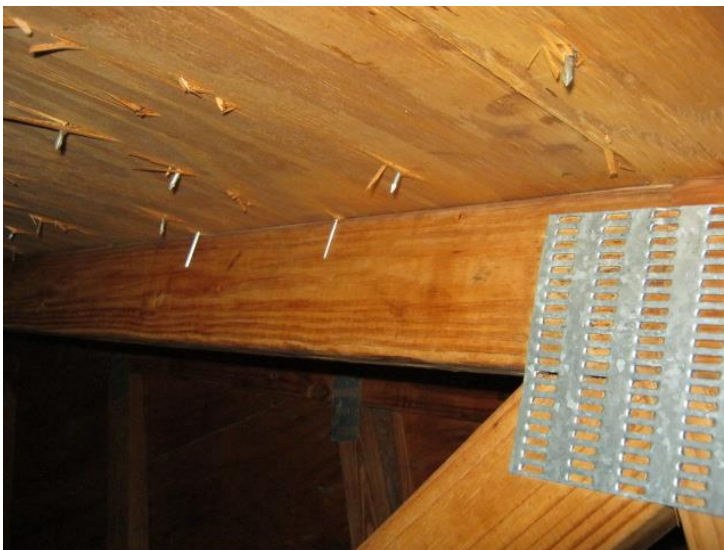
Roof Deck Attachment
(Section 3)

Comments: | Level A
Inspection verified 1/2" plywood roof deck attached with staples at a minimum of 6" on the edge & 12" in the field. |

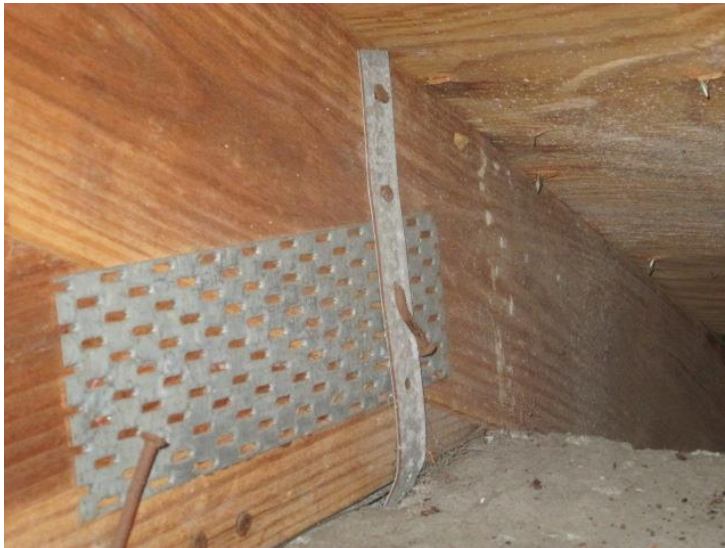
Roof to Wall Attachment (Section 4)

Comments: | Clips
Inspection verified embedded straps fastened with a minimum of three nails. |

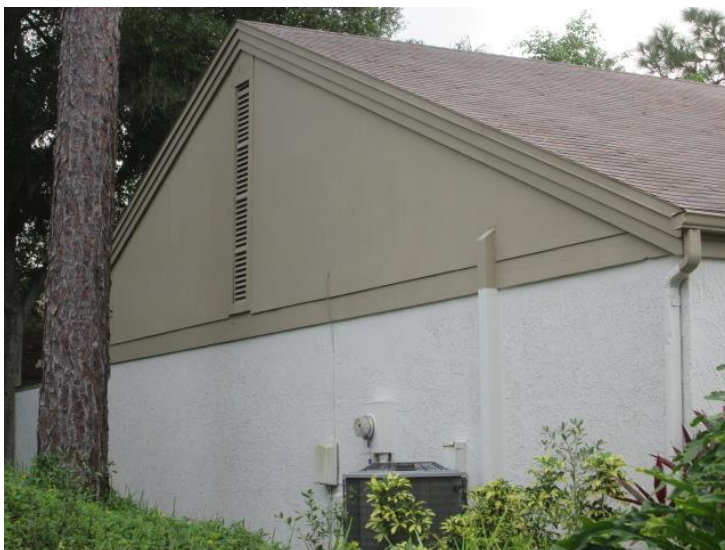
Roof Shape (Section 5)

Comments: | Other Roof
Inspection verified a gable roof shape. |
