COMMERCIAL WINDSTORM MITIGATION INSPECTION REPORT (OIR-B1-1802)

Windrush Bay Condominium Association, Inc.

4 Windrush Bay Dr
Tarpon Springs, FL 34689

As of 10/5/2015

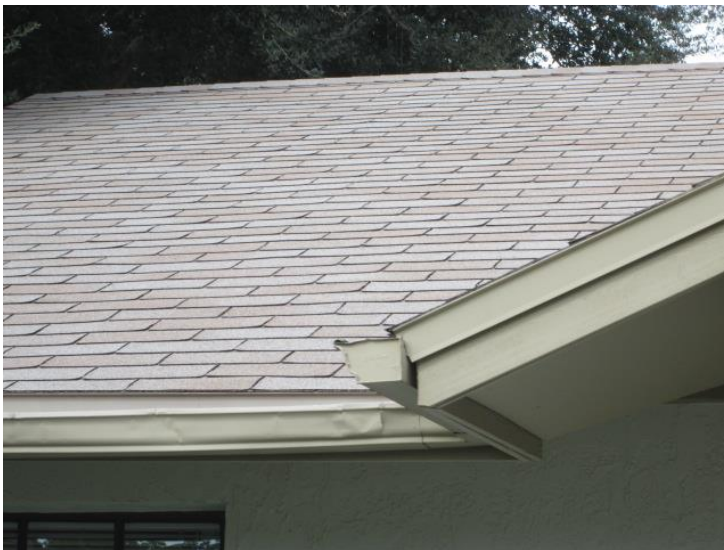
Roof Covering (Section 2)

Comments: | FBC Equivalent
The roof covering was replaced in 2003. The roof permit was confirmed and the permit number is 03-100. This roof was verified as meeting the building code requirements outlined on the mitigation affidavit. |

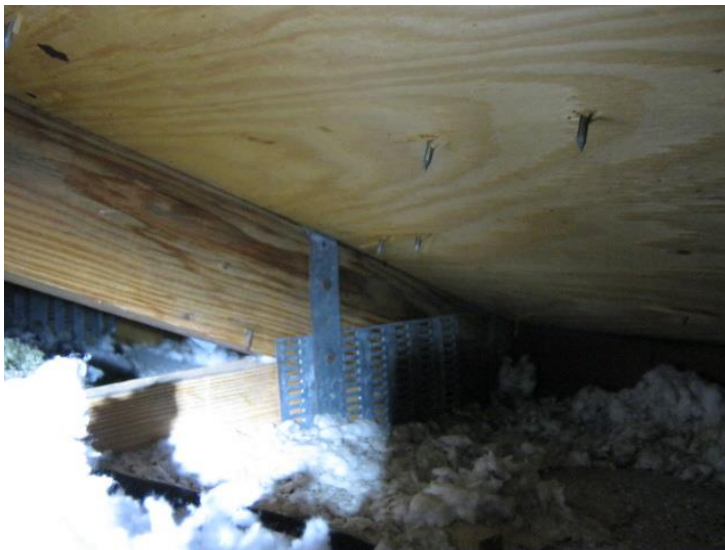
Roof to Wall Attachment (Section 4)

Comments: | Clips
Inspection verified embedded straps fastened with a minimum of three nails. |

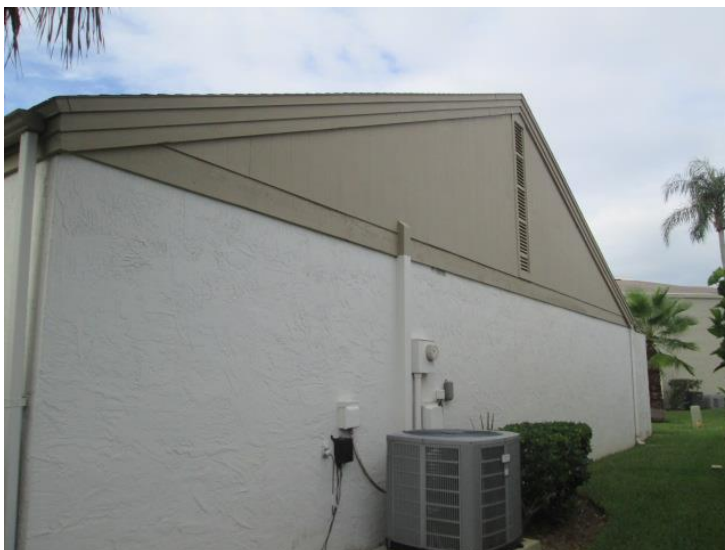
Roof Shape (Section 5)

Comments: | Other Roof
Inspection verified a gable roof shape. |
