## COMMERCIAL WINDSTORM MITIGATION INSPECTION REPORT (OIR-B1-1802)

Windrush Bay Condominium Association, Inc.

6 Windrush Bay Dr  
Tarpon Springs, FL 34689

As of 10/5/2015

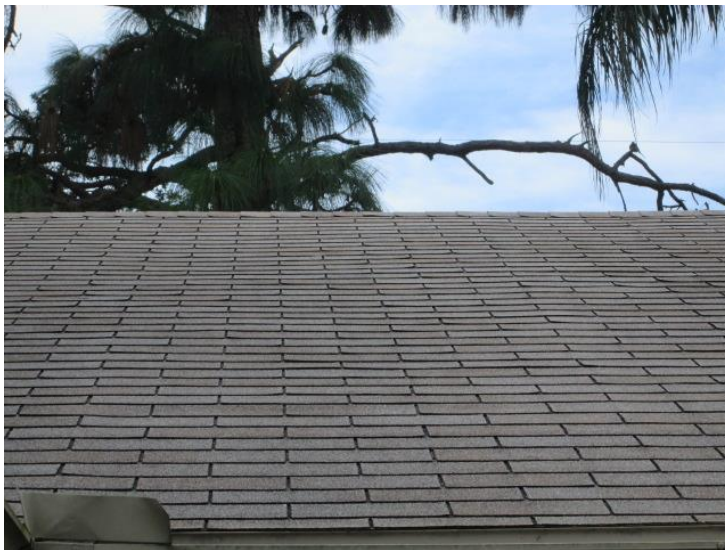
Roof Covering (Section 2)

| <b>2. <u>Roof Covering:</u></b><br>Comments: | <b>FBC Equivalent</b><br>The roof covering was replaced in 2003. The roof permit was confirmed and the permit number is 03-103. This roof was verified as meeting the building code requirements outlined on the mitigation affidavit. |

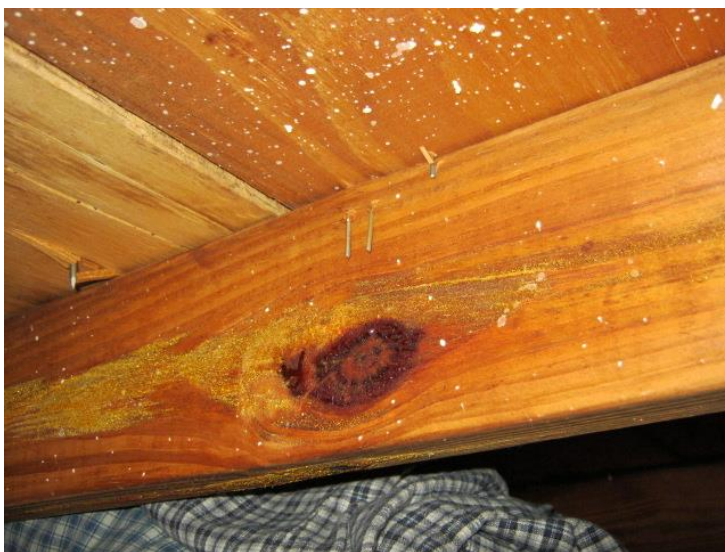
Roof Deck Attachment  
(Section 3)

| <b>3. <u>Roof Deck Attachment:</u></b><br>Comments: | <b>Level A</b><br>Inspection verified 1/2" plywood roof deck attached with staples at a minimum of 6" on the edge & 12" in the field. |

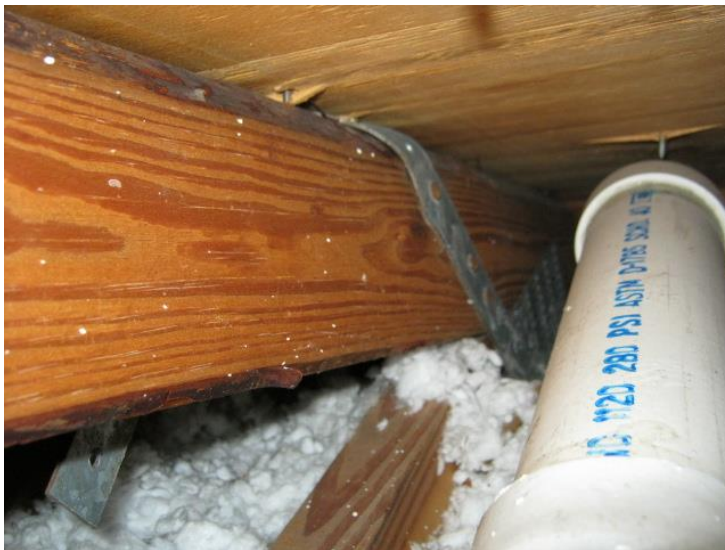
Roof to Wall Attachment (Section 4)

| <b>4. <u>Roof to Wall Attachment:</u></b><br>Comments: | <b>Clips</b><br>Inspection verified embedded straps fastened with a minimum of three nails. |

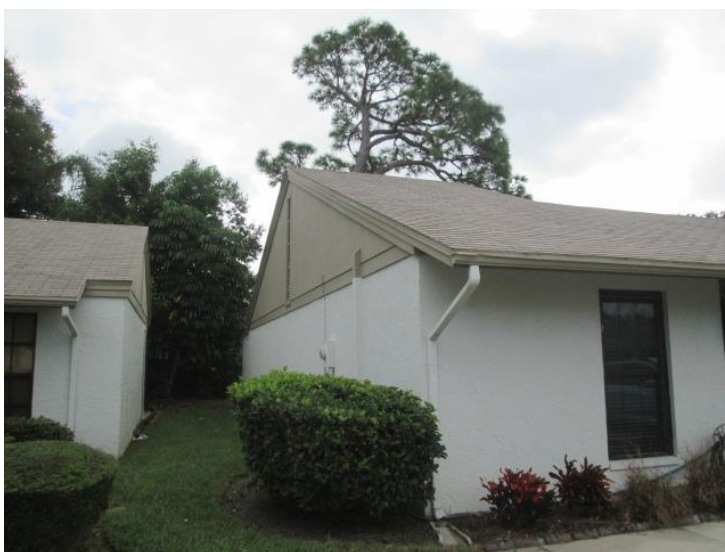
Roof Shape (Section 5)

| <b>5. <u>Roof Geometry:</u></b><br>Comments: | <b>Other Roof</b><br>Inspection verified a gable roof shape. |
