COMMERCIAL WINDSTORM MITIGATION INSPECTION REPORT (OIR-B1-1802)

Windrush Bay Condominium Association, Inc.

9 Windrush Bay Dr
Tarpon Springs, FL 34689

As of 10/5/2015

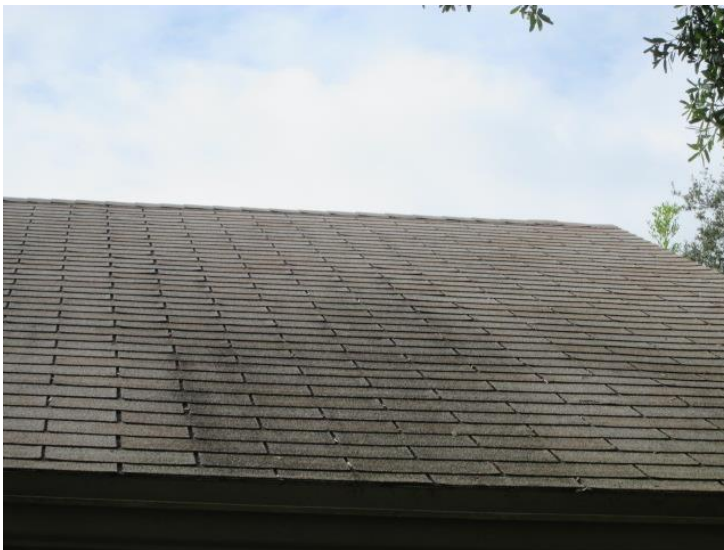
Roof Covering (Section 2)

Comments: | FBC Equivalent
The roof covering was replaced in 2003. The roof permit was confirmed and the permit number is 03-106. This roof was verified as meeting the building code requirements outlined on the mitigation affidavit. |

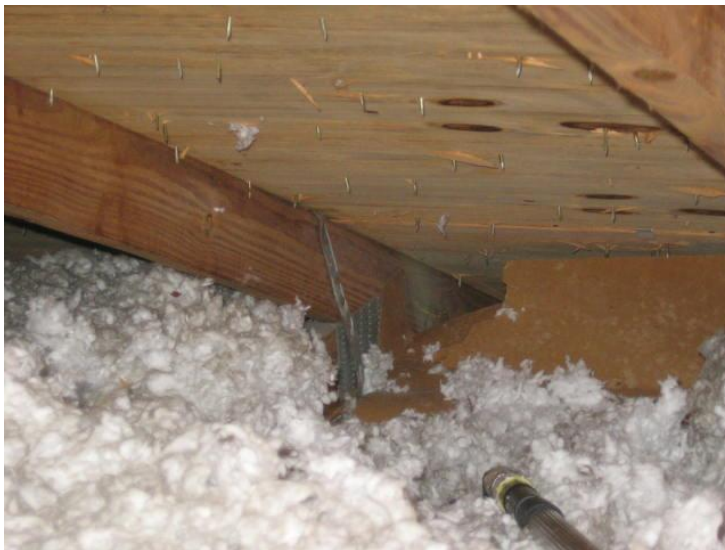
Roof to Wall Attachment
(Section 4)

Comments: | Clips
Inspection verified embedded straps fastened with a minimum of three nails. |

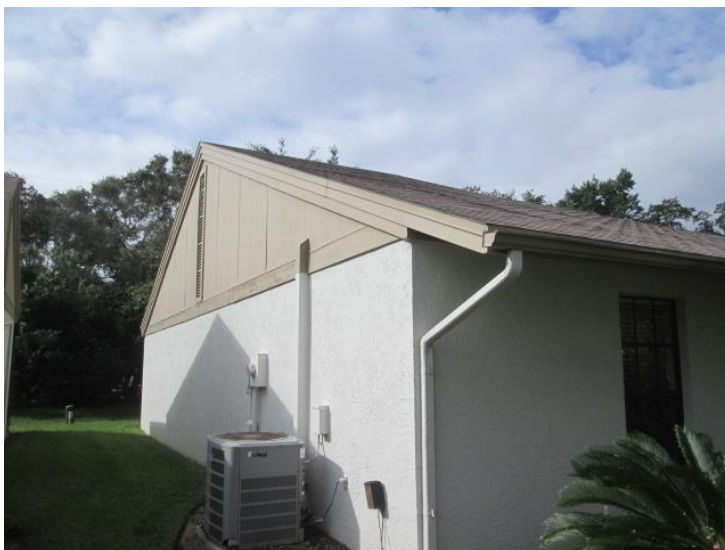
Roof Shape (Section 5)

Comments: | Other Roof
Inspection verified a gable roof shape. |
